Review of Environmental Factors

New Foreshore Lighting along Old Kings Parade Ground
Marsden Street to O'Connell Street, Parramatta

22 July 2020

Prepared by
Andrew Robinson Planning Services Pty Ltd
2/182 Old Canterbury Road SUMMER HILL NSW 2130
Tel 02 9798 0953

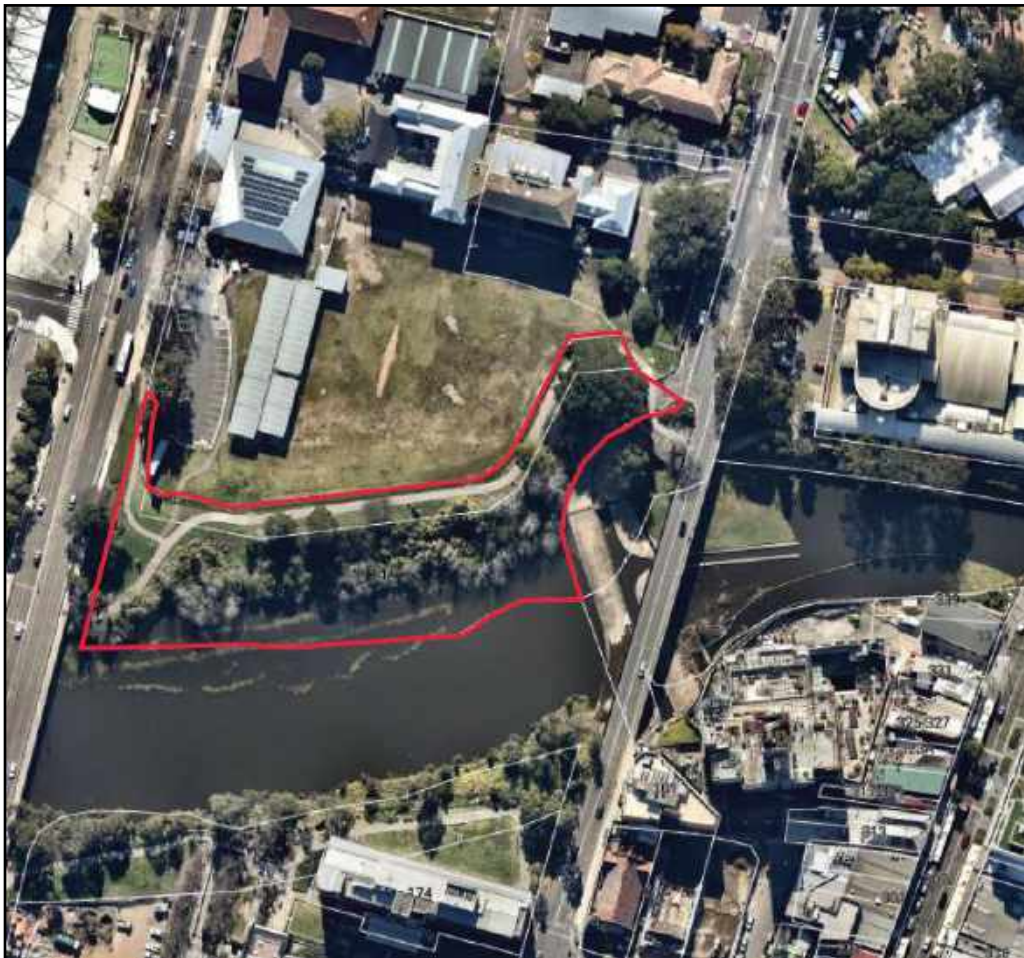
Figure 1.1 – Aerial View delineating the approx. area of works adjacent to the Old Kings Parade Ground.

An aerial view of the shared pathway between Marsden Street and O'Connell Street and the surrounding area is provided in **Figure 1.1** below:

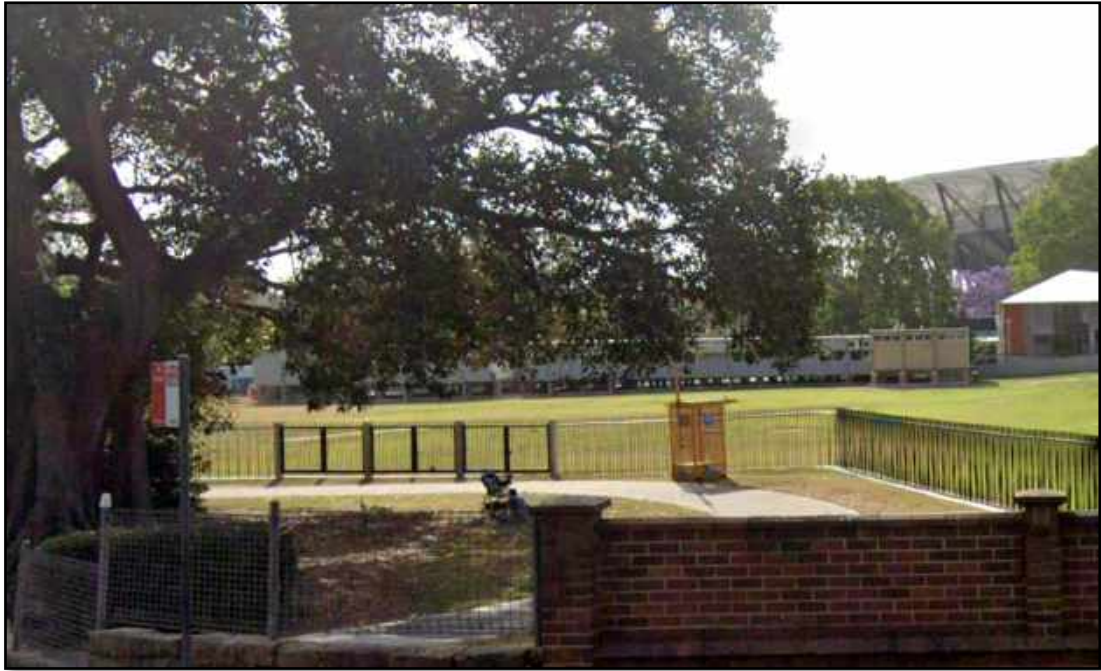
Image 2.1: View of the eastern end of the shared pathway, looking from Marsden Street and showing one of the temporary lighting fixtures (image courtesy of nearmap.com.au).

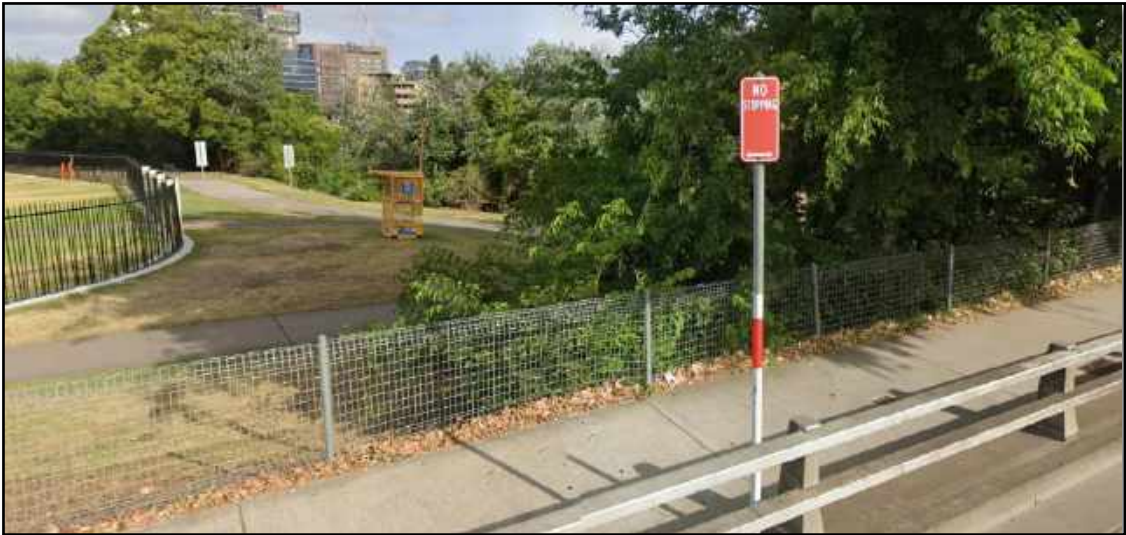
Image 2.2: View of the western end of the shared pathway, looking from O'Connell Street and showing one of the temporary lighting fixtures (image courtesy of nearmap.com.au).

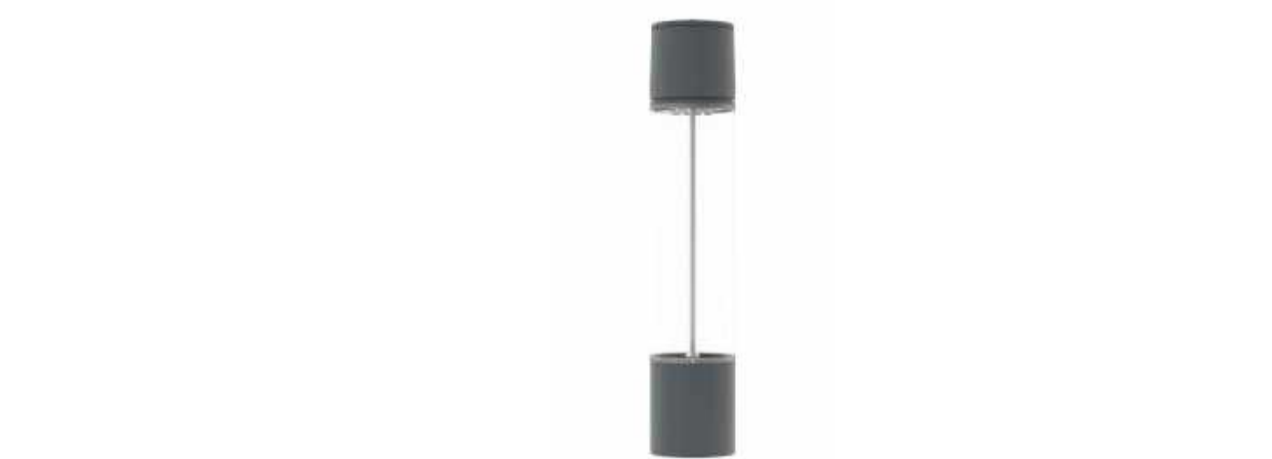
05 AR TOP ELEMENT IMAGE N.T.S.@A1

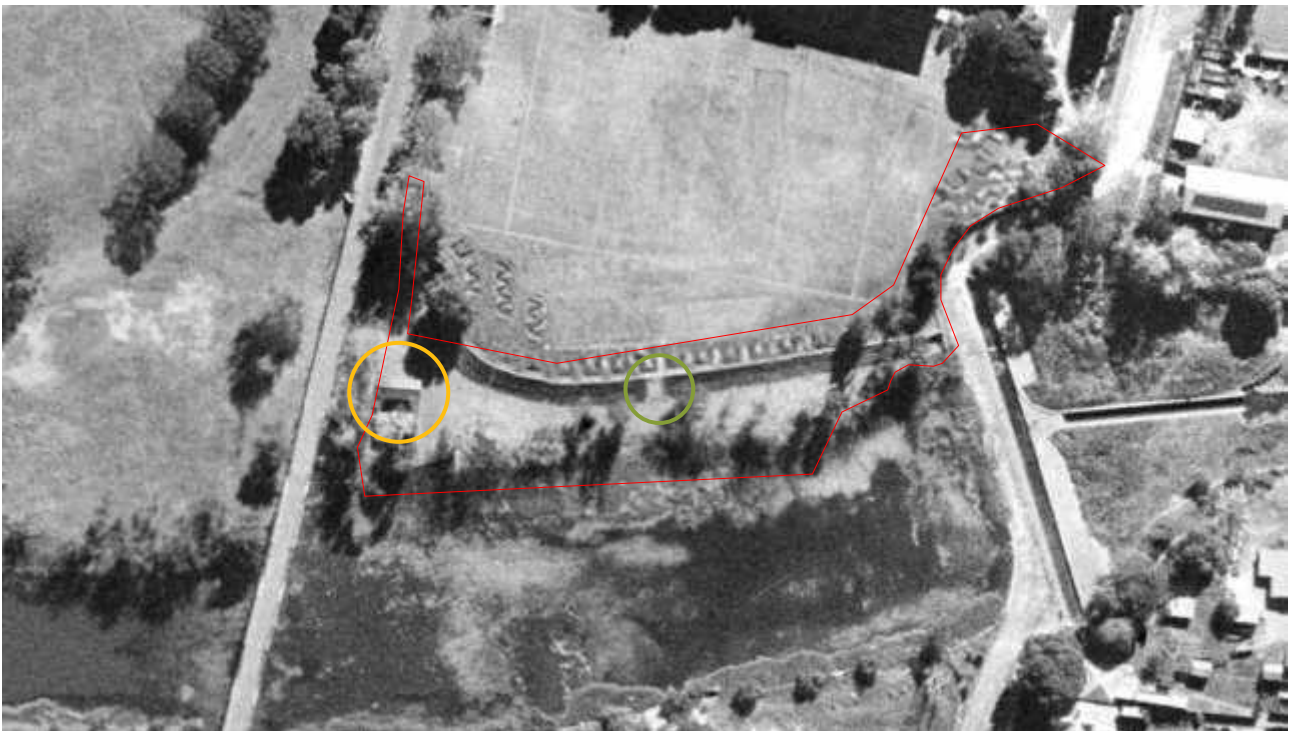
Plate 2.5 A 1943 aerial photograph of the project area (red) with rectilinear structure (yellow), retaining wall and stairs (green). Source: SIX Maps 2020.

This incinerator may be associated with the rectilinear structure identified in the 1943 aerial (Plate 2.5) but not present in the 1970 aerial (Plate 2.6). Refer to Section 6.1 for further discussion regarding the relationship of these two features.

This feature is most likely the staircase identified in the 1943 aerial photograph (Plate 2.5) that was associated with the retaining wall built in the same year. The retaining wall defined the boundary of the Old Kings Parade Grounds with the lower foreshore, most likely to provide a solid barrier between the grounds and the river flood zone. The staircase provided an access point to the foreshore of the Parramatta River and to the rectilinear structure and incinerator (feature described in Section 3.2.1). The staircase is currently the only visible element of the greater retaining wall and it is unclear whether the retaining wall is still present below ground level or if it was partially or fully removed during later works conducted to the project area. Around 3 m of grassed verge separates the brick staircase and terrace edge from the pedestrian pathway.

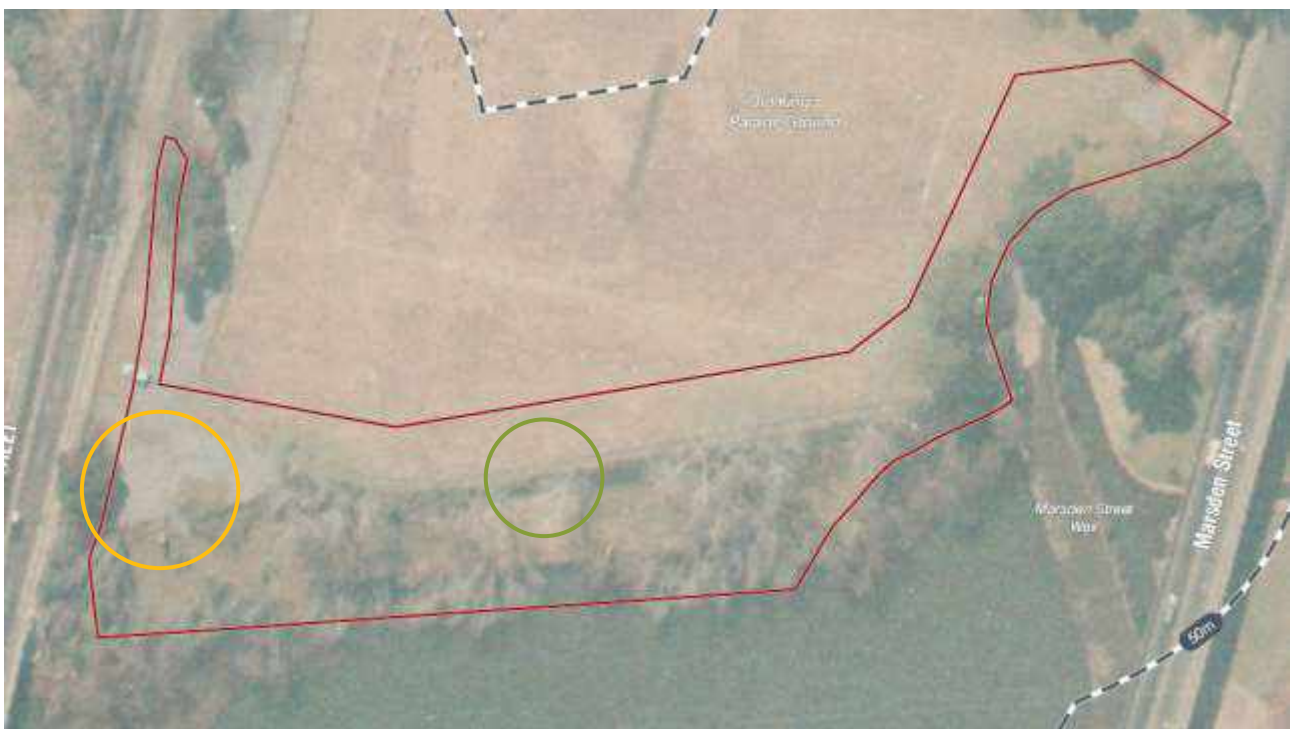
Plate 2.7 1986 aerial photograph of the project area (red) with historic location of the rectilinear structure (yellow) and possible indication of incinerator. Retaining wall and stairs (green) are still present on site. Source: Department of Finance, Services & Innovation.

The upgrade and expansion of the old O'Connell Street and bridge occurred in 1961 and in 1964 the King's School site was sold to the New South Wales Department of Health. Aerial photography from 1965 suggests that retaining wall and rectilinear structure were extant on the site; however similar photographs from 1970 reveal that the vegetation at the edge of river had grown up to the retaining wall and the rectilinear structure to the west of the project area was no longer present or in a severely dilapidated state (Plate 2.6). Between 1975 and 1986 vegetation to the foreshore was cleared revealing that the inter war retaining wall and stairs were still present in the project area (Plate 2.7).

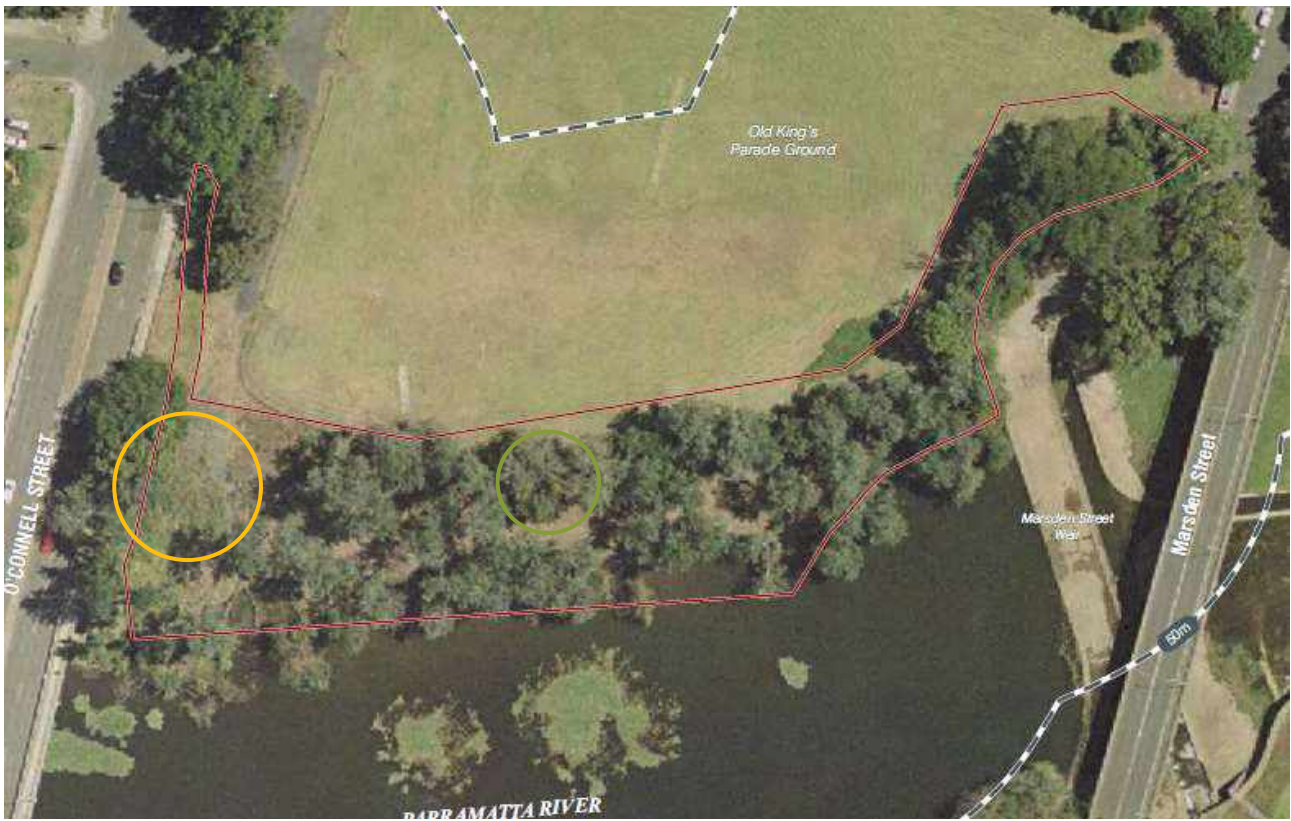
Plate 2.8 2004 aerial map of the project area (red). with historic location of the incinerator (yellow). The retaining wall and stairs (green) are no longer visible on site. Source: Department of Finance, Services & Innovation.

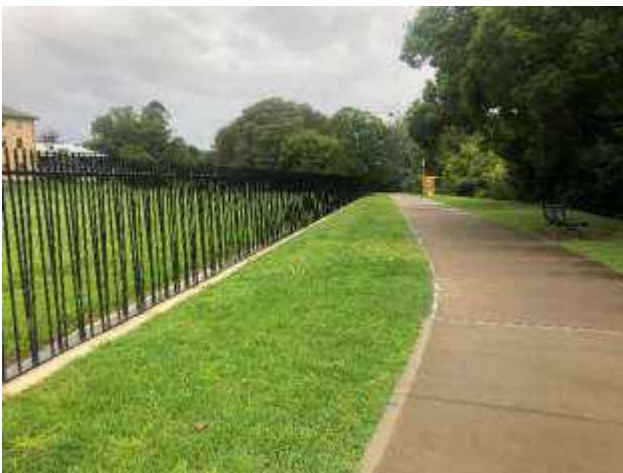
Plate 3.1. The pathway, view east. Note the level topography, from the school (left) to the pathway (right).

Within the project area, the majority of the pedestrian pathway and turfed areas are very gently sloping (refer to Section 2.3) but generally level with the Old Kings Parade Grounds (Plate 3.1). The landscape experiences a steep decline around 3 m south of pathway at the edge of the landscape terracing where dense vegetation is present, impeding views towards the river. The pathway increases in elevation to the east of the project area towards Marsden Street.

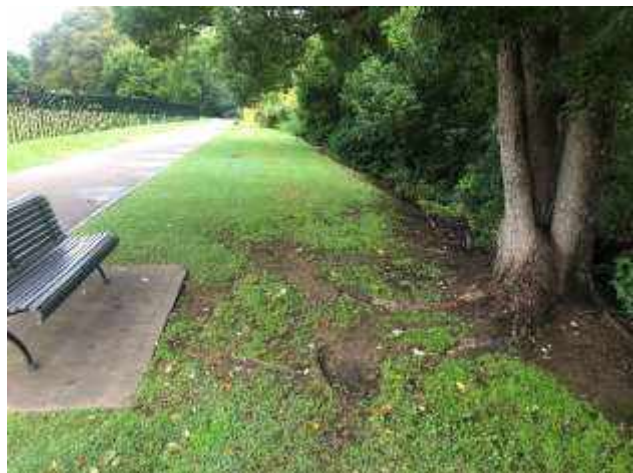
Plate 3.2. The edge of the terracing, view east. Note to the right of frame, the steep slope (~60°) downwards to the river.

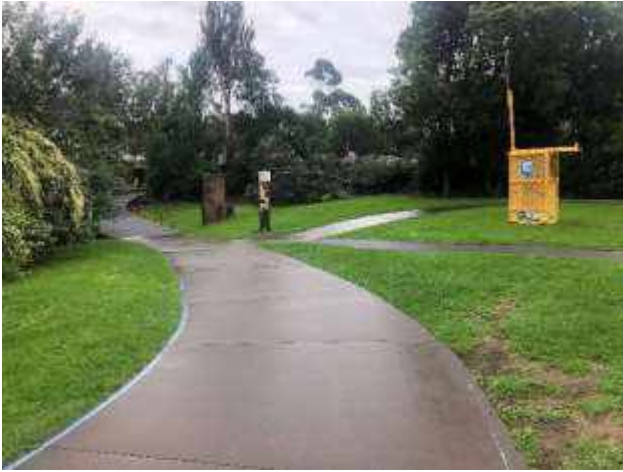
Plate 3.3. The project area facing O’Connell Street (background) with the remnants of the incinerator chimney, view south-west.

- a gradual decline in elevation towards the zone below O'Connell Street, towards Parramatta Park (Plate 3.3);
- a gradual incline for the pathway leading to O'Connell Street (Plate 3.4); and
- general filling to the terrain of the main segment of the pathway adjacent to the foreshore and to the west of the project area near the pathway leading to O'Connell Street.

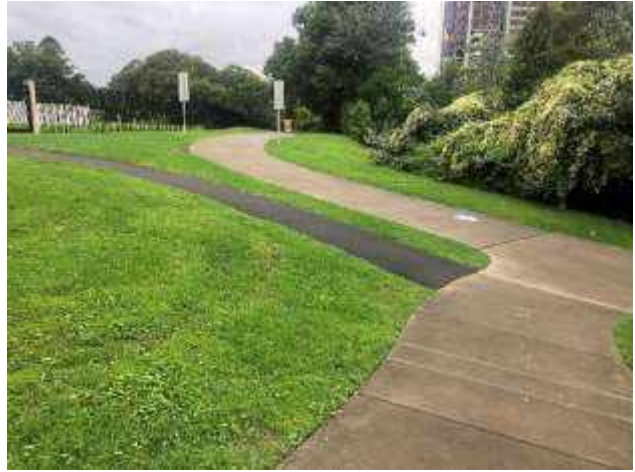
Plate 3.4. Example of turfing across project area and pathway towards O’Connell Street, view east.

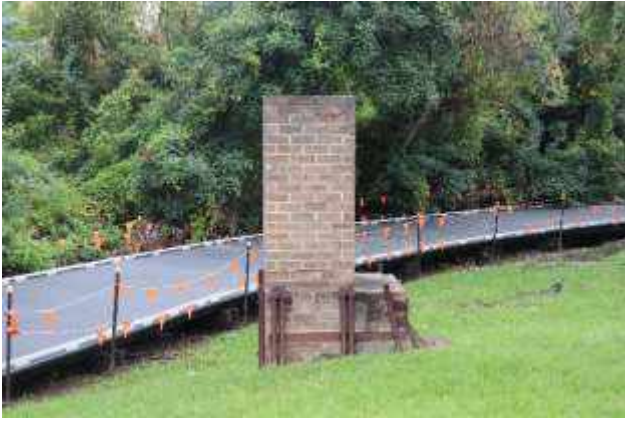
Plate 3.5. The brick incinerator, view south. Note the slightly raised pathway to the background.

The remnants of a brick incinerator are located to the west of the project area near the segment of the pathway that is declining towards the zone below O’Connell Street. The feature consists of a brown brick chimney and base with a number of metal reinforcement bars fixed to its exterior and a metal plate fixed to the opening at the base with text that states “Goodrid Incinerator Sydney – Company Com Pat (commercial patent) 18480” (Plate 3.6).

Although the construction date of the incinerator is unclear it would have been present within the site after the creation of the ‘Goodrid Incinerator’ company that was established in 1927 and before 1943. The type and style of coursing to the brickwork is inconsistent with the typical coursing used in the Colonial, Victorian and Edwardian periods but is consistent with the inter war (c. 1915-1940) and post war periods (c.1940-1960). Based on aerial photography the incinerator would have most likely been constructed in the inter war period between 1927 and 1943.

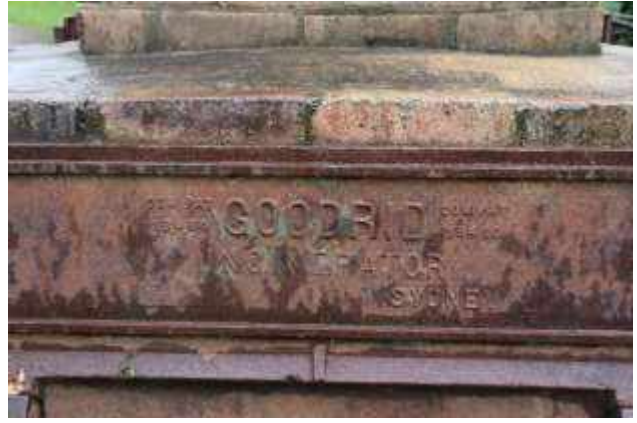
Plate 3.6. Metal plate with lettering, view east.

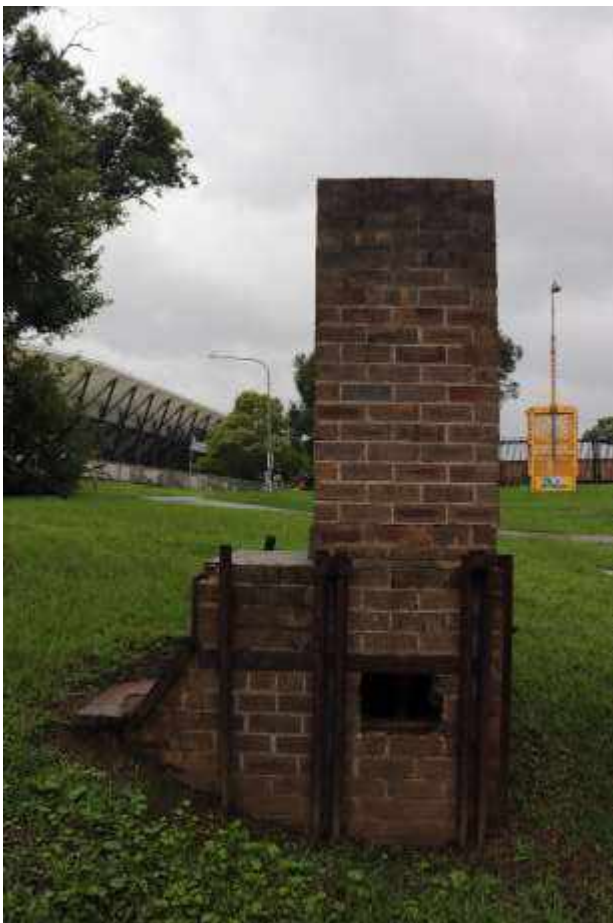
Plate 3.7. The brick incinerator, view north.

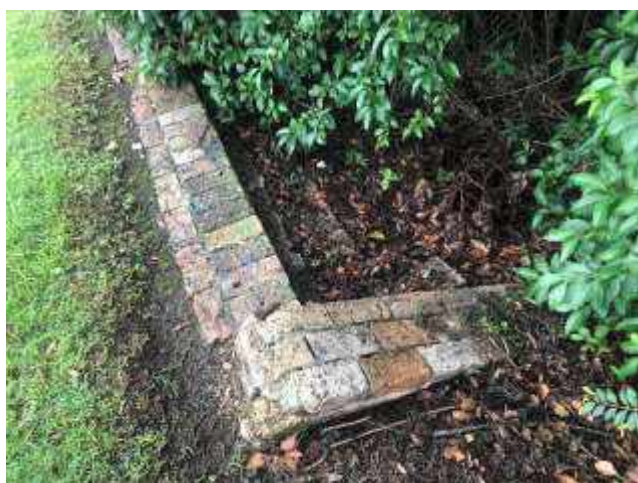
Plate 3.9. Brick staircase, view east.

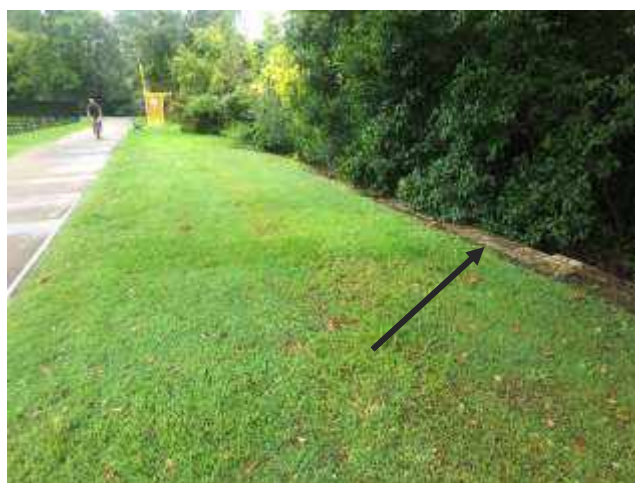
Plate 3.10. Location of brick staircase (indicated with arrow to the right) and turfing separating pathway with brick staircase, view east.

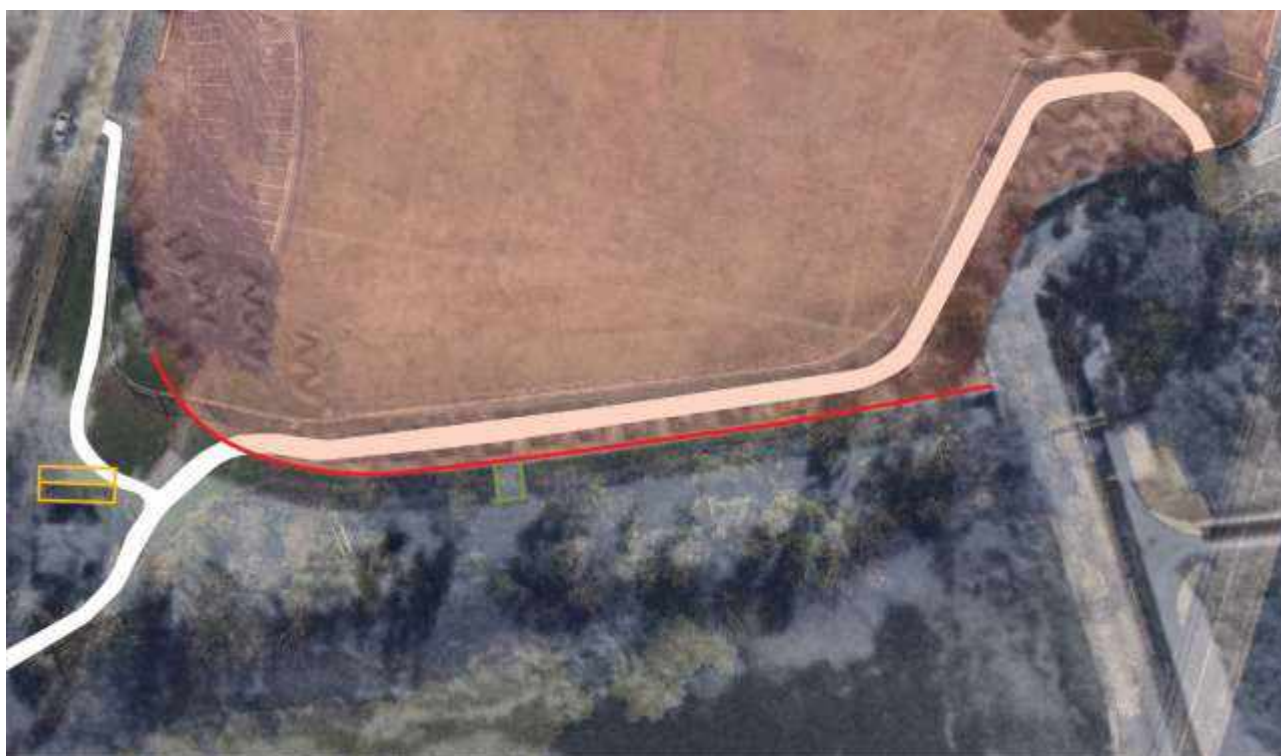
Plate 6.1 Overlay of 1943 and 2017 aerial maps with indication of location of former incinerator (yellow), retaining wall (red) and staircase (green). The historical extent of the Old Kings Parade Grounds is highlighted in red. The early 2000s pedestrian pathway is highlighted in white. Source: EMM.

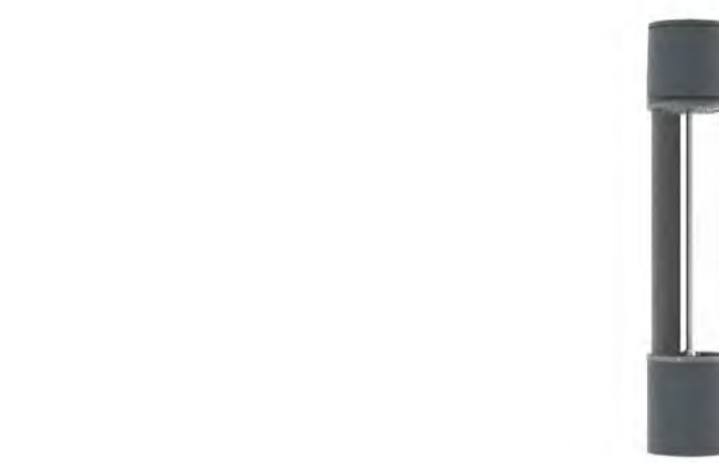
04 AA TOP ELEMENT IMAGE
N.T.S.@A1

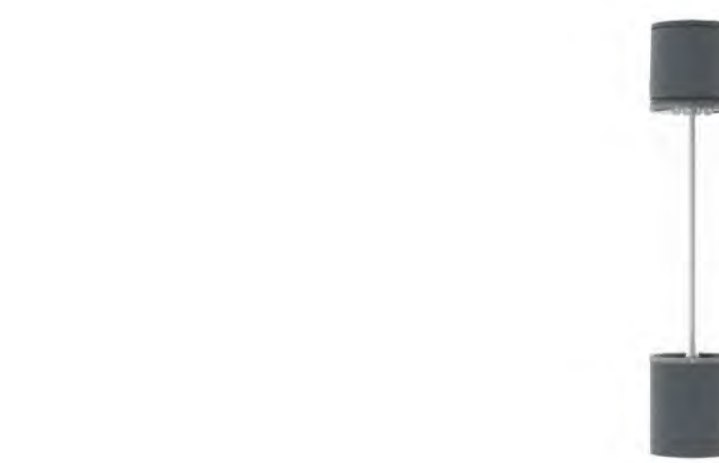
05 AR TOP ELEMENT IMAGE
N.T.S.@A1

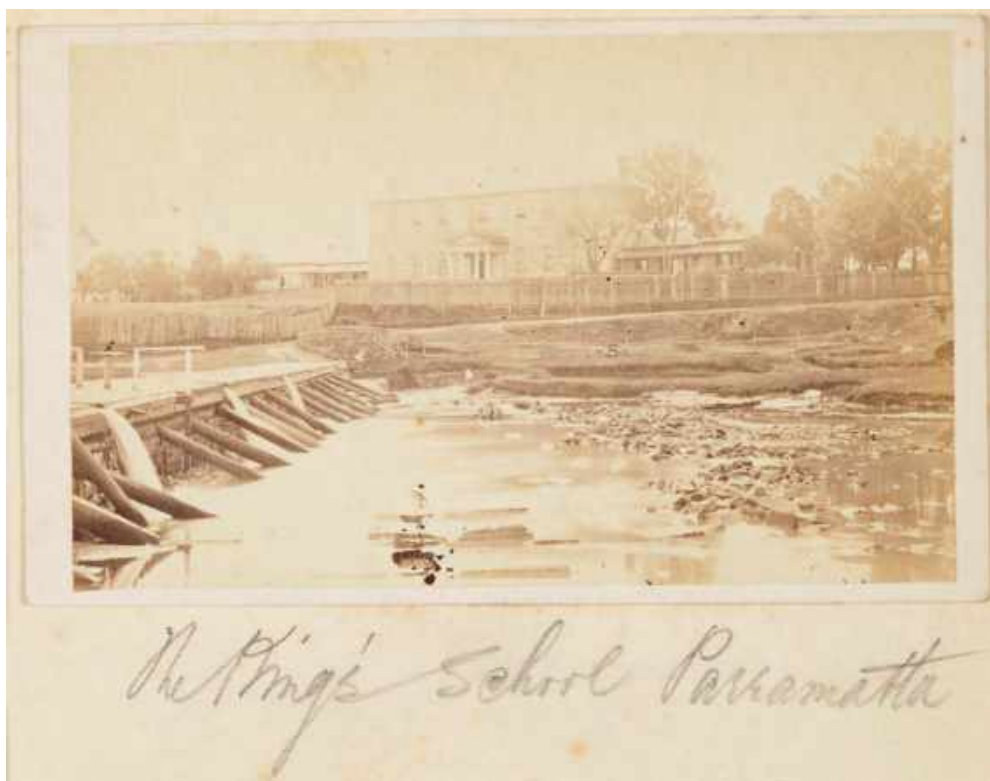
Plate 2.2 The King's School, Parramatta (c. 1871). The view is towards the north from the eastern side of Marsden Street Weir. The study area is mostly outside the frame to the left, however note the substantial ground modifications along the riverbank in this locale. (Source: Mitchell Library, SLNSW. Album of photographs of Sydney & country New South Wales, ca. 1871 / American & Australasian Photographic Company [FL1075972])

- iii) Mid-19th century (1833-1900) – establishment of Kings School in 1831, study area forms southern portion of the oval. The oval was prepared in stages (c. 1850 – 1870) and some portion, mostly in the northeast corner of the study area, was levelled up with introduced fill (Plate 2.2);

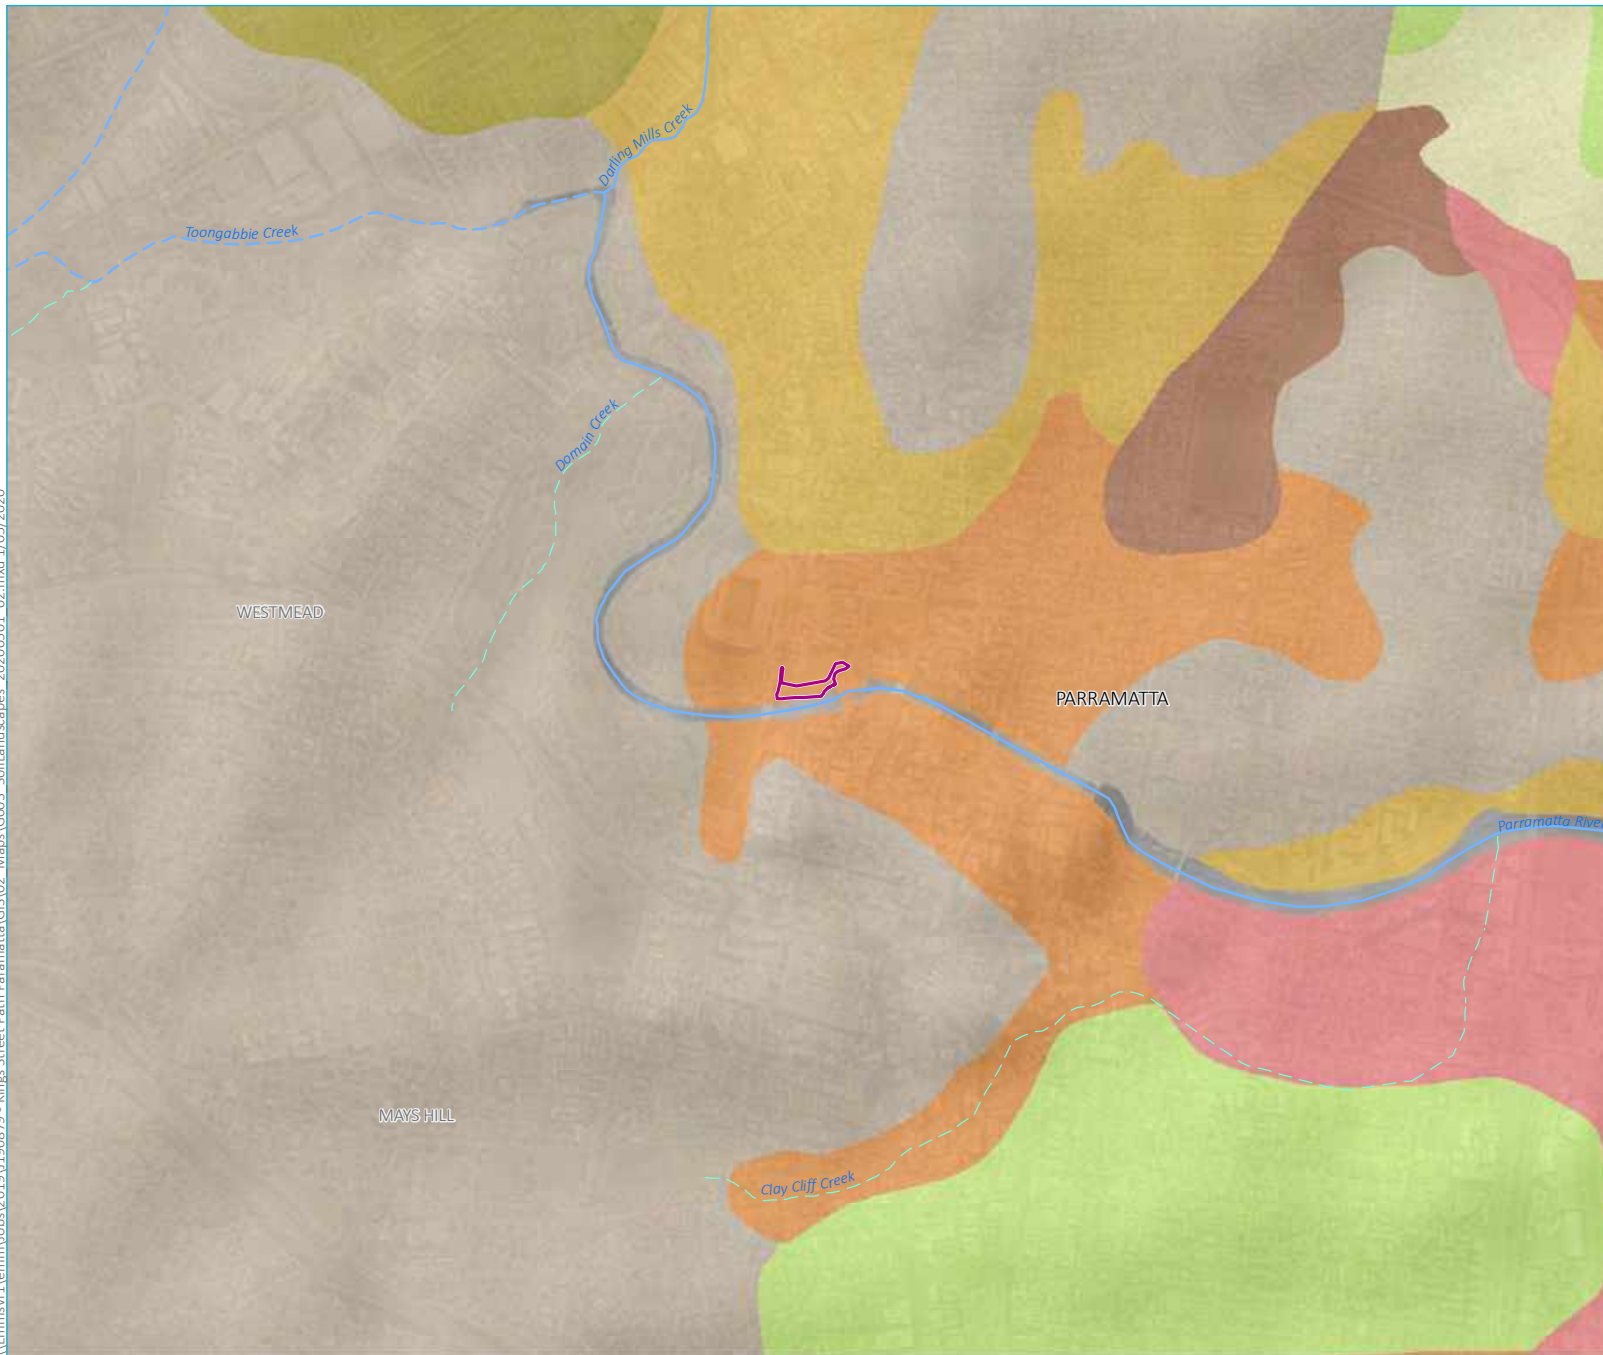
Old Kings Parade Ground - Foreshore Lighting
Aboriginal heritage due diligence
Figure 2.2

- KEY**
- Study area
 - Strahler stream order
 - 1st order
 - 3rd order
 - 4th order
 - Soil landscapes
 - Birrong
 - Blacktown
 - Deep Creek
 - Disturbed Terrain
 - Glenorie
 - Gymea
 - Lucas Heights
 - Luddenham

Soil landscapes

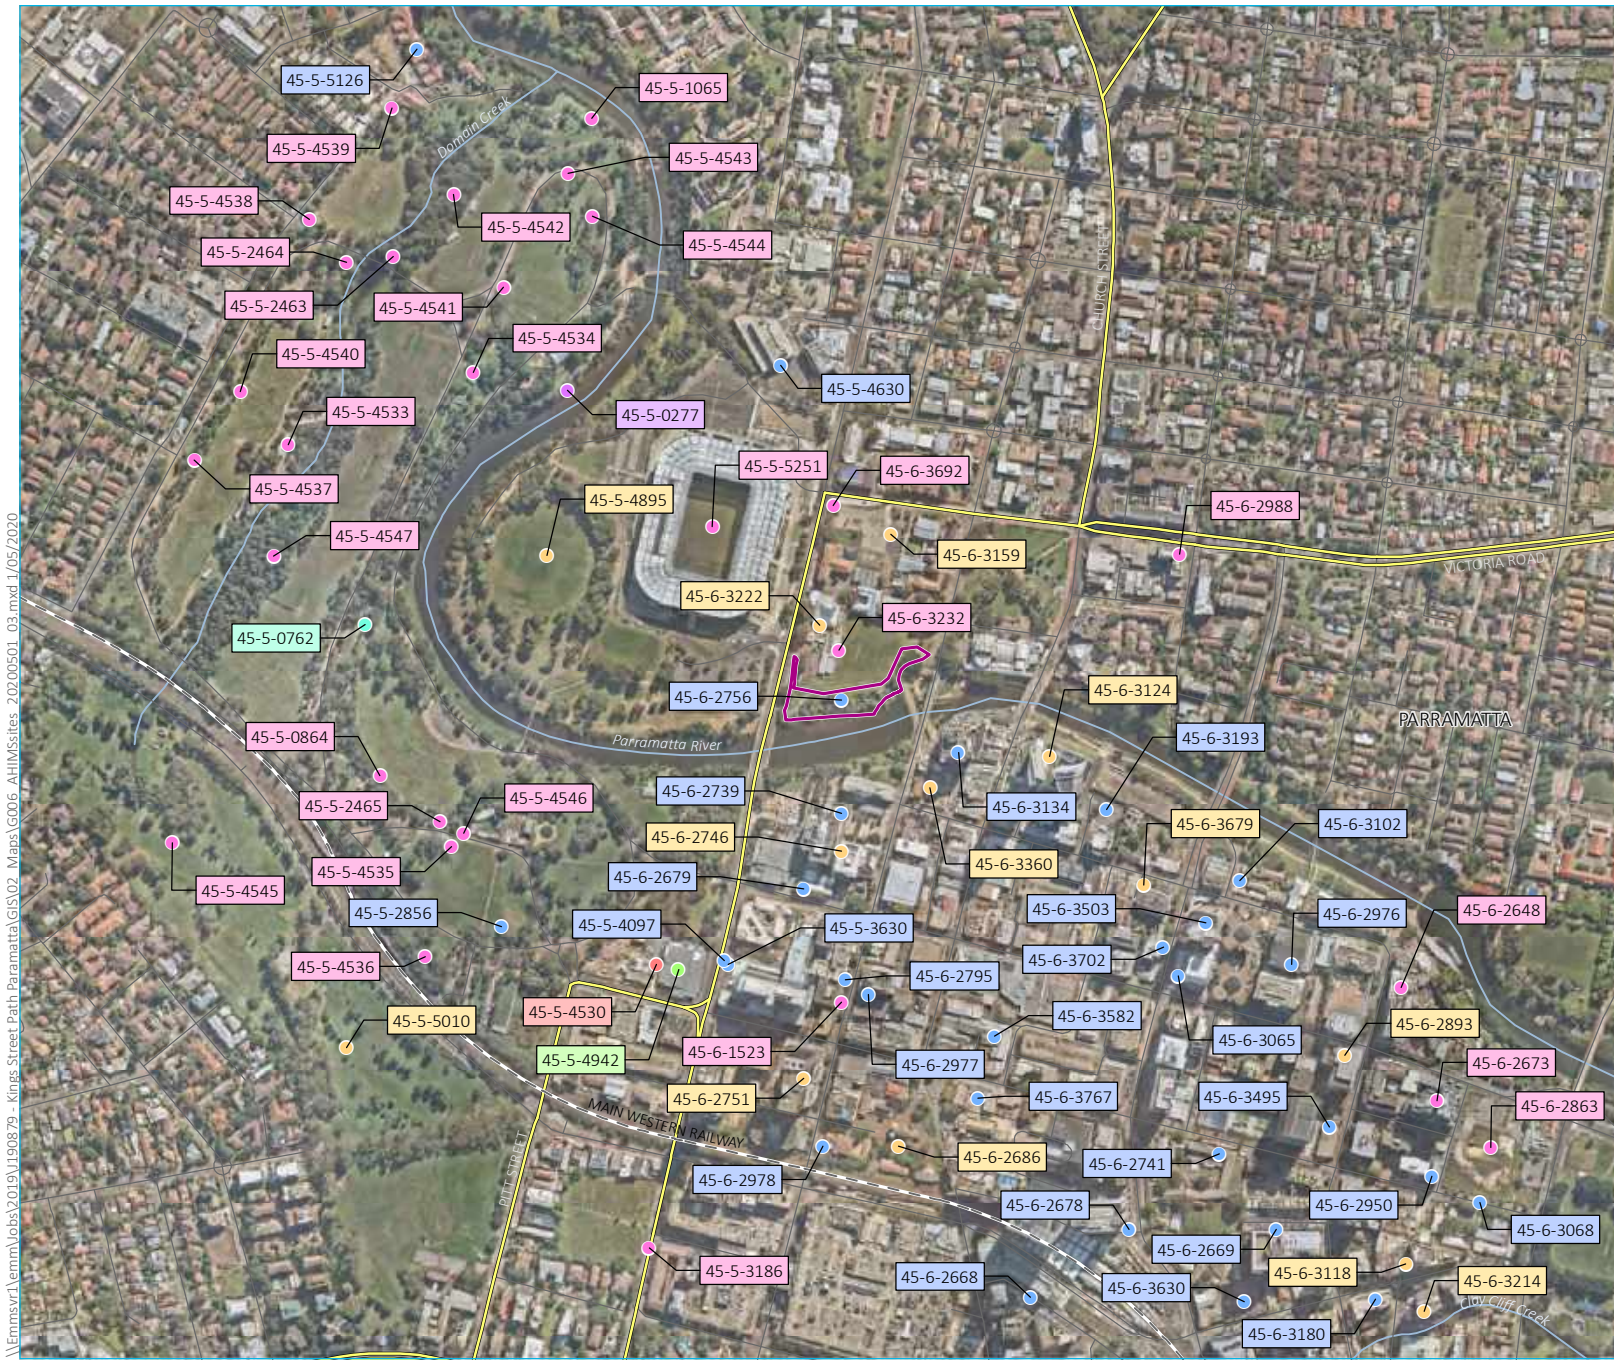
- KEY**
- Study area
 - Rail line
 - Major road
 - Minor road
 - Named watercourse
- AHIMS site**
- Artefact
 - Artefact, Hearth
 - Artefact, Modified tree
 - Artefact, Potential archaeological deposit (PAD)
 - Artefact, Hearth, Potential archaeological deposit (PAD)
 - Modified tree
 - Potential archaeological deposit (PAD)

DPIE maintains the Aboriginal Heritage Information Management System (AHIMS), a database of known and registered Aboriginal sites in NSW. An AHIMS search was undertaken on 13 March 2020 (ID: 490989) encompassing an area of 4km² around the study area. The results can be found in Table 3.2, Figure 3.1, and Appendix A. The search identified 75 sites within the search area; six sites have been destroyed as a result of authorised impacts, and 13 have been partially destroyed. Additionally, two sites have been investigated and determined to not be archaeological sites, and one has been deleted from the AHIMS database; these three sites, along with the six destroyed sites, have been excluded from the following discussion, bringing the total number of sites to 66.

Table 3.2 Summary of AHIMS results (valid and partially destroyed sites only)

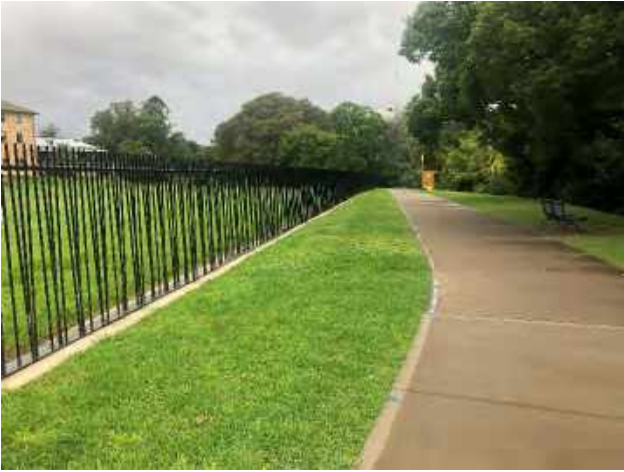
Plate 4.1. The pathway, view facing east. Note the level topography, from the school (left) to the edge of the terrace (right).

A site inspection of the study area was undertaken on 25 March 2020 by Georgia Burnett and Anthony Dakhoul (EMM Heritage). The study area was inspected to identify any previously recorded Aboriginal objects and areas of potential that may be present. Topographically, the study area is located on the north bank of the Parramatta River, and comprises a public walkway on the foreshore of the river bounded by O’Connell Street in the west and Marsden Street in the east (Plate 4.1 – Plate 4.12).

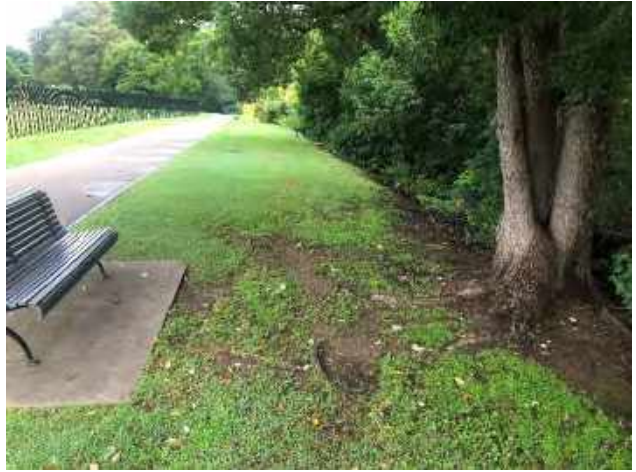
Plate 4.2. The edge of the terracing, view facing east. Note to the right of frame, the steep slope (~60°) downwards to the river.

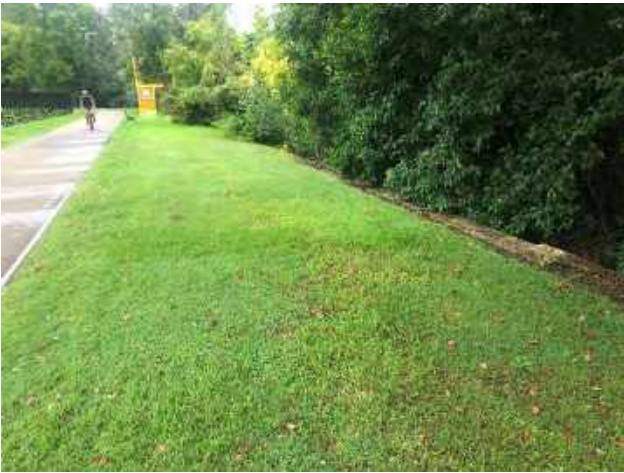
Plate 4.3. The southern side of the pathway, view facing east. Note the thick vegetation (left frame).

The site inspection confirmed that the study area has been subject to significant disturbance since European contact, and this disturbance has likely removed and/or buried any natural soil profile at depths likely below those currently proposed for the activity. The major source of disturbance within the study area is the infilling of the foreshore to level the surface of what was previously Old Kings Parade Ground (Plate 4.1 & Plate 4.2). Modern disturbance has also likely the study area further, as various services were observed, typically aligned to the pathway. Notably, many of these services appear to be water related services, which have relatively deep subsurface impacts. The level, elevated terrace that forms the historic Old Kings Parade Ground drops sharply (~2m) down to the river, though the profile of this section could not be investigated due vegetation overgrowth and poor visibility. This unnatural and sharp slope supports previous assessments which identified high levels of fill material that have historically been used to ‘build up’ the study area (Plate 4.3 & Plate 4.4).

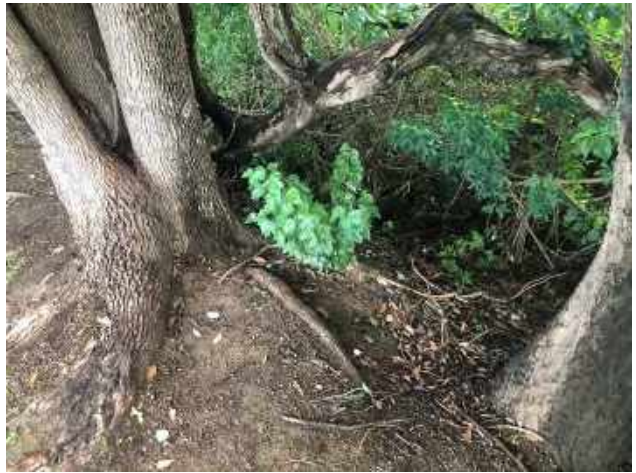
Plate 4.4. Detail of vegetation and slope dropping down the terrace, view facing south.

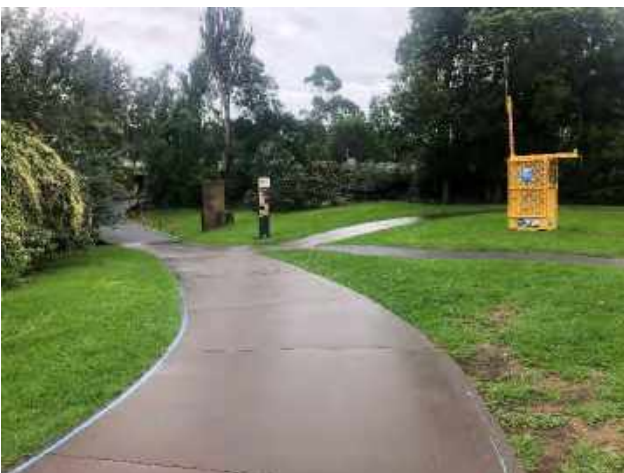
Plate 4.5. The study area facing O'Connell Street (background), viewing facing south west.

Further, the site inspection also confirmed the significant impacts from construction associated with road upgrades to O’Connell Street in the west (Plate 4.5 & Plate 4.6) and Marsden Street in the east (Plate 4.7 & Plate 4.8). Near O’Connell Street, the study area has been cut and built up to accommodate the road upgrades; at Marsden Street, the driveway leading down to the weir cuts into the modified terrace that forms the study area, though no soil profile could be observed as the section is walled.

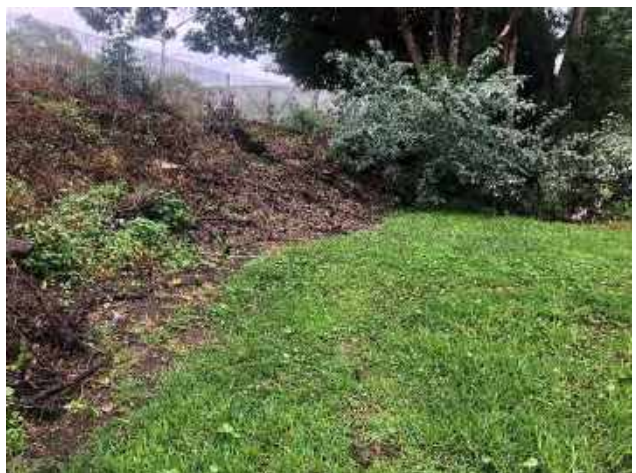
Plate 4.6. Detail of modification on east side of O'Connell Street within the study area, view facing north west.

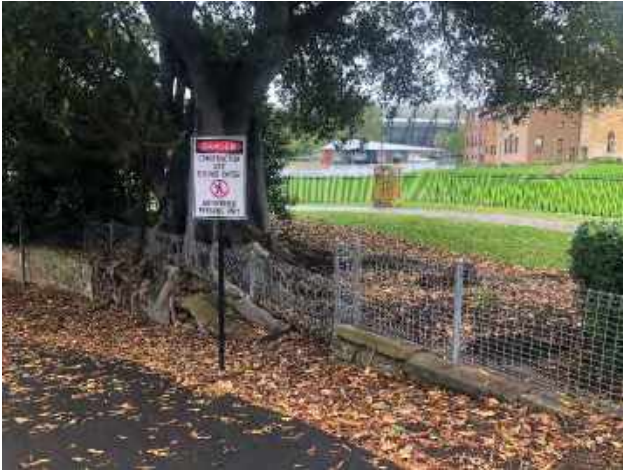
Plate 4.7. The study area (background) from Marsden Street, view facing west. Note the landscape modification/elevation change from the driveway leading to the weir (foreground) as compared to the study area.

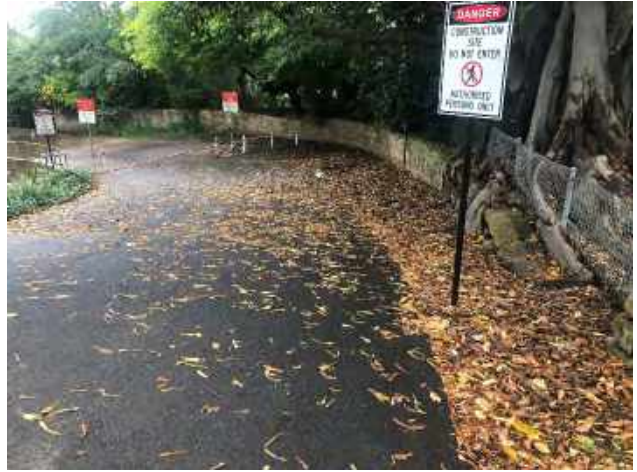
Plate 4.8. Driveway off Marsden Street, leading down to the weir, view facing southwest. Observations suggest a steeper natural slope than the path to the weir itself (Plate 2.2), suggesting more substantive earthworks at this location.

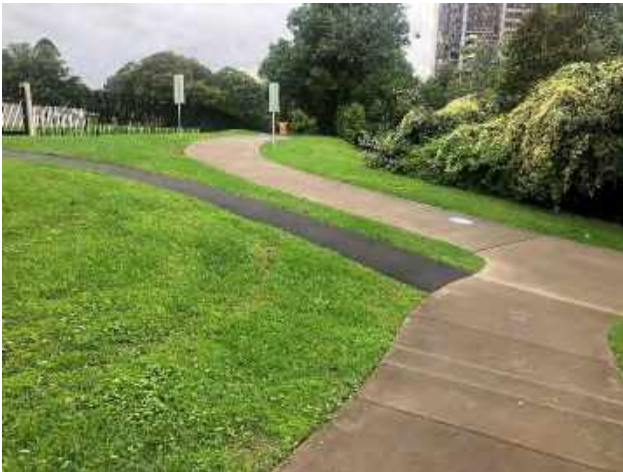
Plate 4.9. Example of turfing across study area, view facing east.

The ground surface visibility was generally low to nil (<10%) across the study area, as most of the area has been turfed and/or overlain with mulch/leaf litter (Plate 4.9 & Plate 4.10). Some ground surface exposures were observed, particularly on the O’Connell Street side of the study area (Plate 4.11). These exposures exhibited grey-brown sandy loam with many introduced gravels, largely fragmented road base and crushed concrete aggregate, all suggestive of fill and/or reworked materials (Plate 4.12). No Aboriginal objects were observed or identified on the ground surface within these areas of exposure, or across the study area.

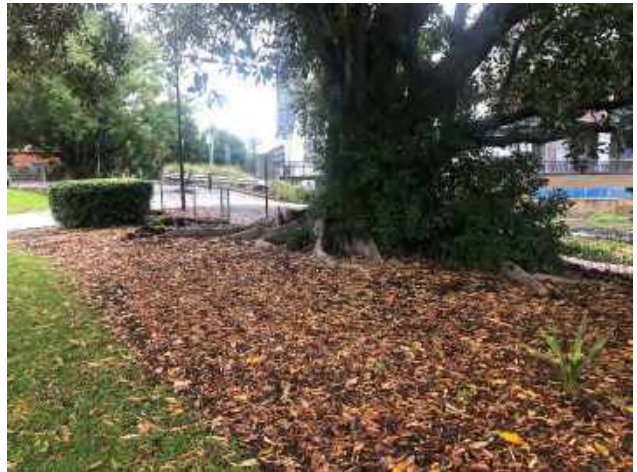
Plate 4.10. Example of mulching and/or leaf litter observed in study area, viewing facing east.

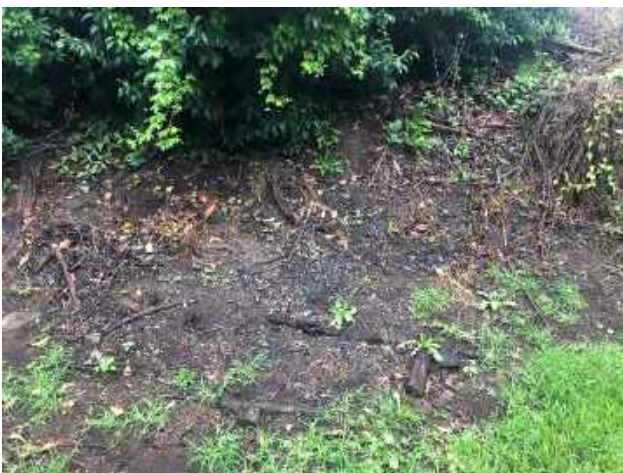
Plate 4.11. Example of exposure near O'Connell Street, view facing west.

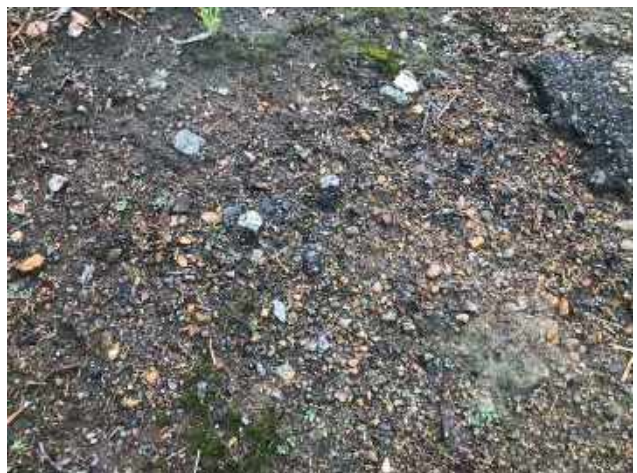
Plate 4.12. Detail of ground surface exposure.
