Review of Environmental Factors

New Foreshore Lighting along Old Kings Parade Ground
Marsden Street to O'Connell Street, Parramatta

22 July 2020

Prepared by
Andrew Robinson Planning Services Pty Ltd
2/182 Old Canterbury Road SUMMER HILL NSW 2130
Tel 02 9798 0953

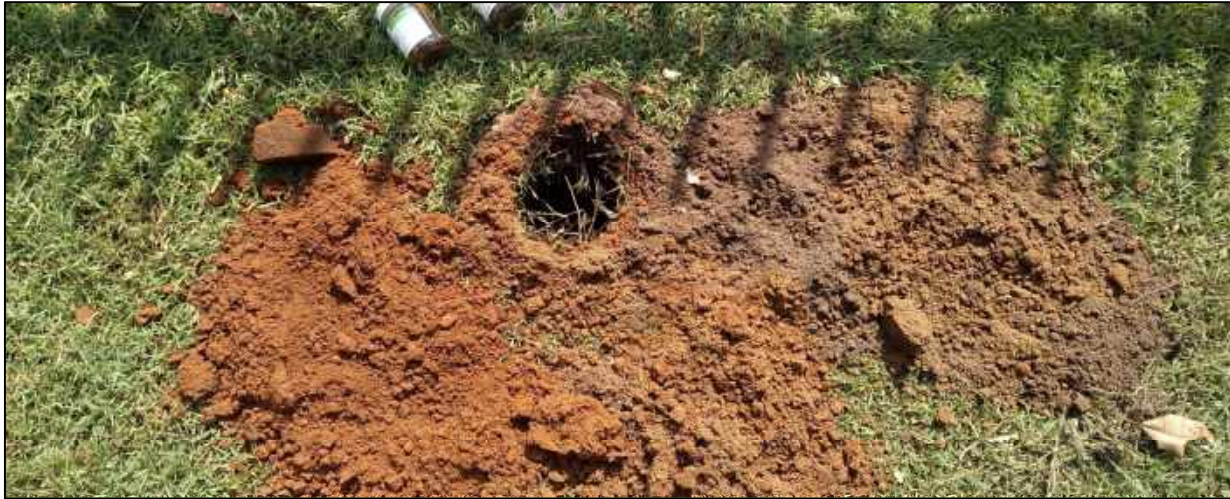
Photograph 1. Sandy CLAY - *in situ* soil materials located at HA03.

- A total of four (4) boreholes (HA01 to HA04) were drilled using a hand auger;
- The boreholes were drilled to depths ranging 0.6m to 0.65m (bgs). The boreholes were logged and soil samples were collected at regular depth intervals or change in stratigraphy (refer to **Figure 2, Attachment 1** and **Site Photographs, Attachment 2**);
- A total of 8 soil samples were collected to facilitate laboratory analysis;
- The soil material was generally comprised of alluvial Silty CLAY/Silty SAND/Clayey SAND, fine to coarse grained/ low to medium plasticity, yellow-brown-red;
- During sample collection no suspected asbestos containing material (ACM) or other contamination such as hydrocarbon odours, foreign materials or staining were noted within the *insitu* soil materials on site; and
- No shells or jarosite was noted during the sample collection activities.

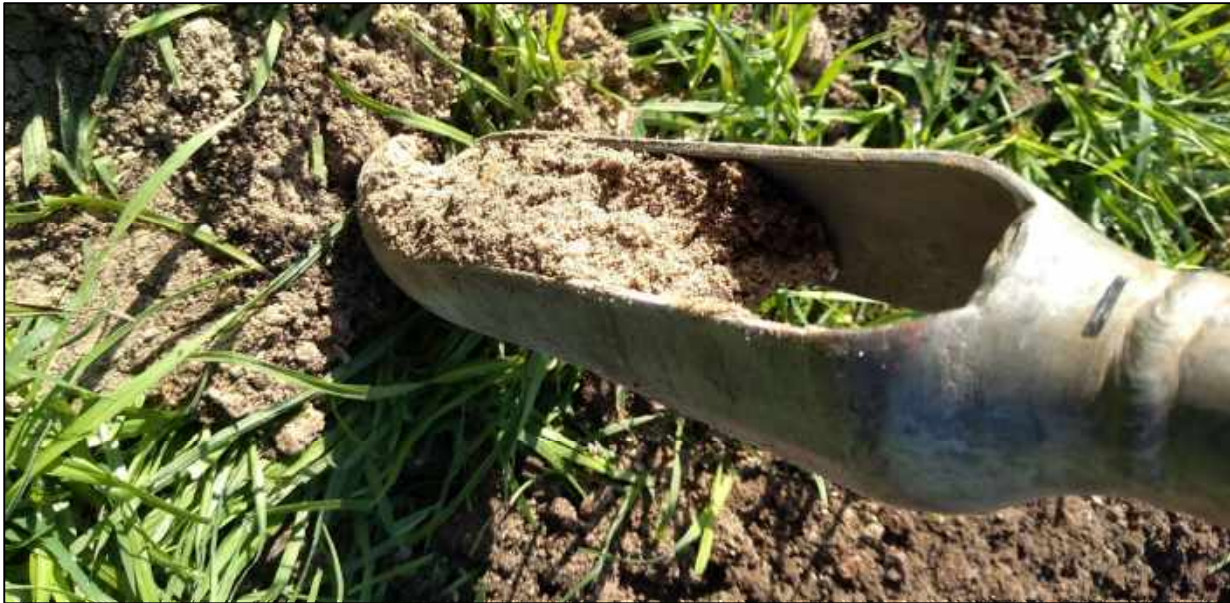
Photograph 2. Alluvial SAND - *in situ* soil materials located at HA02.

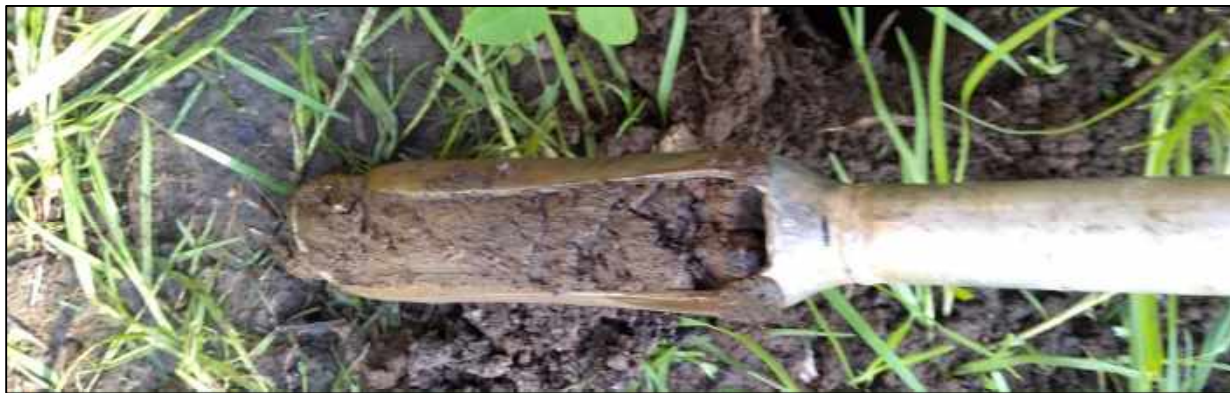
Photograph 3. Silty CLAY - *in situ* soil materials located at HA01.

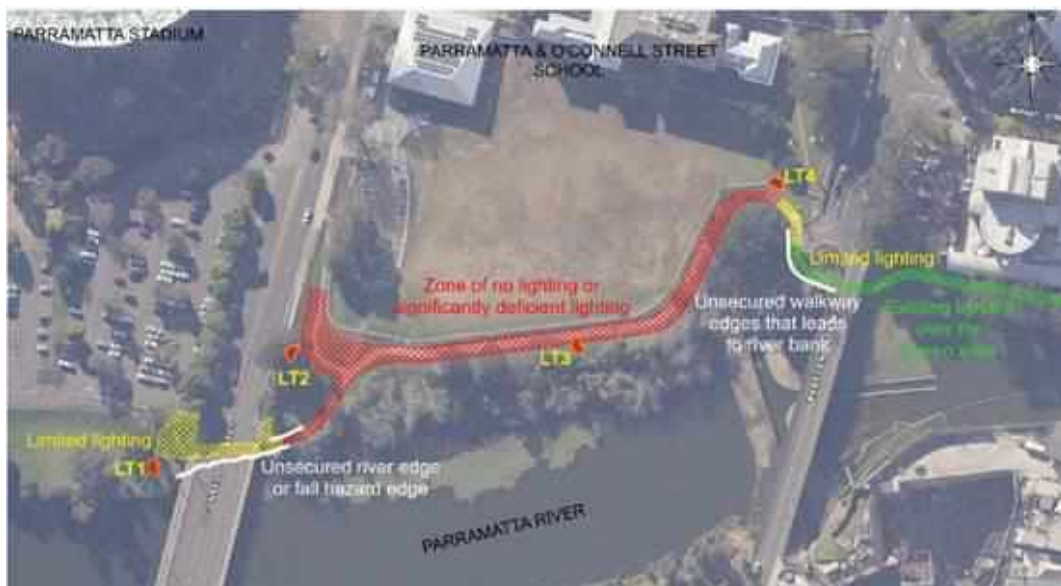
Figure 2 – The Old Kings Parade Foreshore currently lacks lighting infrastructure (Source – Parramatta City Council)

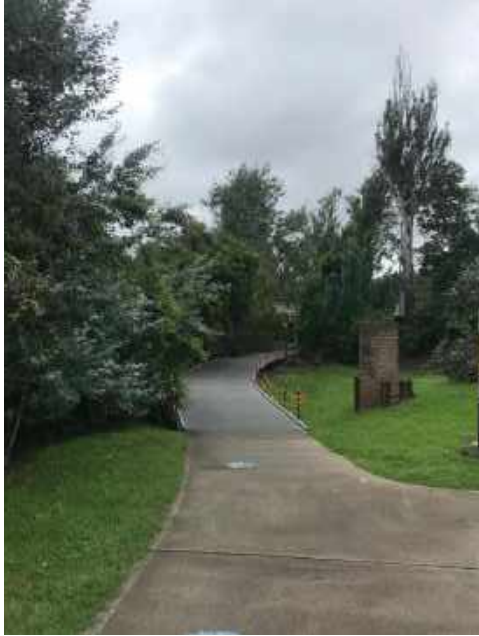
Existing pathway leading to Rings Bridge. Dense vegetation along the riverbank predominantly exotic species.

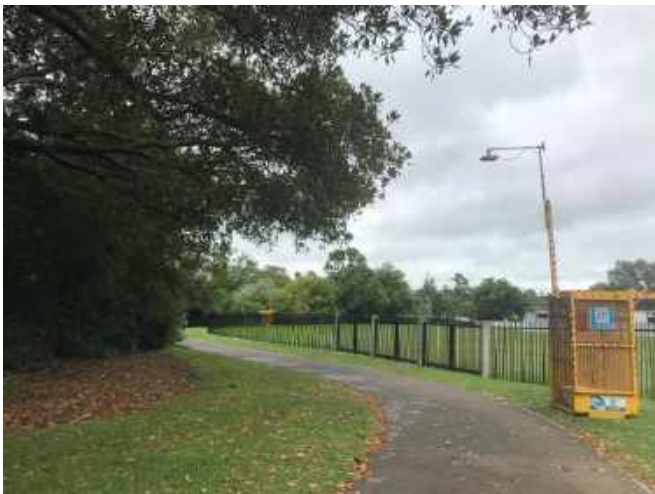
A Fig Tree (*Ficus spp.*) on the Marsden Street side of site.

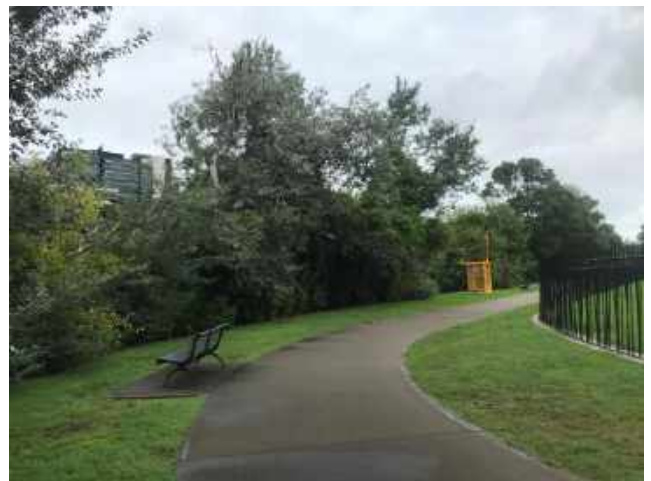
Dense vegetation along the Parramatta River foreshore within this site consist of predominately exotic species.

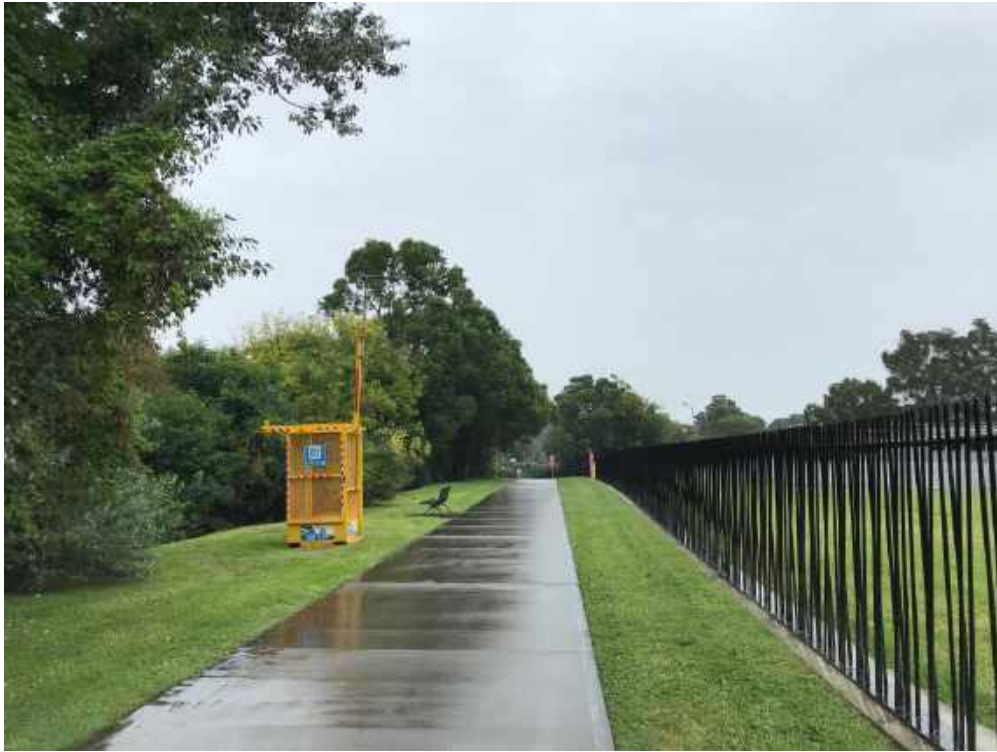
The existing pathway along the Old King's Parade Foreshore with temporary light fixtures. Vegetation along the riverside of the path is dominated by exotic species.
