Report Type:
Detailed Site Investigation

Project Address:
Charles Street Square, Parramatta, NSW
Lot 1 in DP506760, Lot 2 in DP532539, Lot 2 in DP869816,
Lot 2 in DP532539 and Lot 1 in DP1172250

Client Name:
Northrop Consulting Engineers P/L

1 September 2020
Report No: 7957-ER-2-1 Rev02

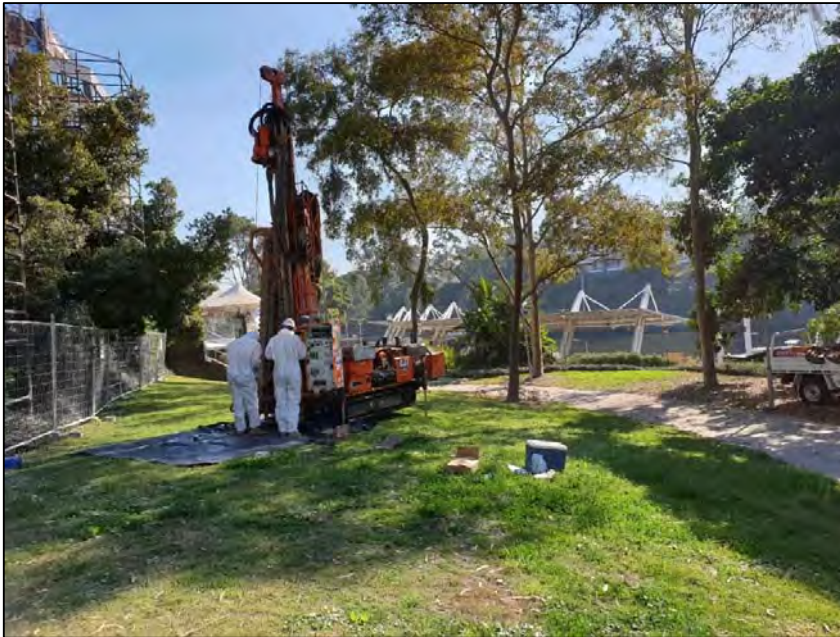
Soil sampling was undertaken by AG on 21 May and 7 June 2019. A total of eight (8) boreholes (BH01-BH08) were advanced across the site using a track mounted excavator to a target depth of 2.0m bgl. Samples for potential analysis were collected from the near surface, at 1.0 m intervals within the soil profile or with change of strata, and in areas of observed contamination. Each soil sample was collected using a new clean pair of nitrile gloves and placed in the appropriate acid rinsed sample containers provided by the laboratory.

Image 8.1.1 View of sampling technique as observed in BH08

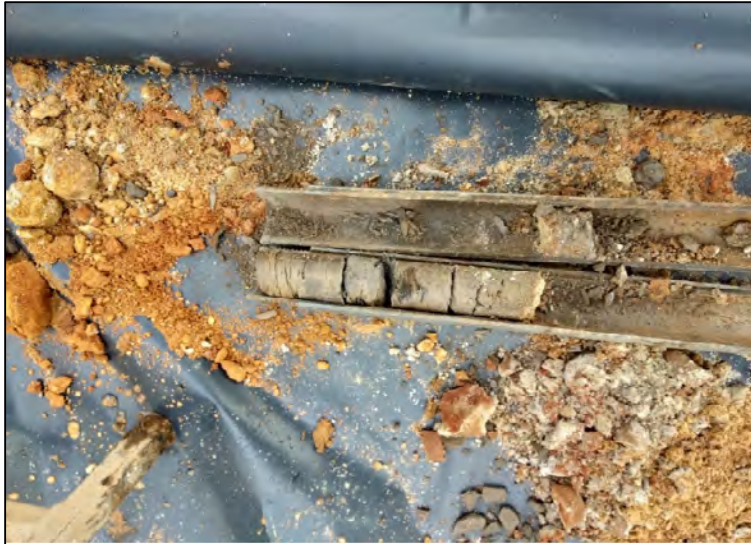
Anthropogenic materials observed in some of the fill material encountered included road base, bitumen, concrete and ceramic tiles.

Inferred natural material was encountered at three locations (BH01, BH02 and BH04), prior to the target depth of 2.0mbgl.

Image 8.2.1 Example of natural soils, as observed within BH01

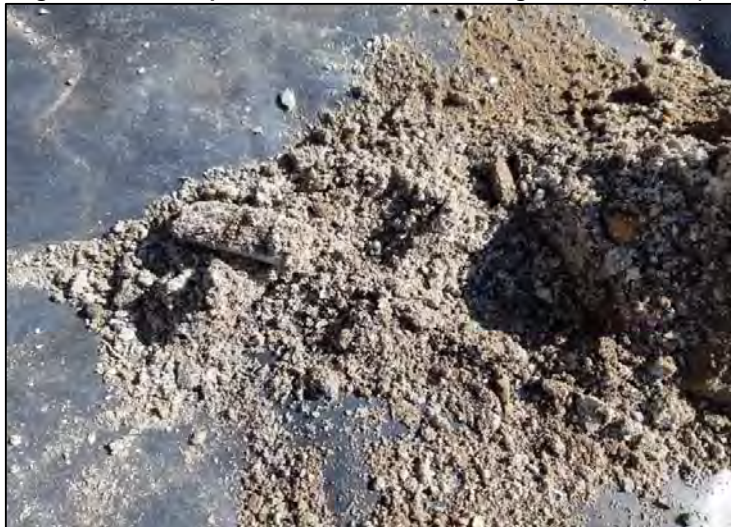
Visual evidence of potential asbestos containing materials (ACM) was observed in BH06, BH07 and BH08 at depths beneath 0.3m. The materials were observed to be in fair to poor condition.

Although no record of asbestos contamination was listed on the Section 10.7 certificates associated with the site, based on the quantity and depth of the potential ACM as well as geofabric materials noted during the borehole drilling, there is a possibility that the area characterised by BH06, BH07 and BH08 is an area of capped asbestos contamination.

Image 8.5.1 View of potential asbestos containing materials (ACM) as observed in BH06

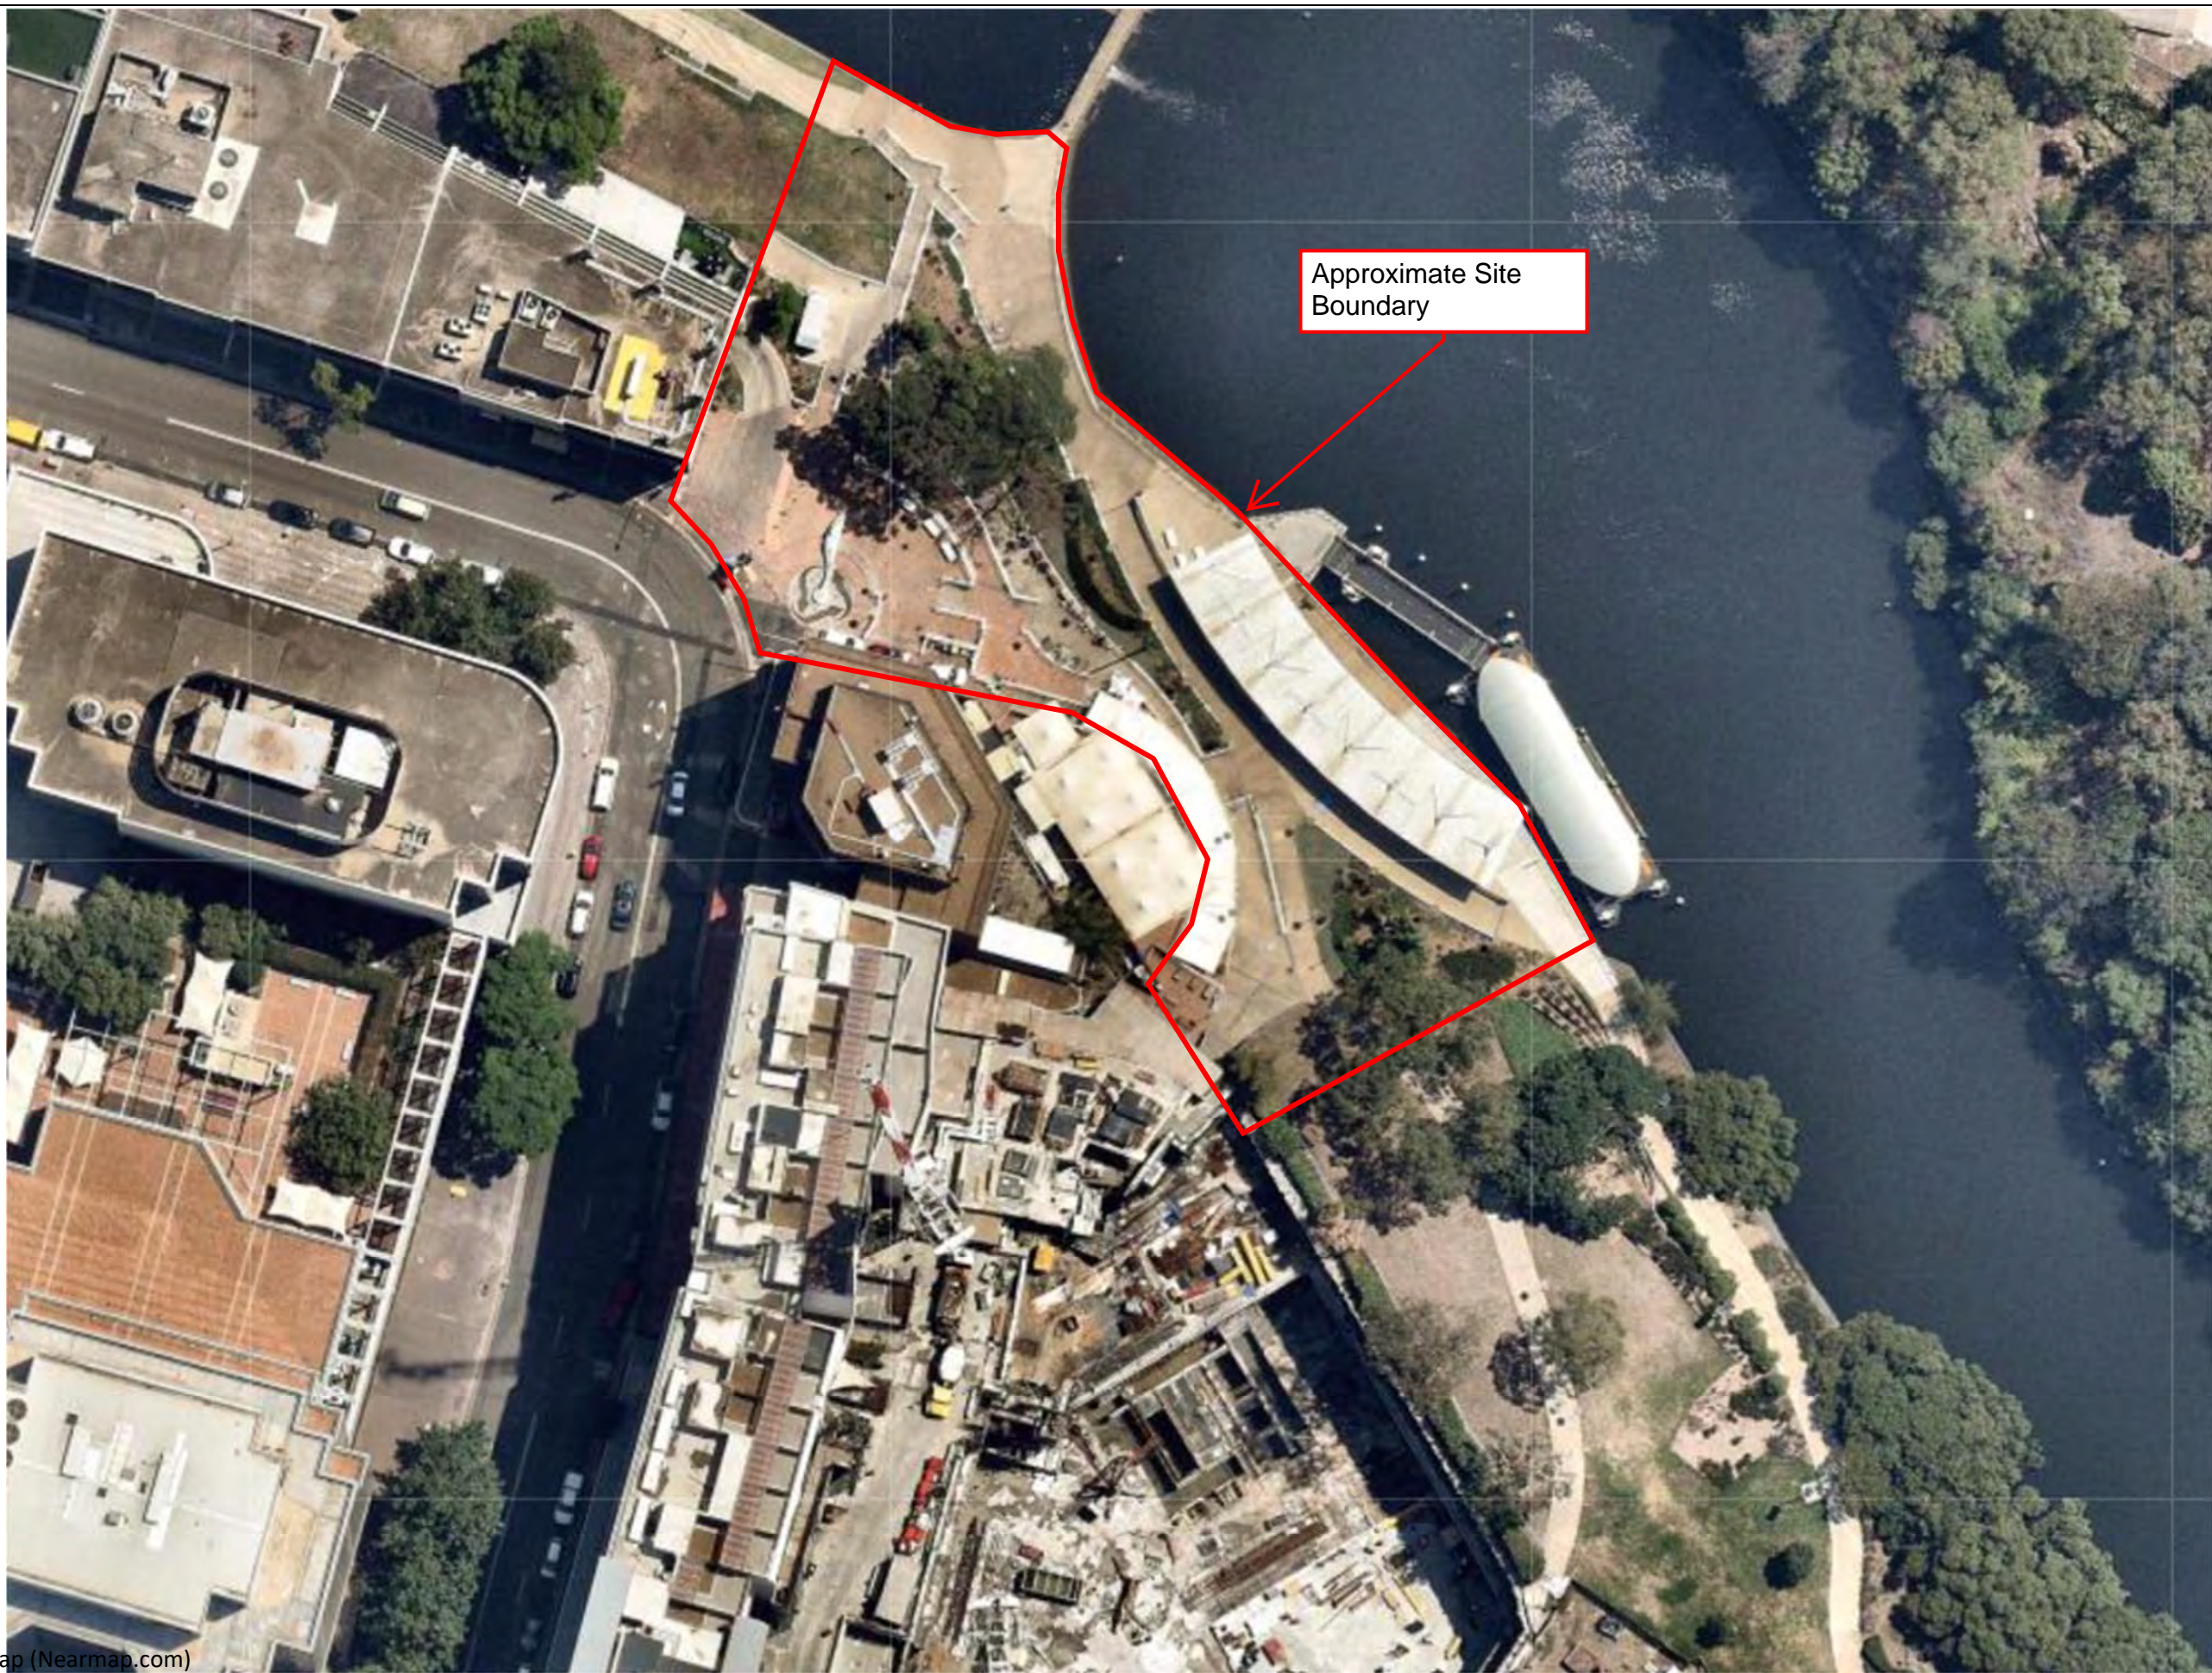
Figure Number:	2
Figure Date:	18 June 2020
Report Number:	7957-ER-2-1

Site Layout
