REMEDIATION ACTION PLAN

October 2021
J170993

City of Parramatta
Council

FS Garside Reserve, Granville
NSW 2142

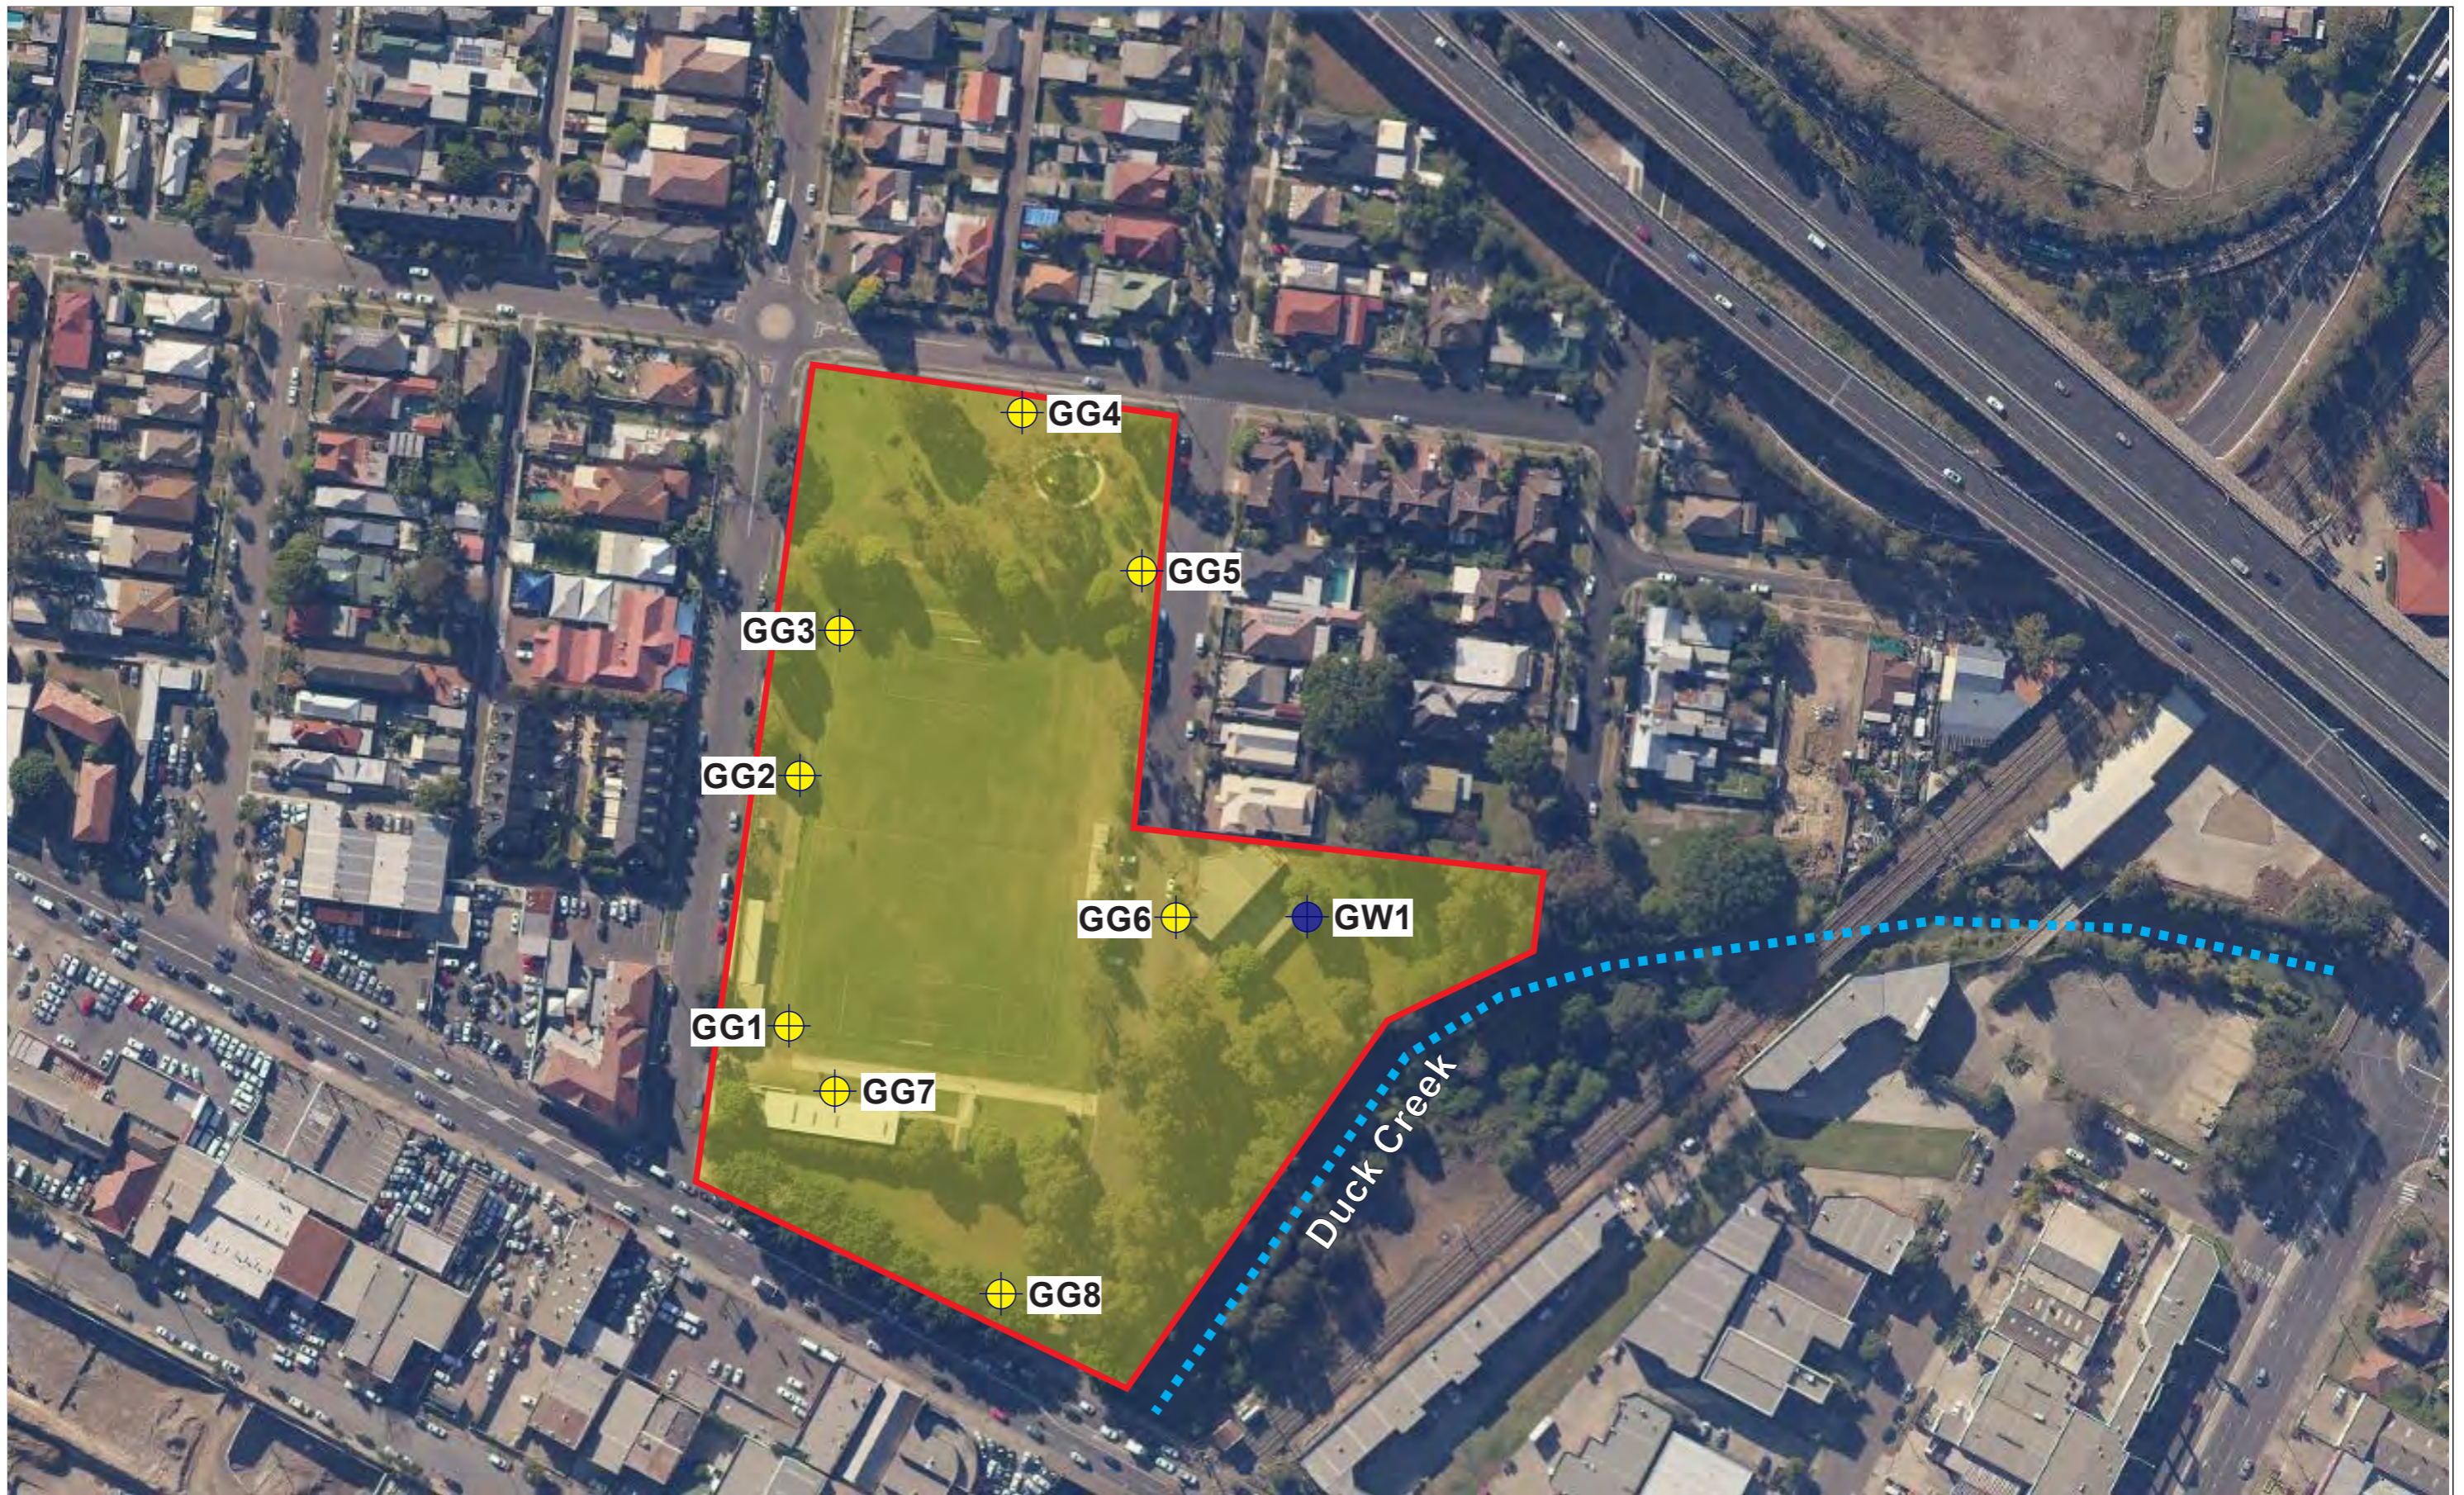
Client Name:		Parramatta City Council	
Client Number:		C107839	Project Number: J174383
Project Description:		Remediation Action Plan	
Address:		FS Garside Reserve, Granville NSW 2142	
Prepared:	EV	Reviewed:	MB
Date:		19/11/2020	
Figure 2		Ground Gas & Groundwater Monitoring Well

- Site Boundary
- Groundwater Monitoring Well
- ⊕ Ground Gas Monitoring Well

Greencap undertook drilling works to install ground gas wells and a groundwater monitoring well in 2019. The fill material generally consisted of brown clayey, gravelly silt or silty sand underlain by natural red/grey clay. Relatively shallow natural soils were only encountered at locations in the northern portion of the site: GG1, GG2, GG4, GG5 and GG7 at depths ranging from 0.2m to 1.1m BGL. Boreholes for the remaining three ground gas wells were terminated in fill material, at target depth of 1.0m BGL. At GW1 in the south-east, fill material was observed to reach 6 mBGL depth and consisted building rubble and Potential Asbestos-containing material (PACM). Refer to Figure 4 of the Further Investigation report for the drilling locations. Refer to *Figure 2* of this RAP for the location of the ground gas wells and ground water monitoring well (GW1).

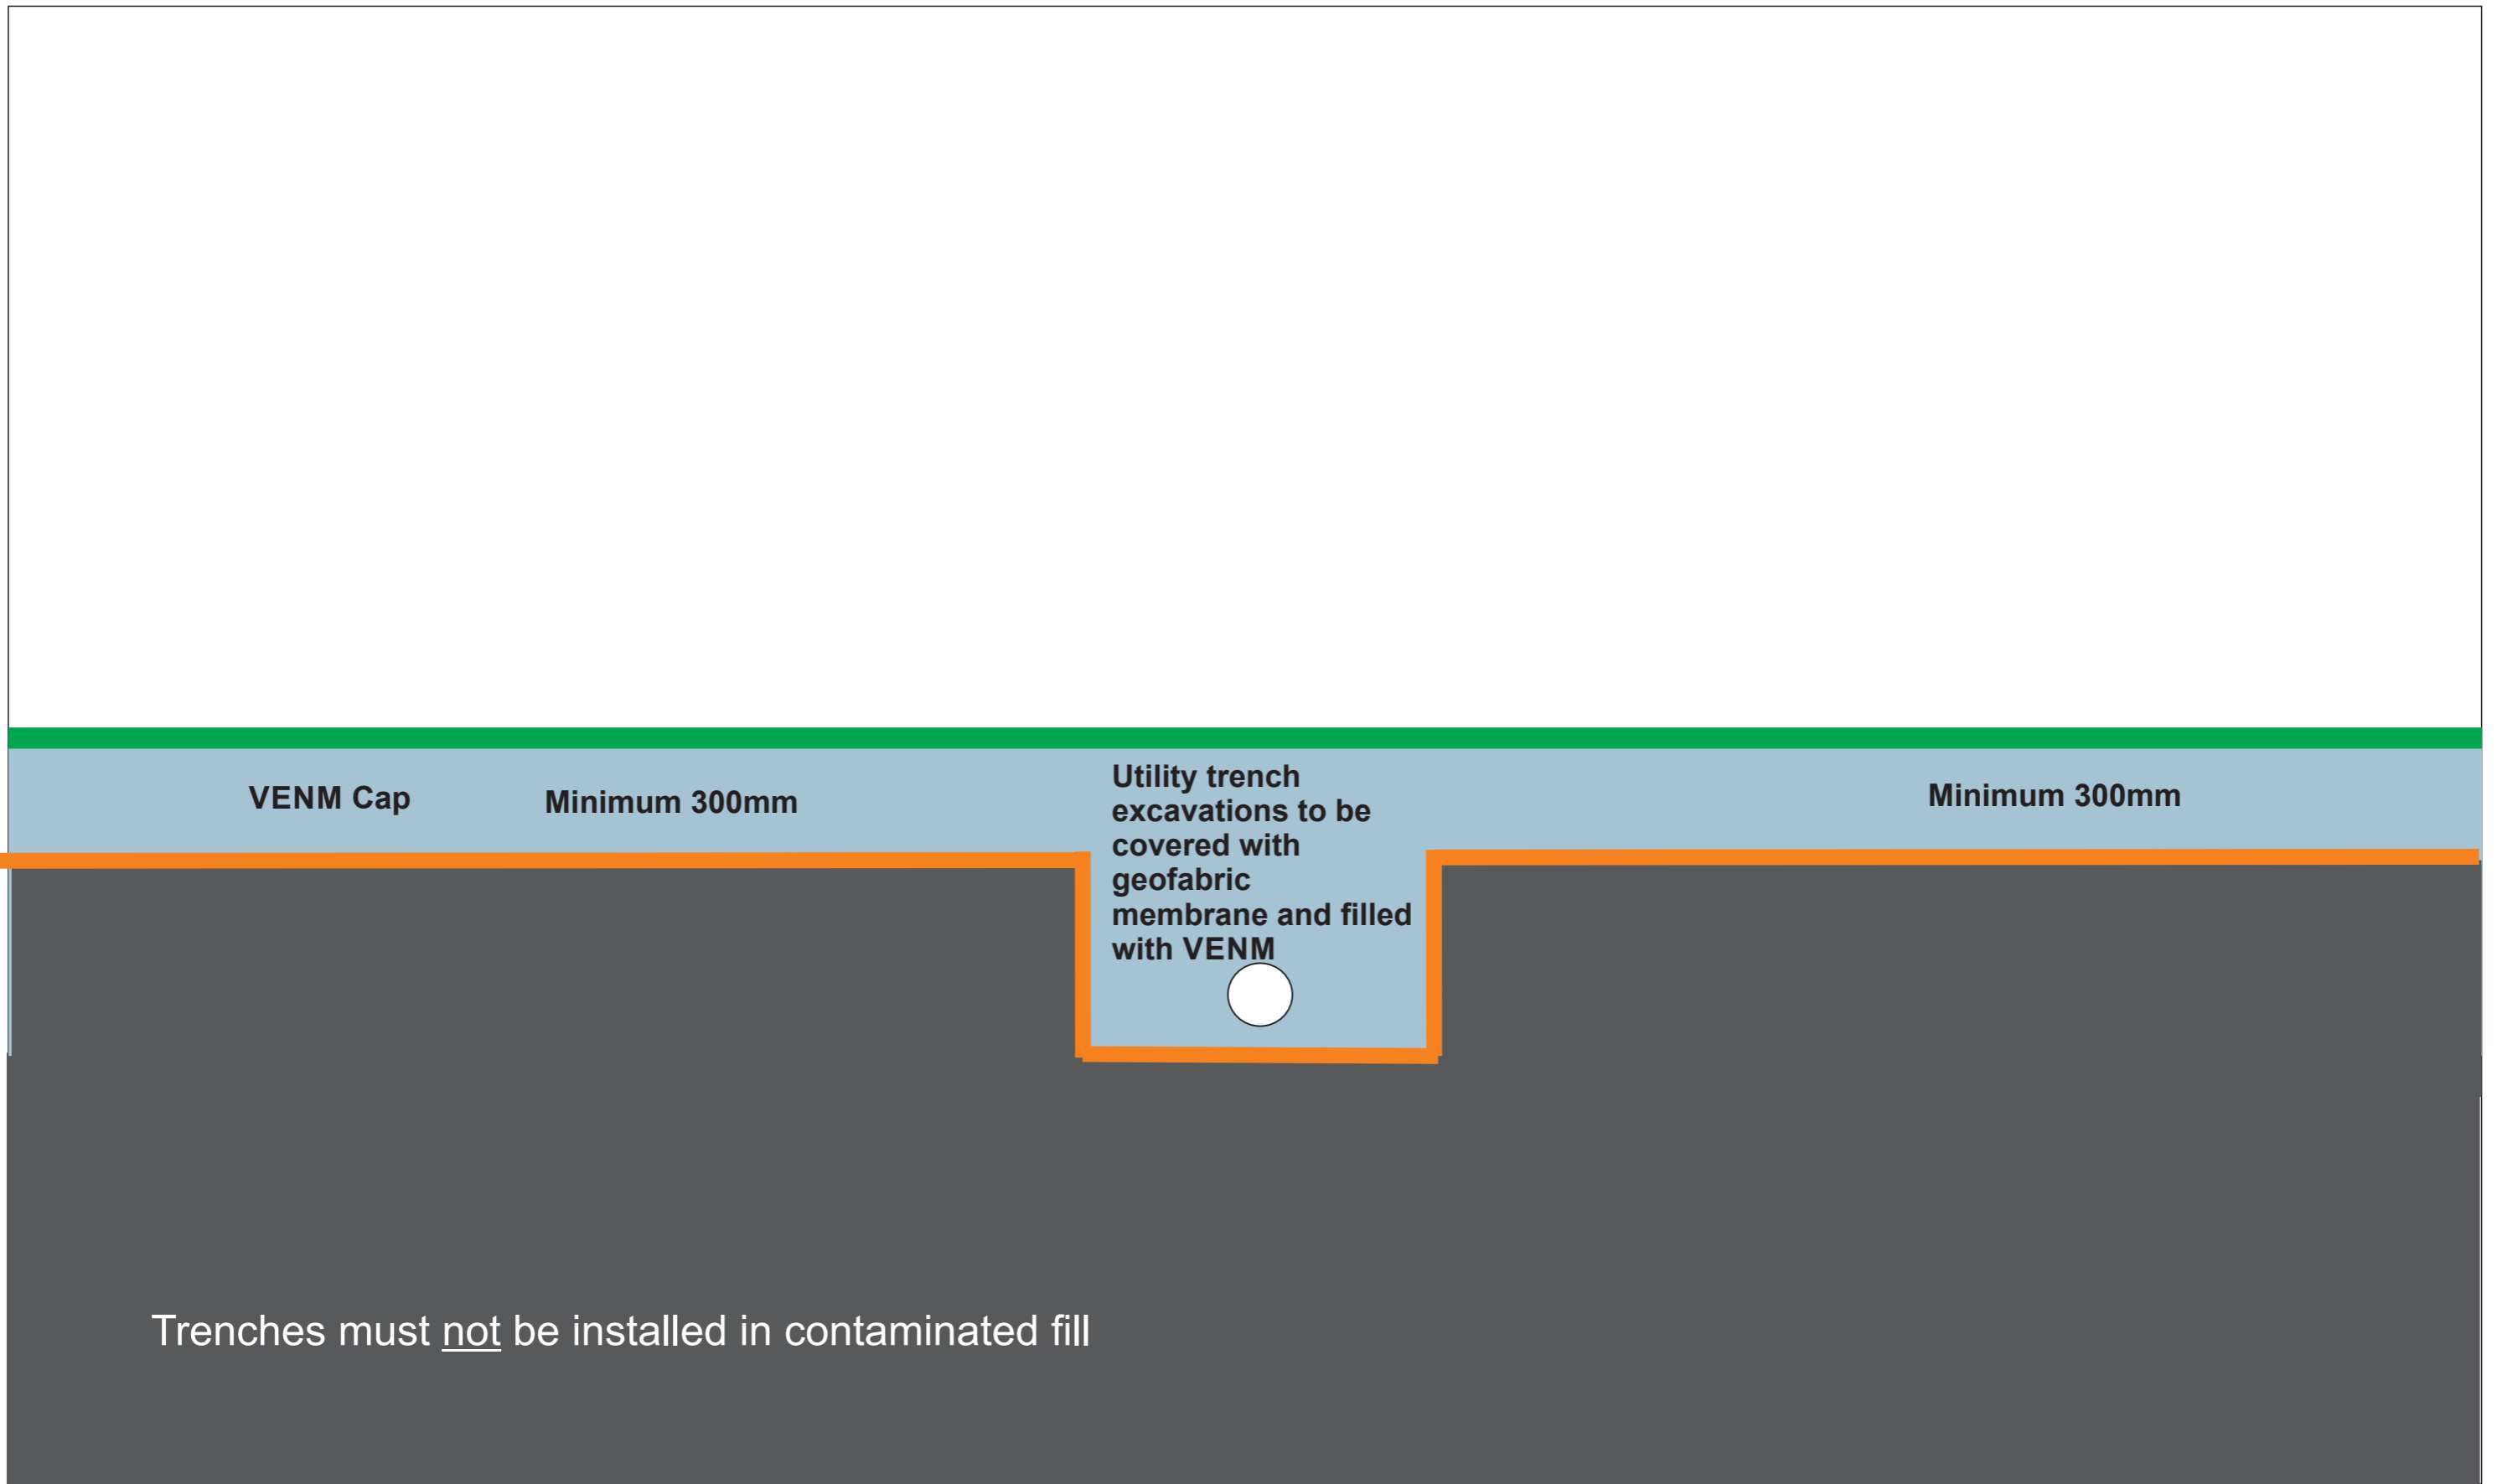
Trenches must not be installed in contaminated fill
