# Lake Parramatta Swimming Area

Review of Environmental Factors

City of Parramatta

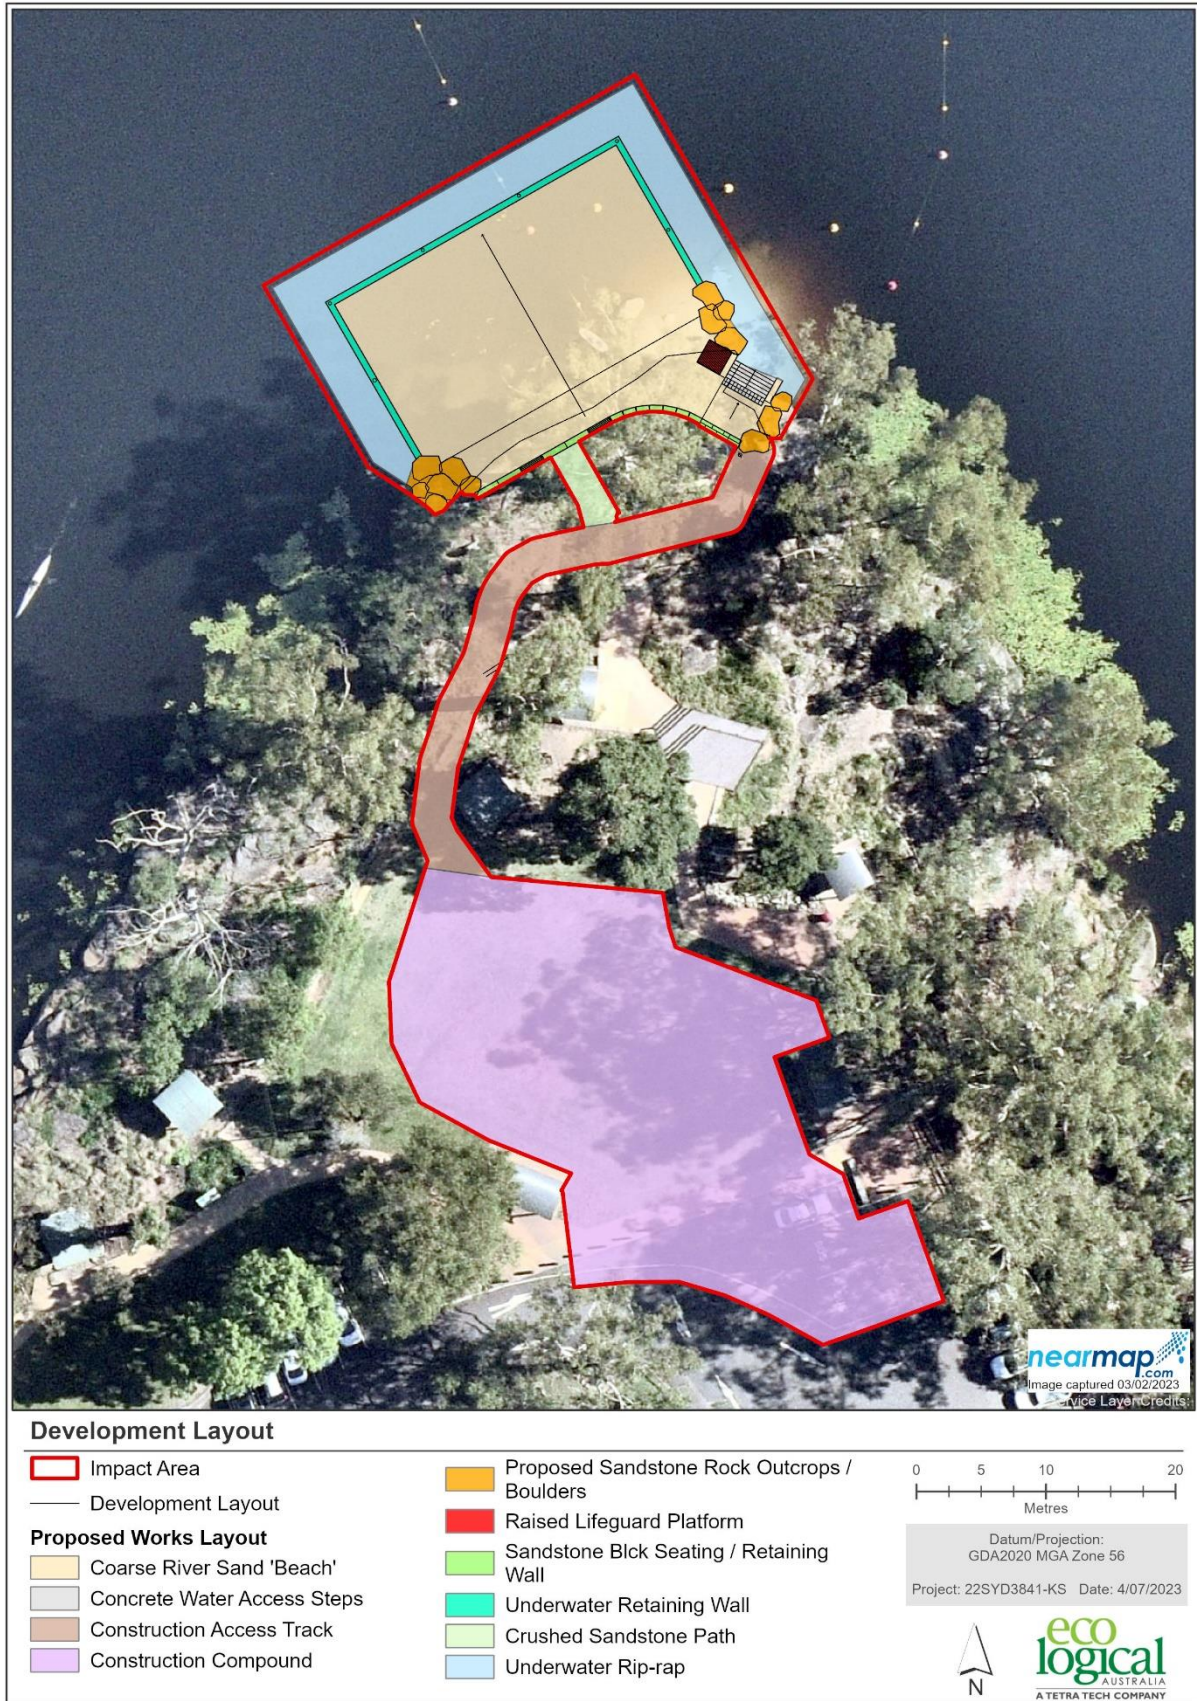
Figure 1-2: Proposed Works Layout

- Sandstone block seating/retaining wall
- Coarse river sand 'beach'
- Concrete water access steps
- Underwater retaining wall
- Raised lifeguard platform

- Concrete water access steps with central stainless steel handrail and tactile surface indicators
- Proposed sandstone rock outcrops/boulders
- Sandstone coloured concrete steps to match existing

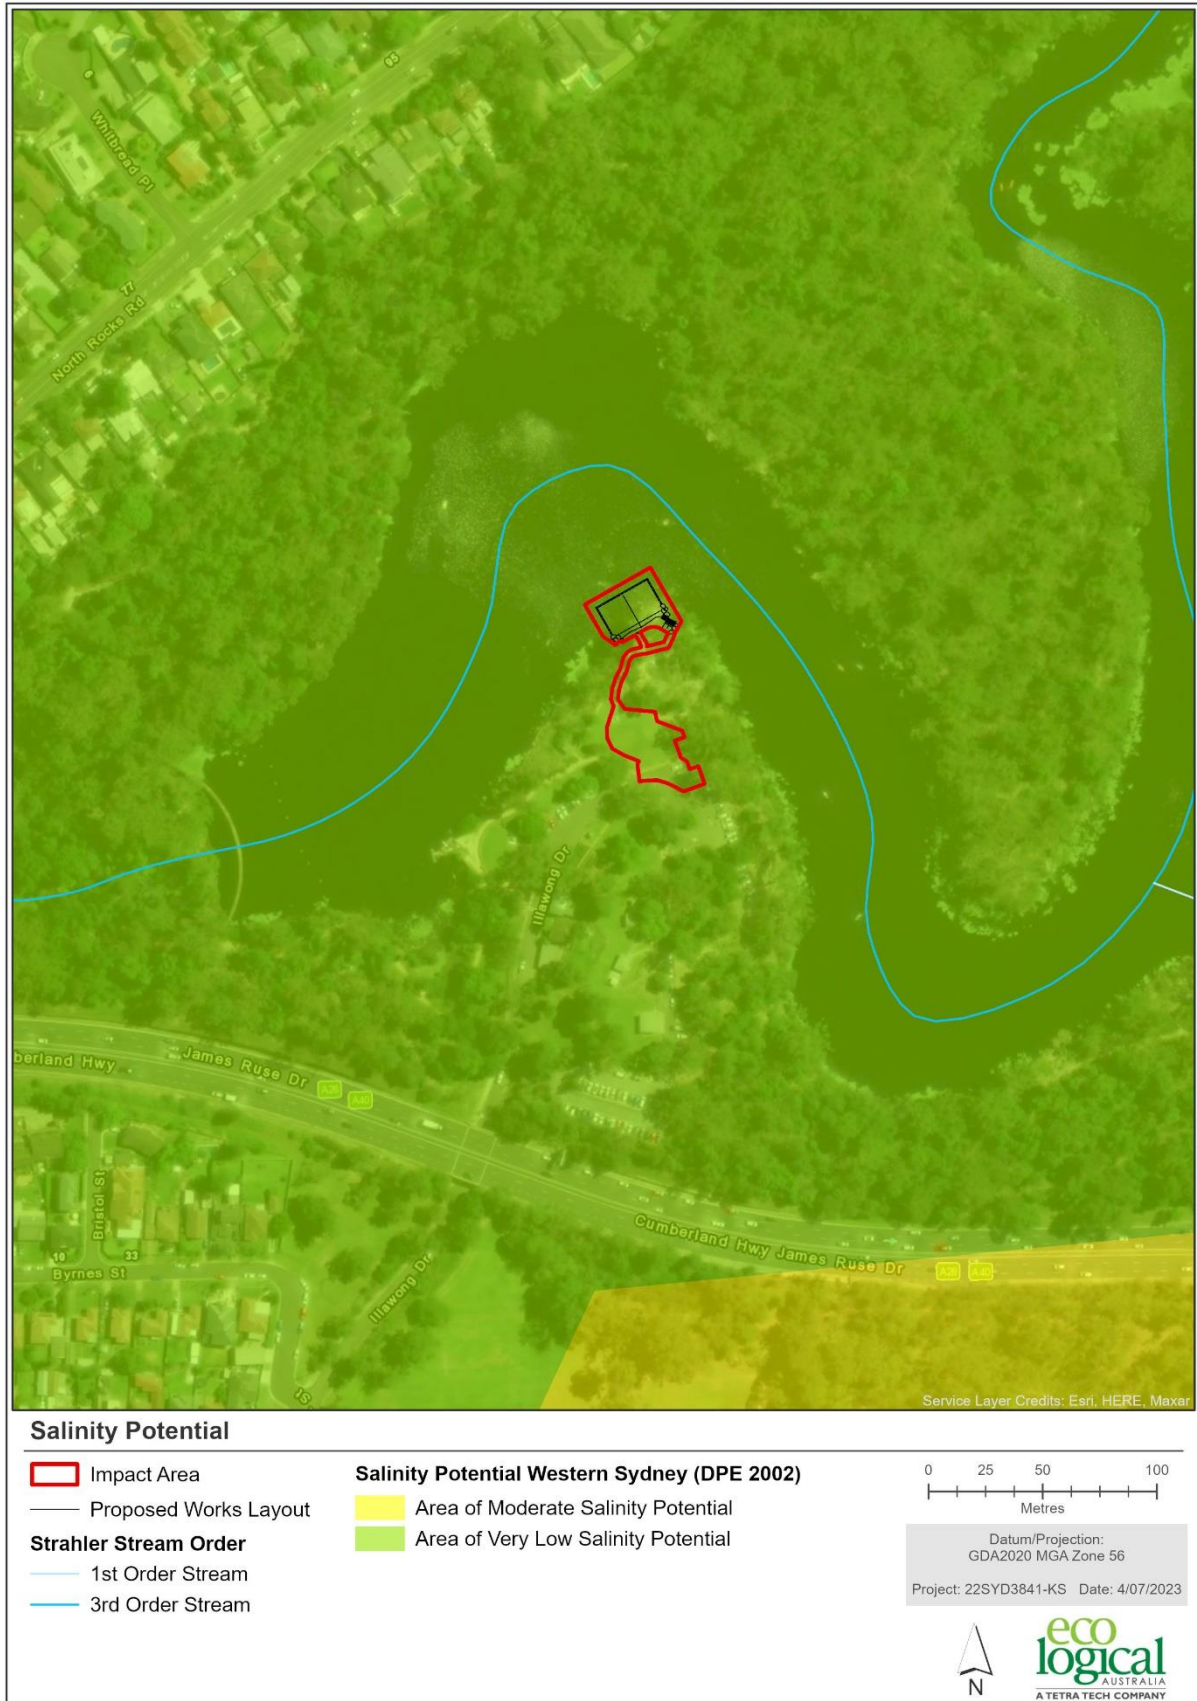
Figure 3-3: Salinity Potential of the study area (DPE 2002)

The study area is mapped under the Salinity Potential Western Sydney dataset as having very low salinity potential (Figure 3-3) (DPE 2002). Nearby salinity soil profiling undertaken within Lake Parramatta Reserve, approximately 300 m southeast of the study area, found no evidence of salting (OEH n.d.). It is unlikely that the study area contains saline soils.

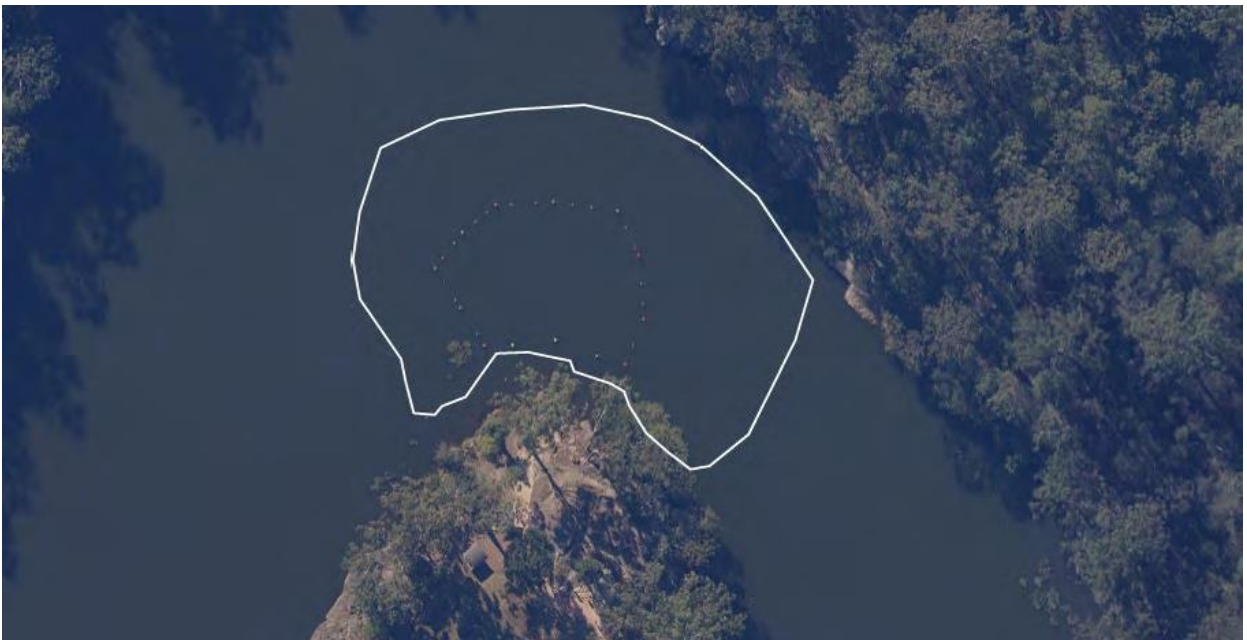
**Figure 3-4: Geotechnical investigation area indicated by white polygon (GBG Group 2023)**

The geophysical investigations found that sandstone bedrock and boulders dominated the investigation area. Some superficial sandy fill/cover was present in some areas. Borehole results confirmed these observations, finding silty sandy fill in BH1 and BH2, to depths of 0.8 m and 0.4 m respectively (GBG 2023). In BH3, concrete pavement was present to 50 mm depth. Silty clays were encountered in disturbed samples from BH4 to BH9. Sandstone encountered beneath the fill of BH1 to BH3 was found to be moderately weathered, of low to high strength.

The full report prepared by GBG and supplemented by JK Geotechnics is provided in Appendix B.

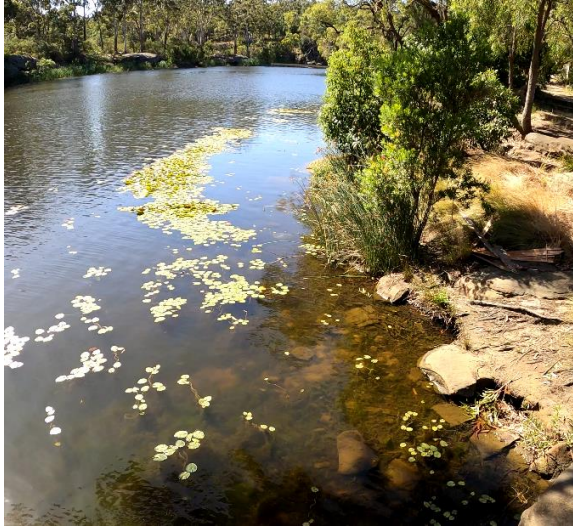
Figure 3-7: *Nymphaea alba* (White Water Lilly)

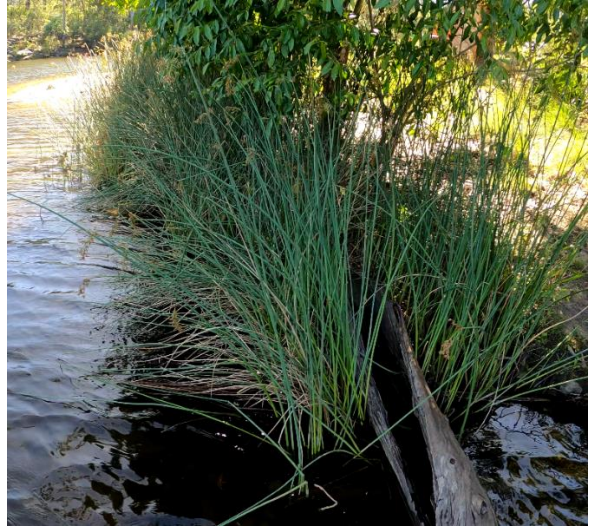
Figure 3-8: *Schoenoplectus validus* (Club-rush)

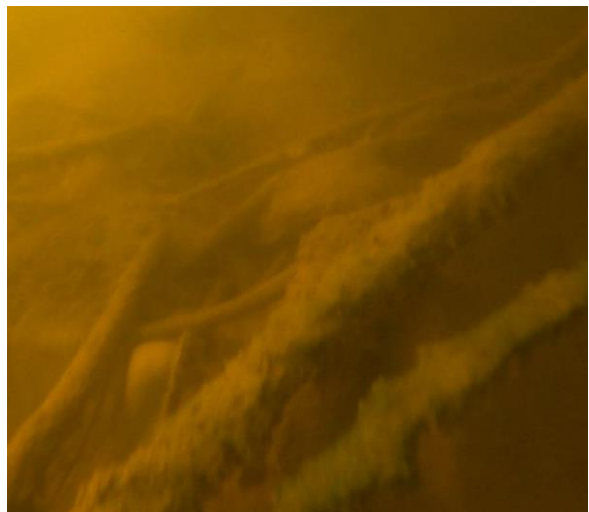
Figure 3-12: Sediment covered debris

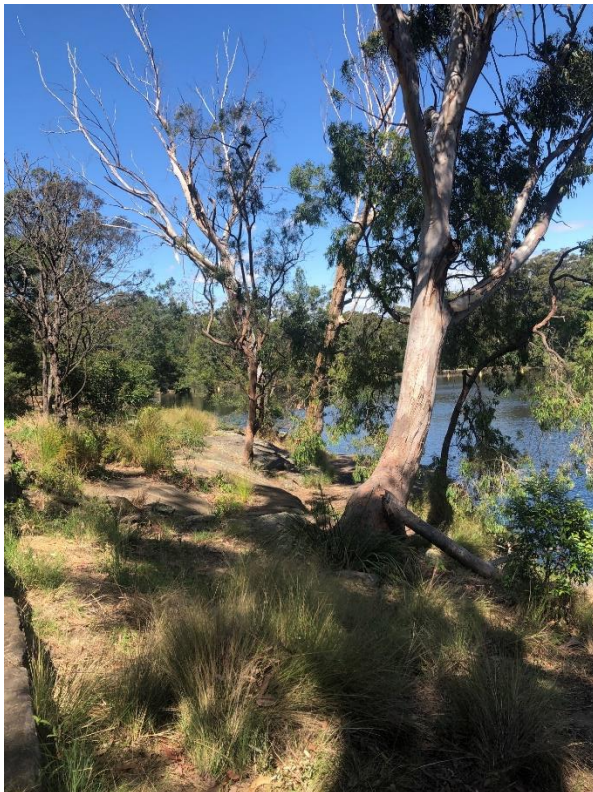
**Figure 3-16: PCT 3592 in moderate condition within the study area**

PCT 3592 Sydney Coastal Enriched Sandstone Forest	
TEC: BC Act	Not listed
TEC: EPBC Act	Not listed
Vegetation Description	<p>PCT 3592 occurred in moderate condition along the edges of the terrestrial land within the study area, bordering the lake, in low condition in the south west corner of the study area (Figure 3-16 and Figure 3-17). There are patches of moderate condition PCT 3592 within the impact area.</p> <p>PCT 3592 in moderate condition was characterised by a canopy dominated by <i>Eucalyptus pilularis</i> (Blackbutt), <i>Syncarpia glomulifera</i> (Turpentine) and the occasional <i>Eucalyptus piperita</i> (Sydney Peppermint) and <i>Angophora floribunda</i> (Rough-barked Apple). The mid storey and ground storey appeared to be a combination of natural and revegetated occurrences. The midstorey was sparse, containing a dominance of <i>Pittosporum undulatum</i> (Sweet Pittosporum), <i>Glochidion ferdinandi</i> (Cheese Tree) and <i>Dodonaea triquetra</i> (Large-leaf Hop-bush). The ground storey was dominated by <i>Themeda triandra</i> (Kangaroo Grass), <i>Lomandra longifolia</i> (Spiny-headed Mat-rush) and <i>Poa labillardierei</i> (Tussock).</p> <p>PCT 3592 in low condition consists of two <i>S. glomulifera</i> with a cleared understorey, mainly consisting of <i>Cynodon dactylon</i> (Couch), <i>Cenchrus clandestinus</i> (Kikuyu) and <i>Poa annua</i> (Winter Grass).</p>

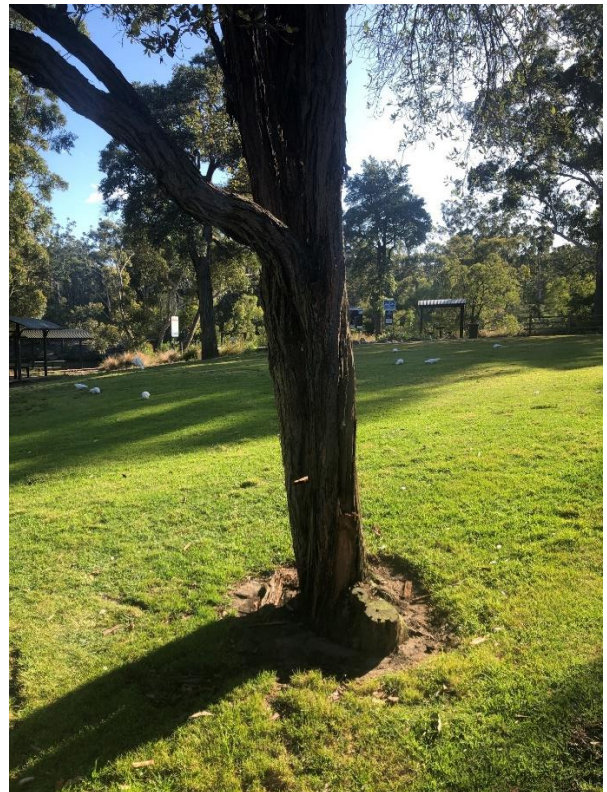
**Figure 3-17: PCT 3592 in low condition within the study area**

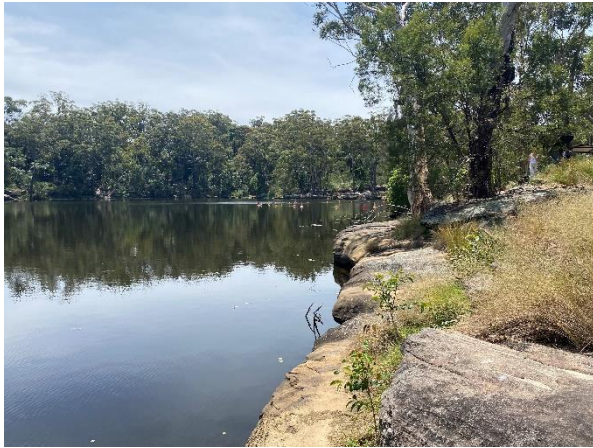
**Figure 3-25: View north-east towards existing swimming area showing vegetation and exposed sandstone bedrock surrounding the lake**

Surface visibility was limited due to grass cover, footpaths, and the existing structures, and in areas of exposure, mixed deposits of gravel, leaf litter and yellow-grey sand and loams were observed (Figure 3-27). No surface artefacts were identified in any exposures. Native vegetation and exposed sandstone bedrock surrounded the lake (Figure 3-25), and no cultural markings were observed on any areas of exposed bedrock.

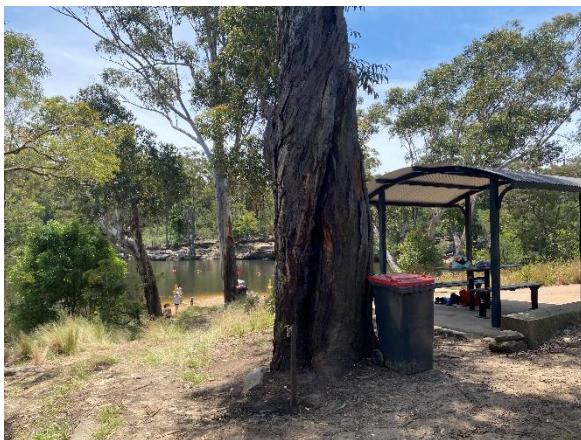
**Figure 3-27: View north showing existing swimming area, with picnic tables and exposed sand**

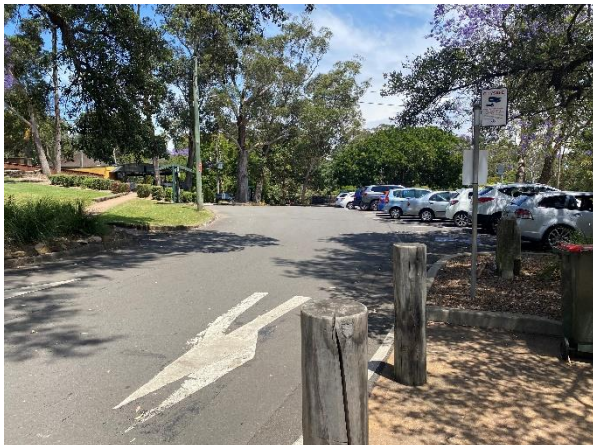
**Figure 3-29: View west of road and parking area (modification of original landform)**

The study area was situated on a moderate south-north orientated slope down towards the lake (Figure 3-28 – Figure 3-30). The visual inspection revealed that the majority of the study area had undergone prior ground disturbance related to the construction of and continued recreational use of Lake Parramatta Reserve as a swimming and picnic area (Figure 3-25 – Figure 3-30). The existing disturbance included the clearance of vegetation and associated landscaping, the construction of picnic structures, park benches, and concrete footpaths, as well as a concrete staircase that lead towards the road and carpark (Figure 3-26 – Figure 3-30), all of which had modified the original landform (Figure 3-29).

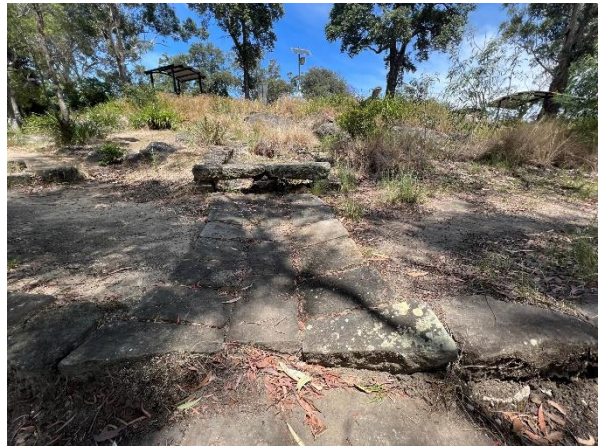
**Figure 3-34: View of existing sandstone culvert structure within proposed construction access track**

The study area is located within Lake Parramatta Reserve, defined by an extensive lake system surrounded by remnant bushland interspersed with recreational facilities. The proposed construction compound area would be located within an existing carpark with adjoining grassed picnic area (Figure 3-33 and Figure 3-36), whilst the construction access track would traverse bushland to Lake Parramatta’s shoreline. This bushland is interspersed with existing access tracks, and a sandstone culvert and sandstone pathway edging were encountered here during the site inspection (Figure 3-34 - Figure 3-35).

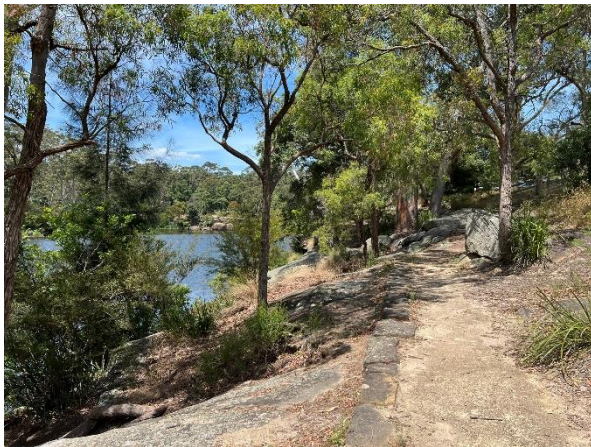
**Figure 3-35: View of existing sandstone pathway edging within proposed construction access track**

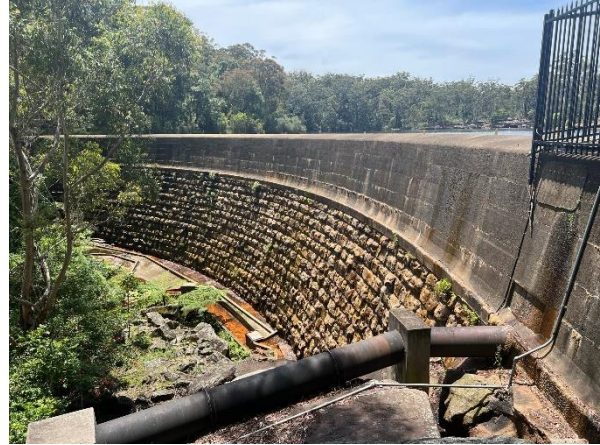
Figure 3-38: View of Parramatta Dam within Lake Parramatta Reserve (outside study area)

Lake Parramatta Dam lies to the west of the study area (Figure 3-38). It is a cylindrical masonry arch dam with vertical water face, considered to be in good condition with little evidence of weathering or spalling.

The Dam is constructed from solid sandstone blocks quarried from Hunts Creek, bonded together with Roman and Portland cement mortar. The dam wall is visible from the study area and is considered to contribute to the overall setting of the Reserve (Figure 3-37).

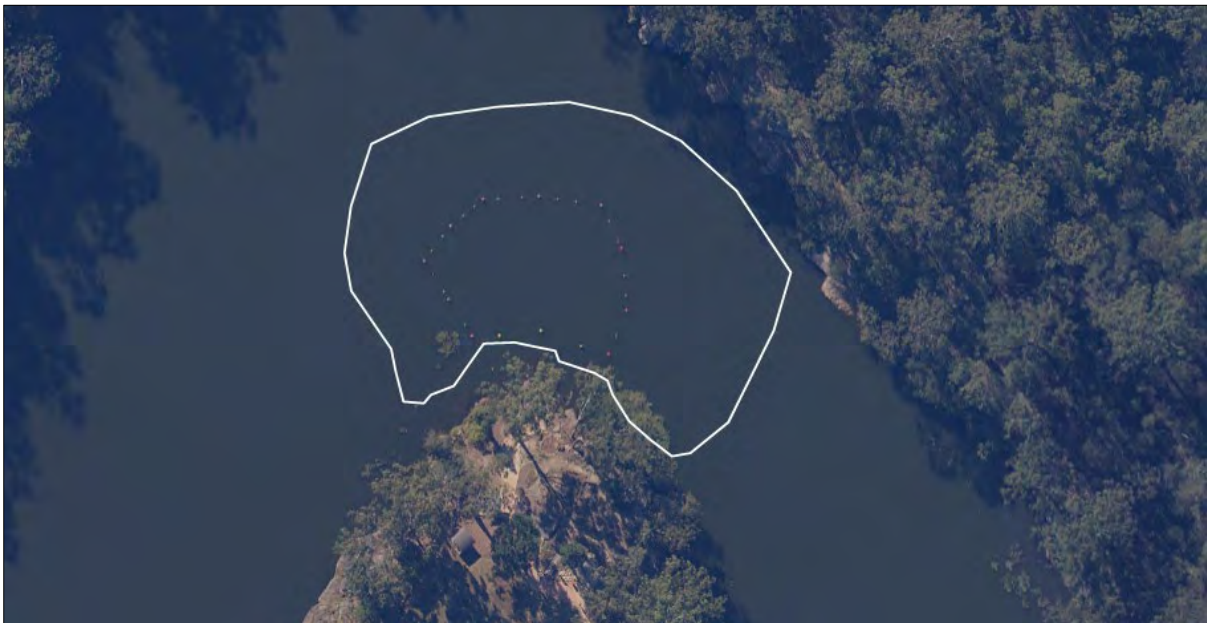
**Figure 1.** Lake Parramatta investigation area (white polygon). The dotted area within the white polygon represents the swimming area boundary. Image courtesy of SixMaps.

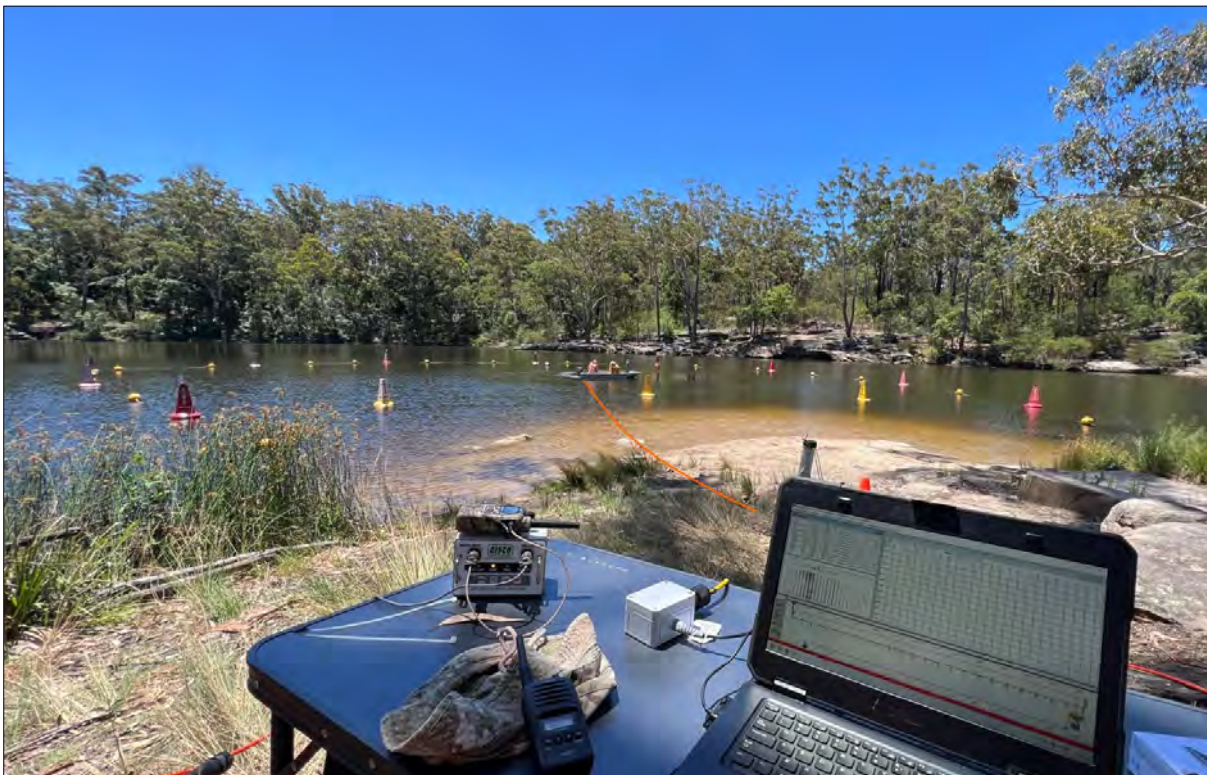
**Figure 2.** MSR setup for Line 2. Picture taken from seismograph operator looking out towards air gun operators. Note the orange polyline representing the seismic array.

The receiving equipment was setup on the land side. The airgun was setup on the small boat. Figure 2 shows the land equipment setup on the east side. The boat is moving into position for the first air gun shot.

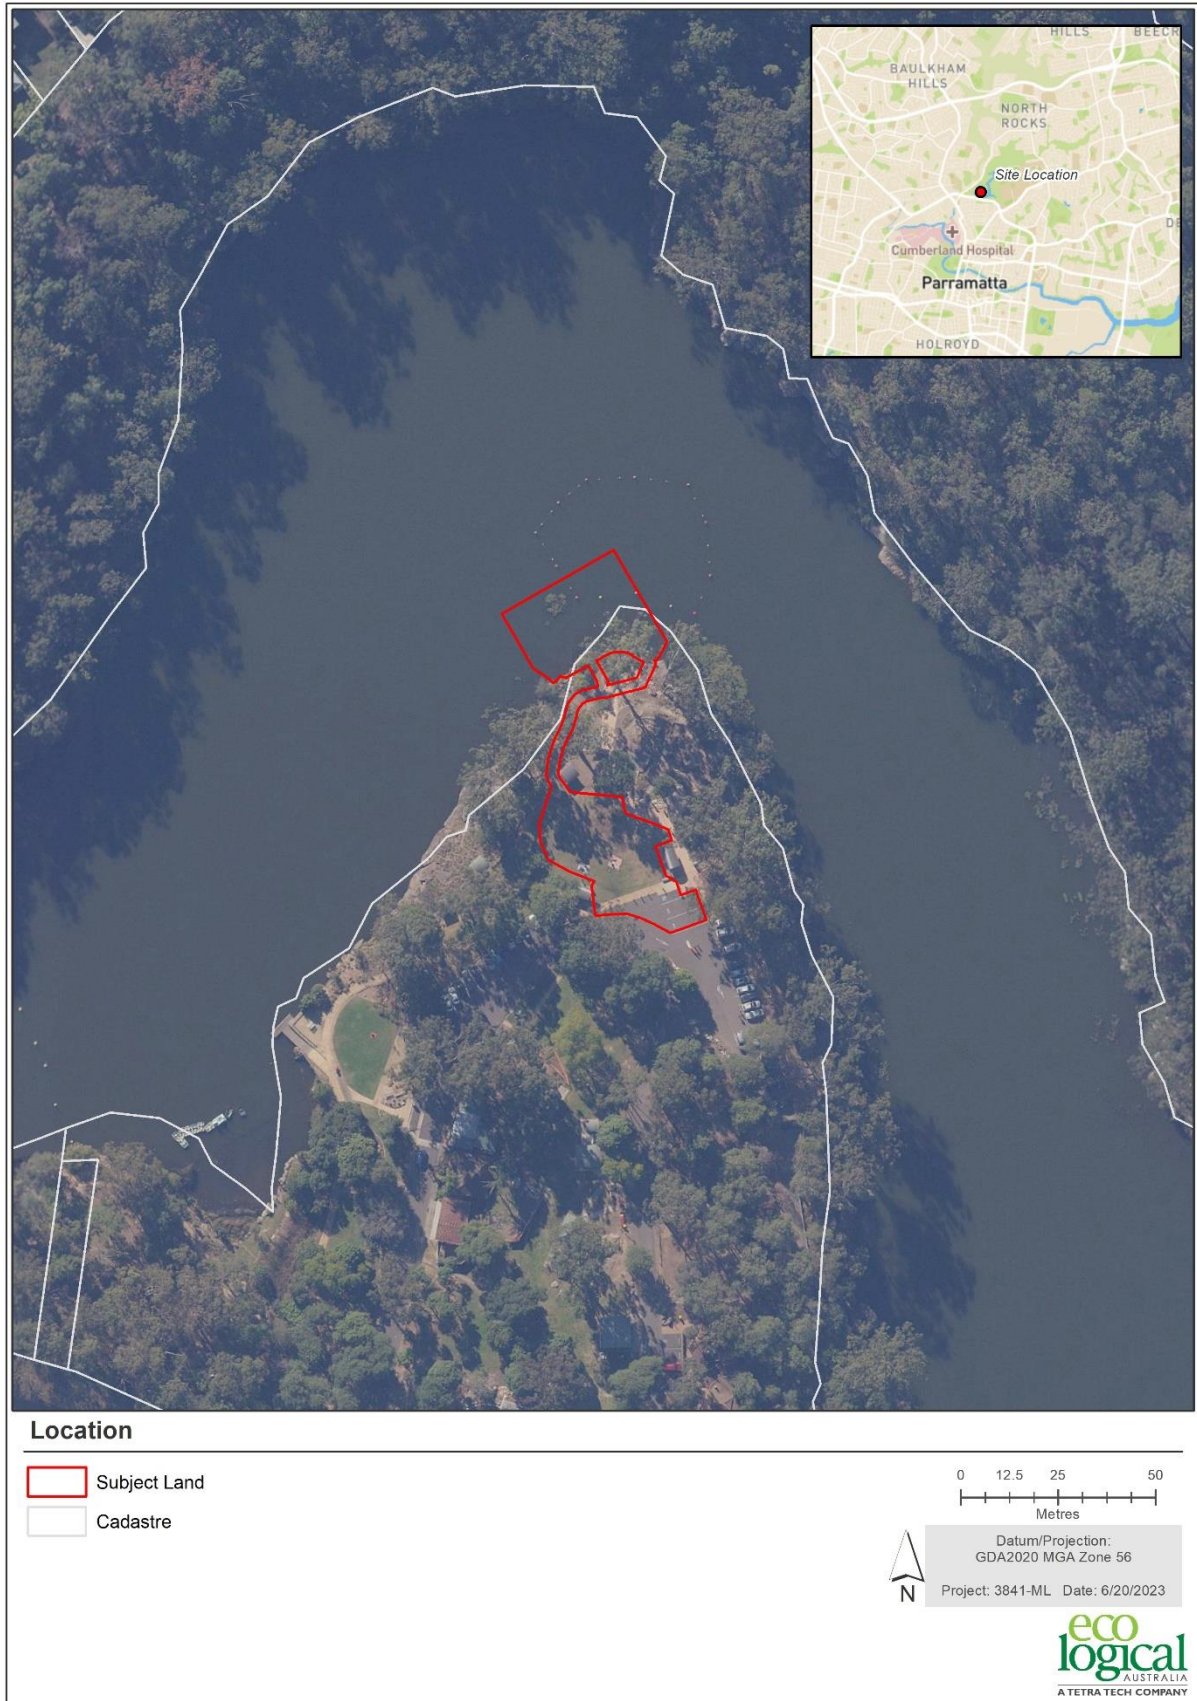
Figure 3: Location of the proposed works

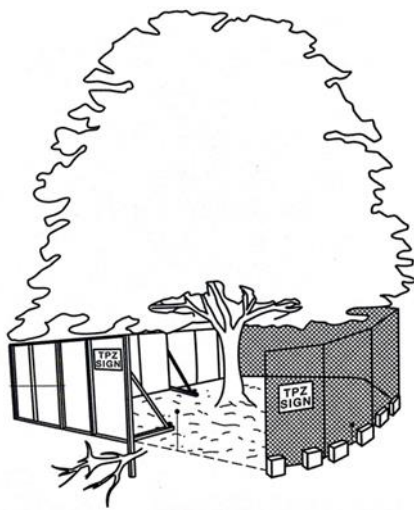
Tree protection fencing

The timbers must be secured using galvanised hoop strap (aluminium strapping). The timbers shall be wrapped around the trunk but not fixed to the tree, as this will cause injury/damage to the tree.

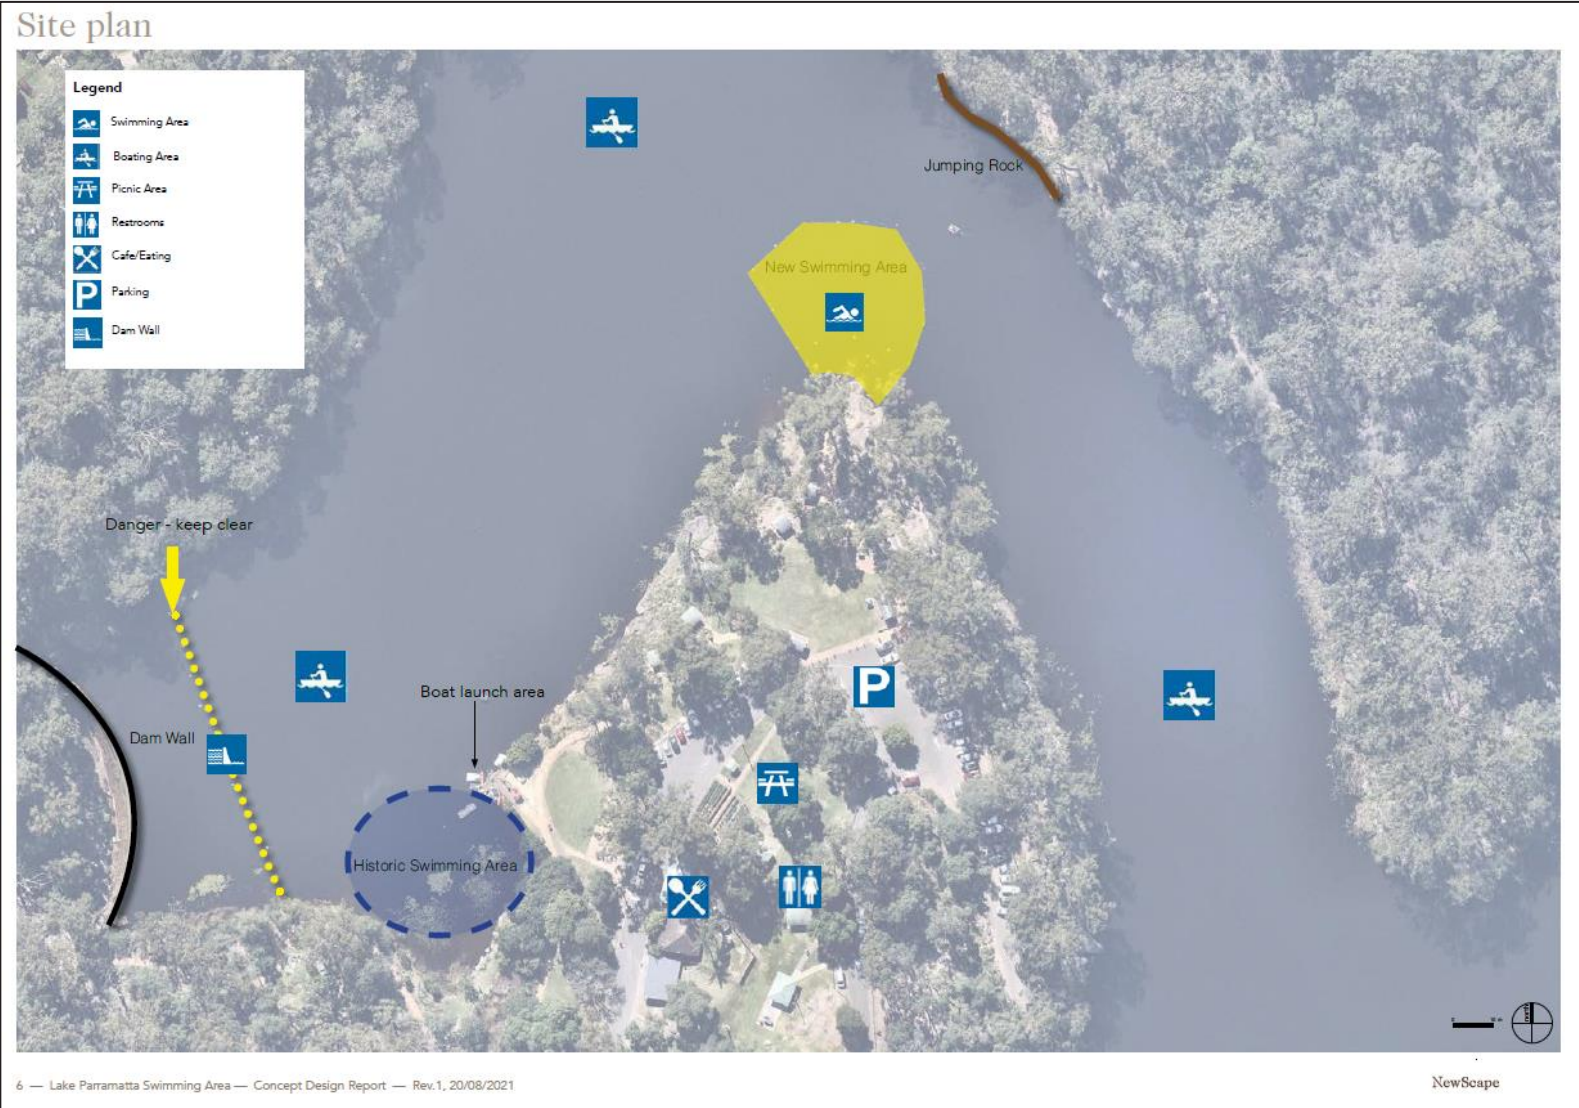
Figure 3: Site plan of existing site assets and locations of historic and contemporary swimming areas (Newscape 2021)

From the 1920’s, Lake Parramatta Reserve, as it had become recognised, enjoyed immense popularity as a recreational destination due to the bushland environment, fauna, and the lake itself. The lake was used extensively for swimming, rowing, water-skiing and other aquatic activities. A swimming club, clubhouse and lifesaving organisation were established in the 1930’s and a kiosk later opened to service visitor demand in 1937. Figure 4 and Figure 5 shows Lake Parramatta in use as a swimming area in 1938. The historic swimming area is located outside of the study area and current swimming area, located to the south-west, near the dam wall (Figure 3).

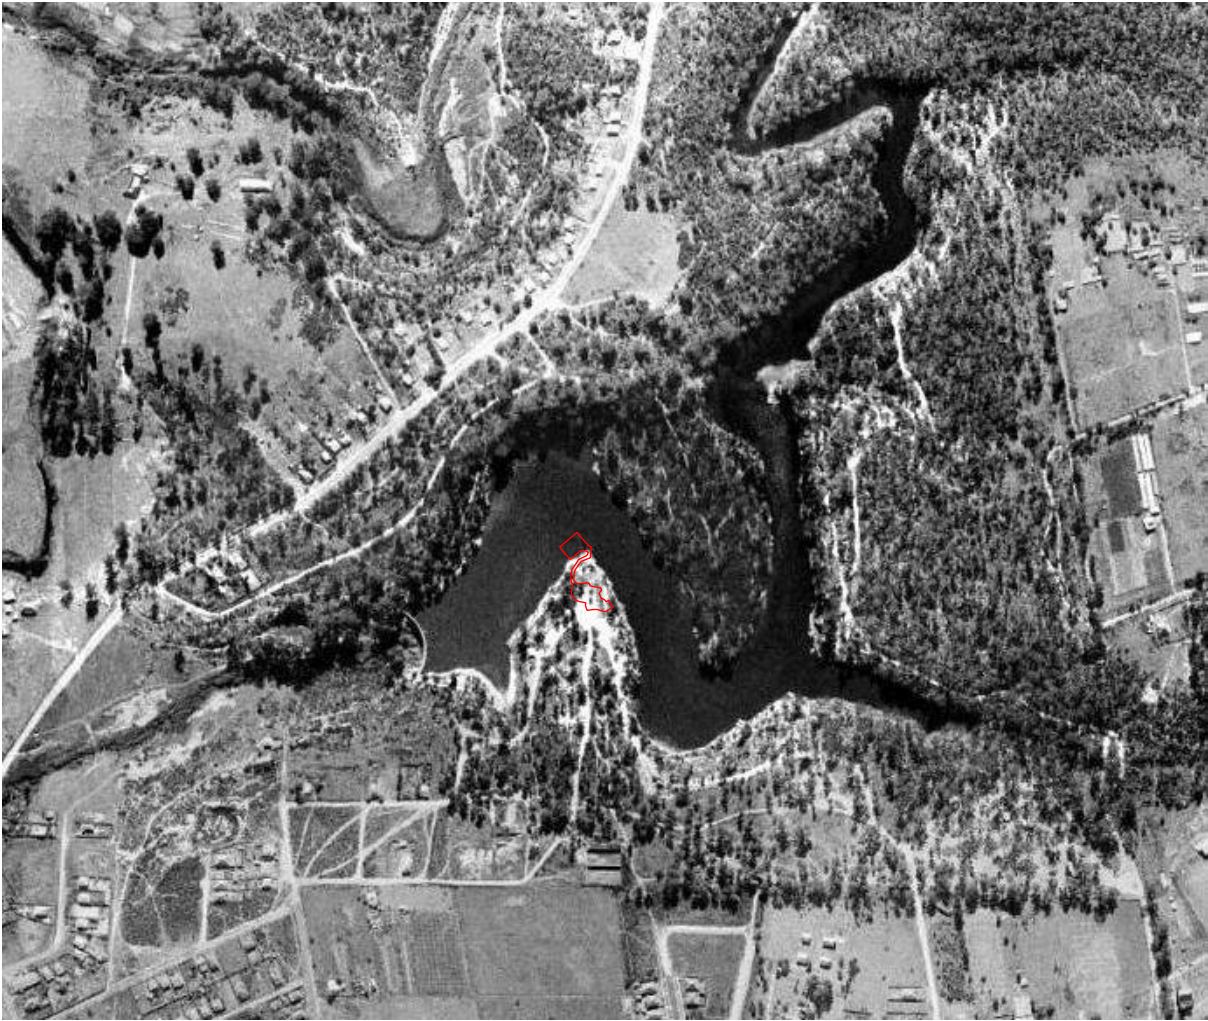
**Figure 8: 1943 historic aerial imagery indicates no structures within the study area**

There is no documentary evidence of substantial building development having taken place within the study area. Aerial imagery from between 1943 and present-day indicates that the study area has largely remained in its current configuration (Figure 8). Minor changes to tree plantings and pathways have occurred throughout over time, however, there is no evidence of substantial structural development within the study area.

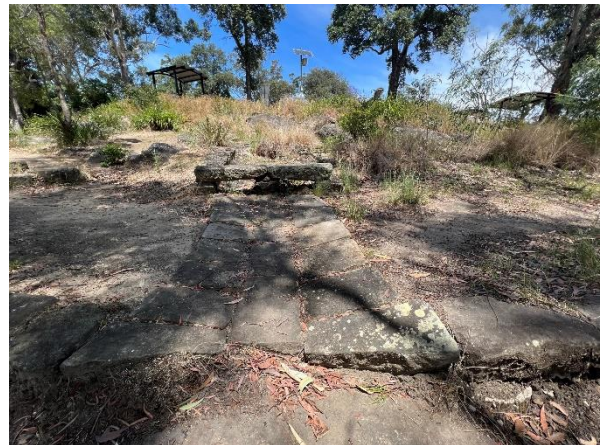
Figure 12: View of existing sandstone culvert structure within proposed construction access track

The study area is located within Lake Parramatta Reserve, defined by an extensive lake system surrounded by remnant bushland interspersed with recreational facilities. The proposed construction compound area would be located within an existing carpark with adjoining grassed picnic area (Figure 11 and Figure 14), whilst the construction access track would traverse bushland to Lake Parramatta’s shoreline. This bushland is interspersed with existing access tracks, and a sandstone culvert and sandstone pathway edging were encountered here during the site inspection (Figure 12 - Figure 13).

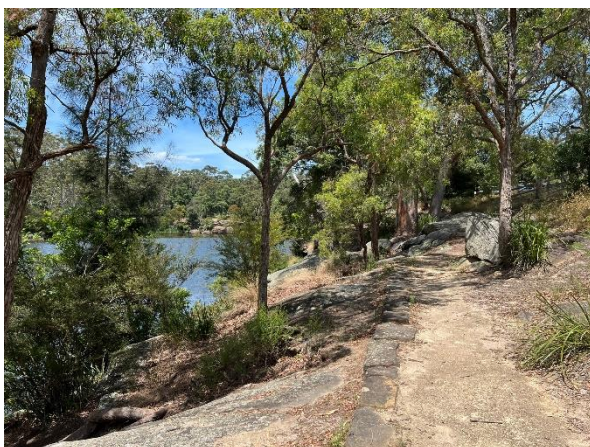
Figure 13: View of existing sandstone pathway edging within proposed construction access track

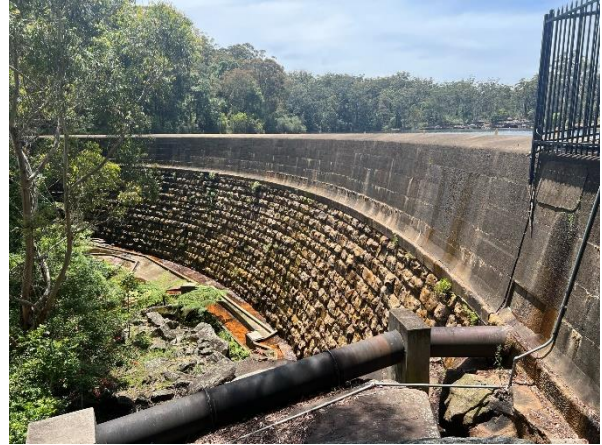
Figure 16: View of Parramatta Dam within Lake Parramatta Reserve (outside study area)

Lake Parramatta Dam lies to the west of the study area (Figure 16). It is a cylindrical masonry arch dam with vertical water face, considered to be in good condition with little evidence of weathering or spalling.

The Dam is constructed from solid sandstone blocks quarried from Hunts Creek, bonded together with Roman and Portland cement mortar. The dam wall is visible from the study area and is considered to contribute to the overall setting of the Reserve (Figure 15).

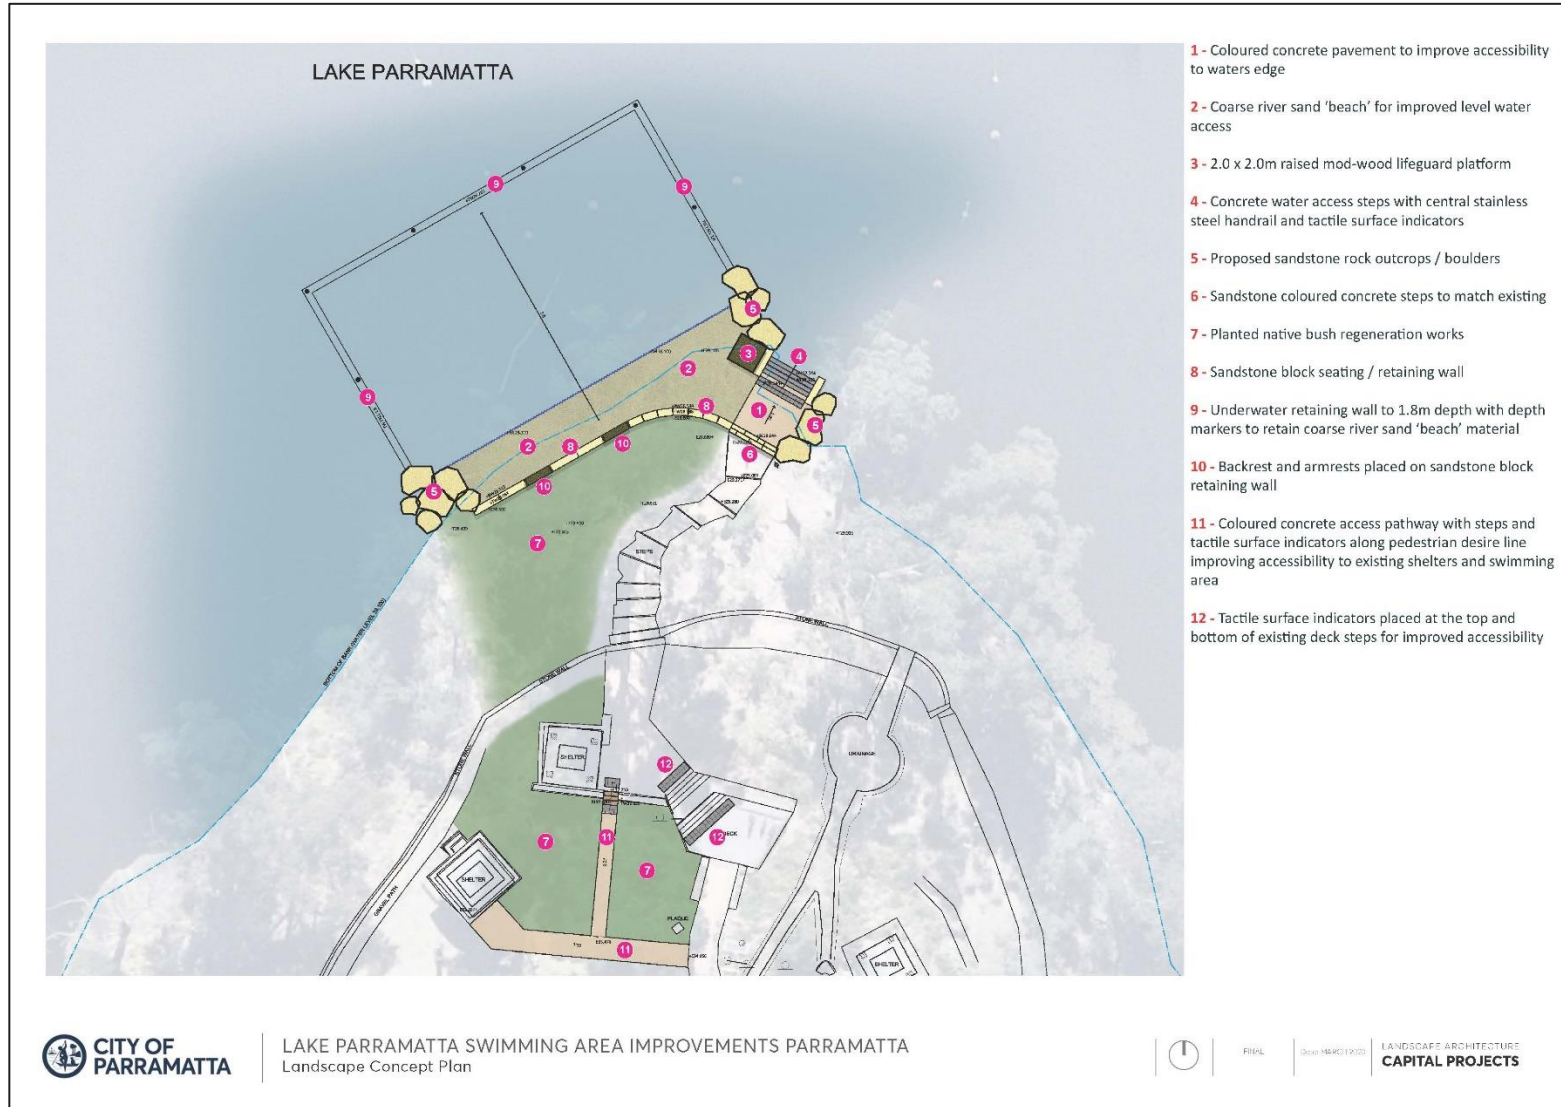
Figure 18: Parramatta Swimming Area Design Plan (Landscape Architecture Capital Projects, 2023)

- Concrete water access steps with central stainless steel handrail and tactile surface indicators
- Proposed sandstone rock outcrops/boulders
- Sandstone coloured concrete steps to match existing

Figure 18 shows the proposed scope of main works.

The proponent is proposing an upgrade to the existing Lake Parramatta swimming area, to be conducted in two stages – Stage 1 involves the construction of a new stepped lake entry area and new swimming area or ‘beach’ including underwater retaining structure for the retention of the new beach material and Stage 2 involves embellishment of the amenity of the immediate embankment area including shade structures, seating, and the installation of an overwater pontoon. The scope of works is discussed in further detail in Section 3.3. Refer to Figure 18 for design plan.

This section provides one possible construction method and is used as a guide to assess the impacts of the works. The actual construction methods and timing will be determined by the Contractor. The final concept plan (City of Parramatta 2023) is provided in Figure 18.
