Appendix 12 – Preliminary Environmental Site Assessment

PRELIMINARY ENVIRONMENTAL SITE ASSESSMENT

261 & 277-281 Pennant Hills Road
14-30 Shirley Street
2, 6 & 10 Janell Crescent
CARLINGFORD NSW 2118

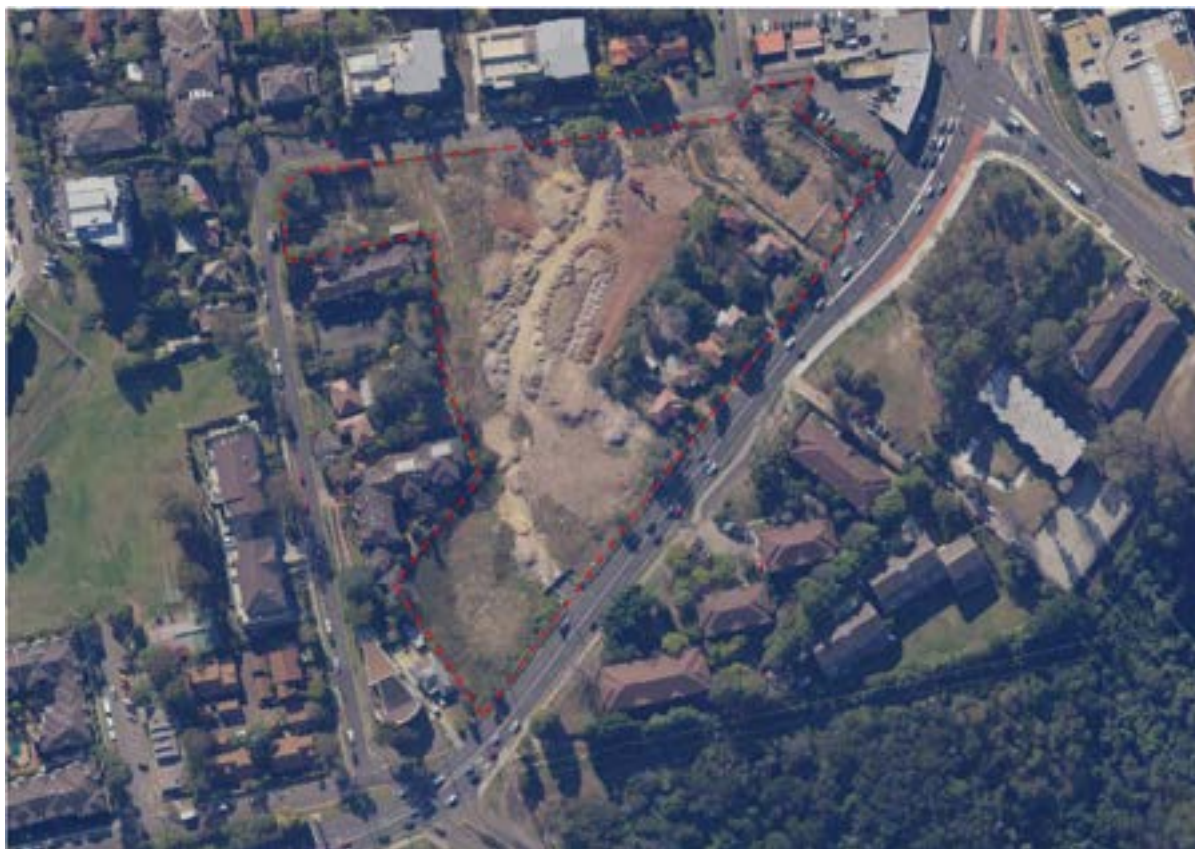
Figure 2.2 – Site Layout

There has been some stormwater mitigation measured established on the Site including a low berm and drainage pathway along the western boundary. Topsoil appears to have been removed from the central area of the Site.

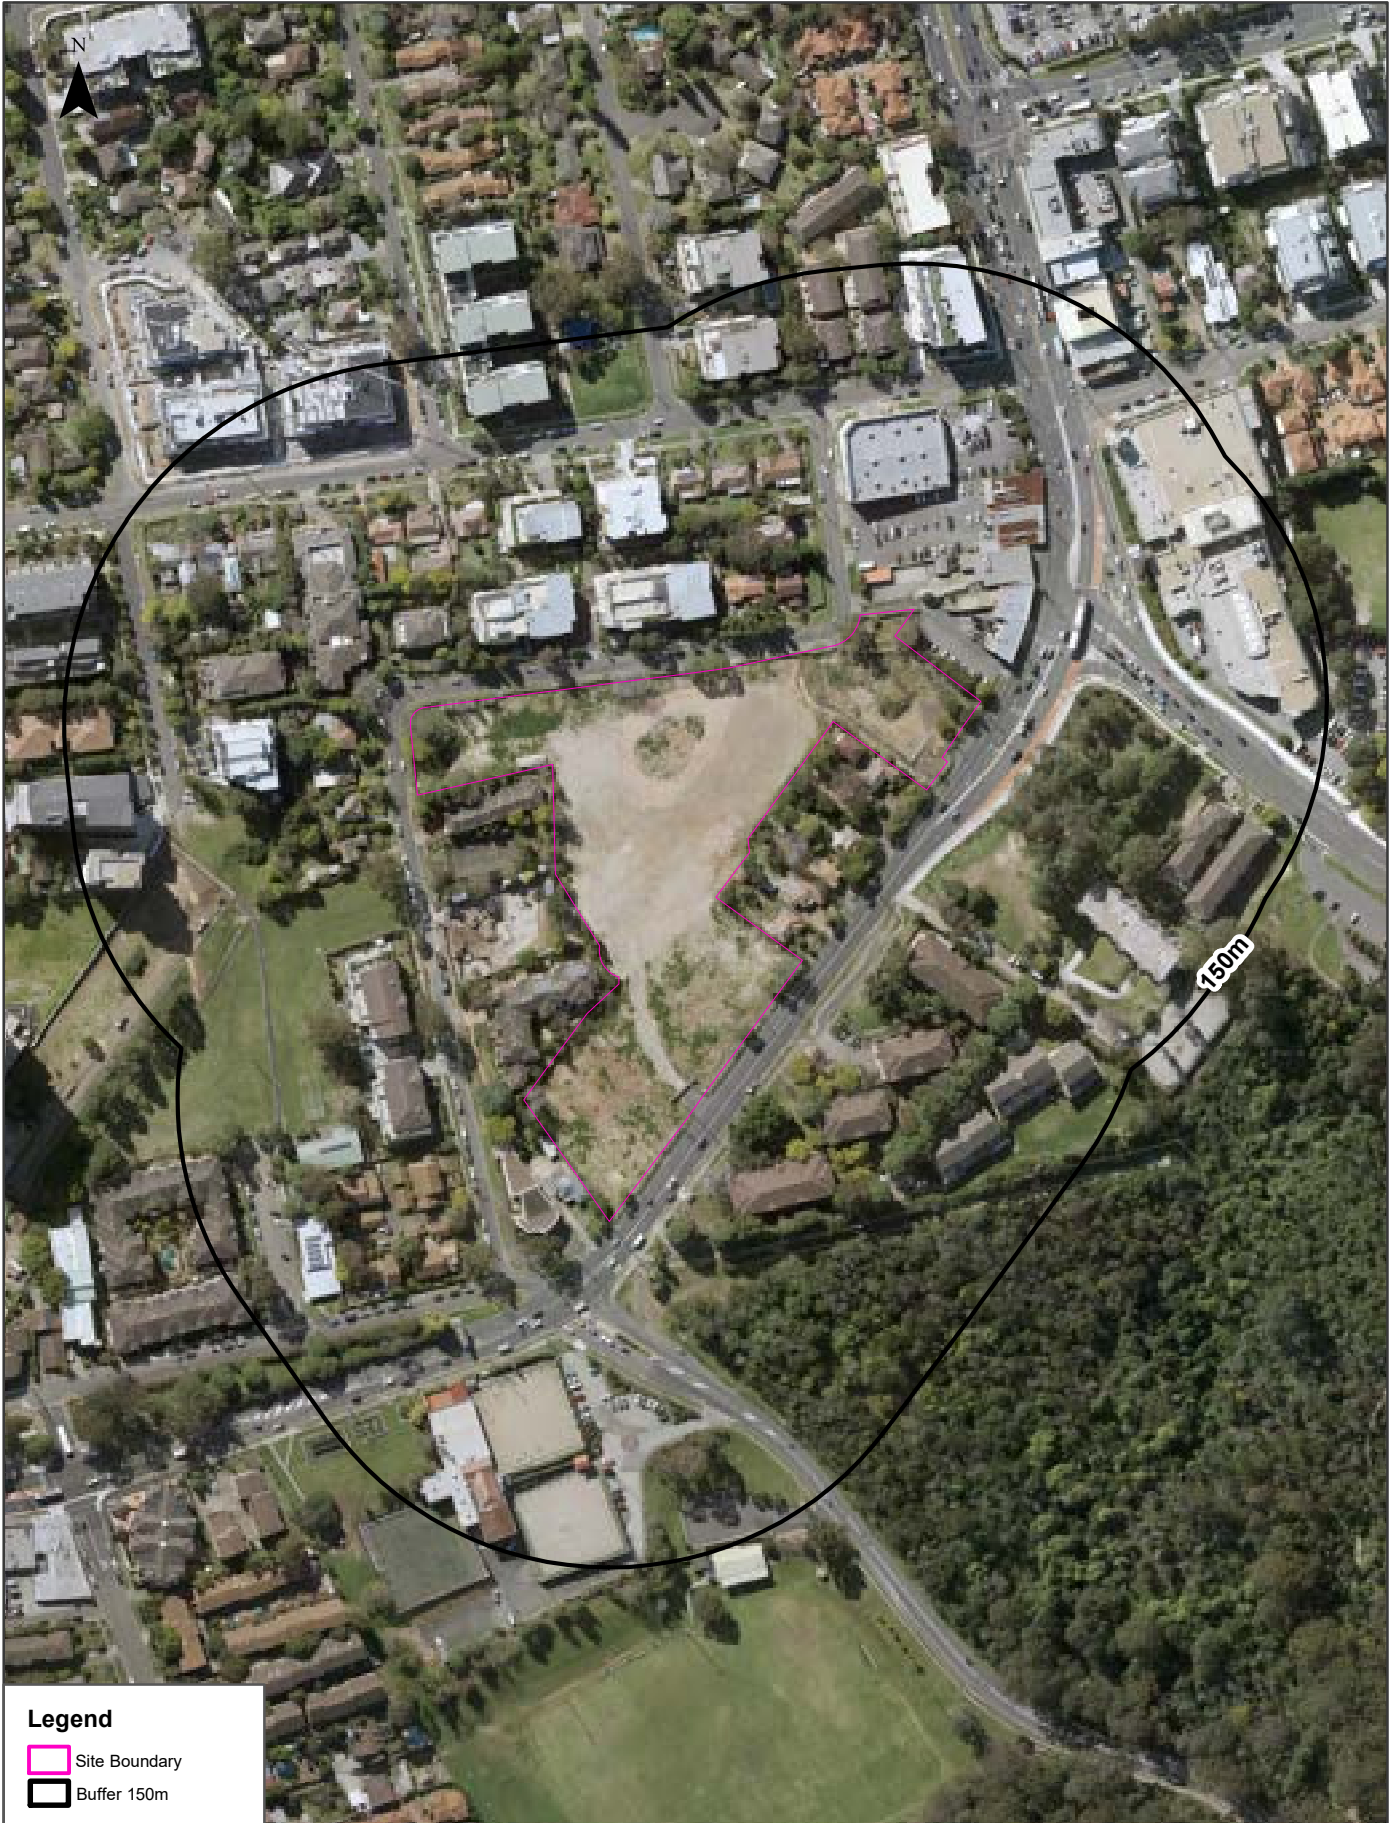
Aerial Imagery 2020

| 2020 | The residential dwellings on the Site have been demolished, vegetation has been cleared and the Site is mostly vacant with the exception of a cluster of residential properties along Pennant Hills Road. Janell Crescent has also been demolished and an unsealed access road entering the Site from Pennant Hills Road has taken its place. It appears a development has begun in the northern corner of the Site with the establishment of foundations which are still present on the Site today. | The surrounding land has undergone further medium and high-density redevelopment transforming the land use of the surrounding area being predominately medium and high-density residential. |

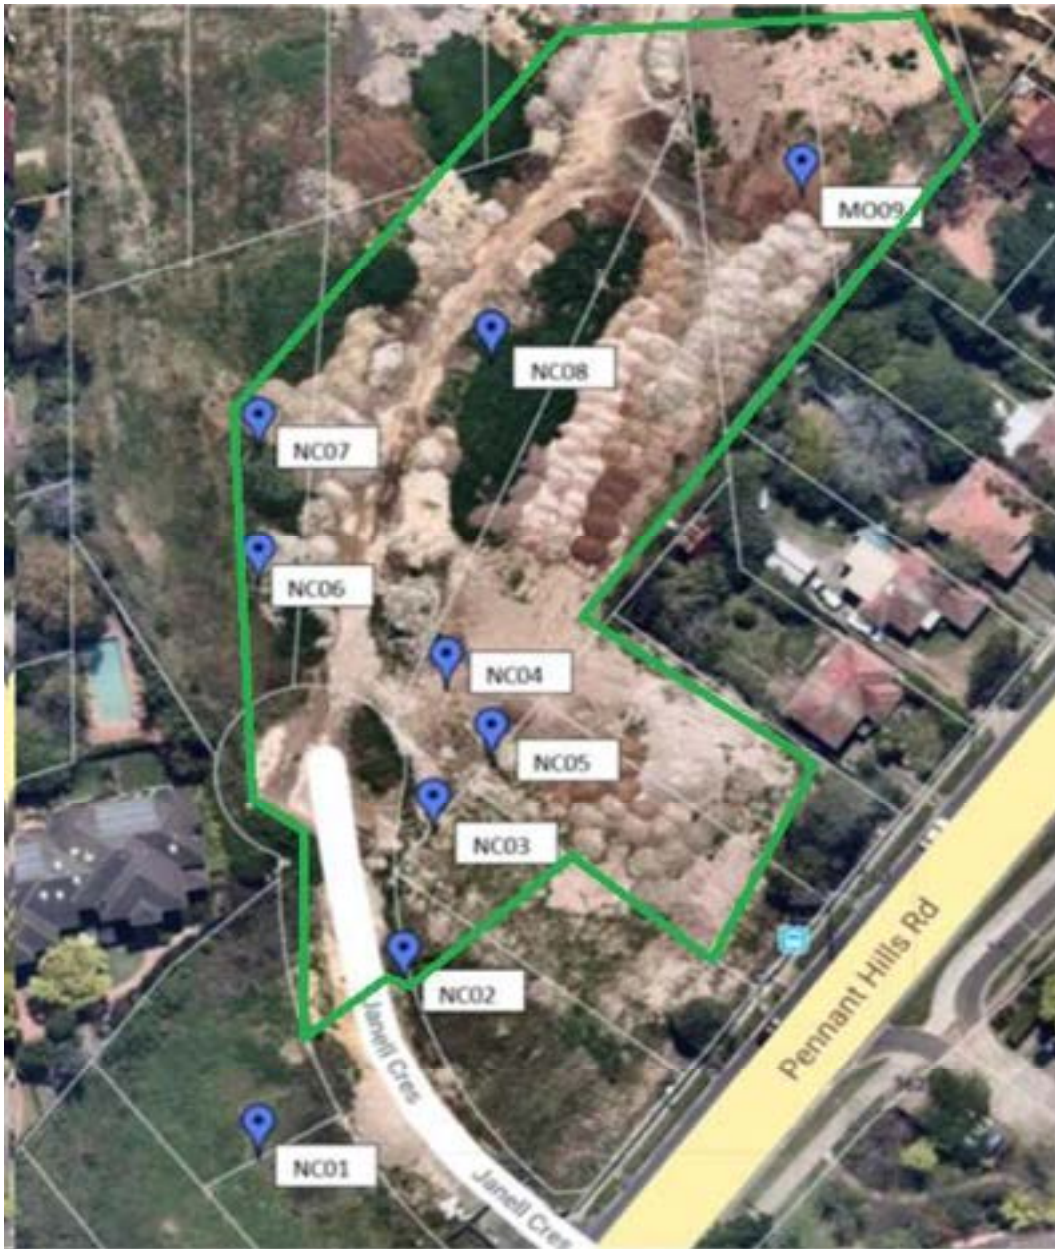
Map 1: suspected asbestos material sampling locations at the Premises on 18 December 2018

- E. On 18 December 2018 EPA officers went to the Premises and observed materials that appeared to be waste applied to the land potentially causing land pollution.
