DETAILED ENVIRONMENTAL SITE ASSESSMENT REPORT
57, 63 & 83 CHURCH STREET, PARRAMATTA, NEW SOUTH WALES
PREPARED FOR GATEWAY PARRAMATTA ONE PTY LTD
REPORT ID: CES150907-DYL-AE

Written by: J. Dobson

Date: 3 January 2016

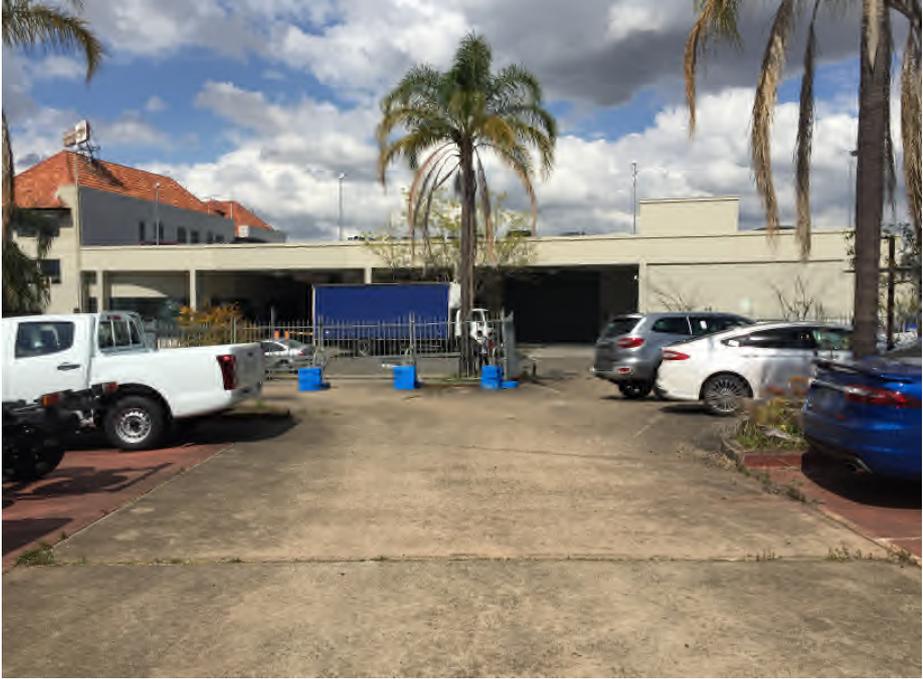
Client Name: Gateway Parramatta One Pty Ltd		Site Location: 57, 63 & 83 Church Street, Parramatta, New South Wales	Project Number: CES150907-DYL
Date: 12/09/15	Plate No: 1

Description: Southern boundary and entry way to site 1. Early Street and Site 2 in background.			
Direction Photo Taken: South

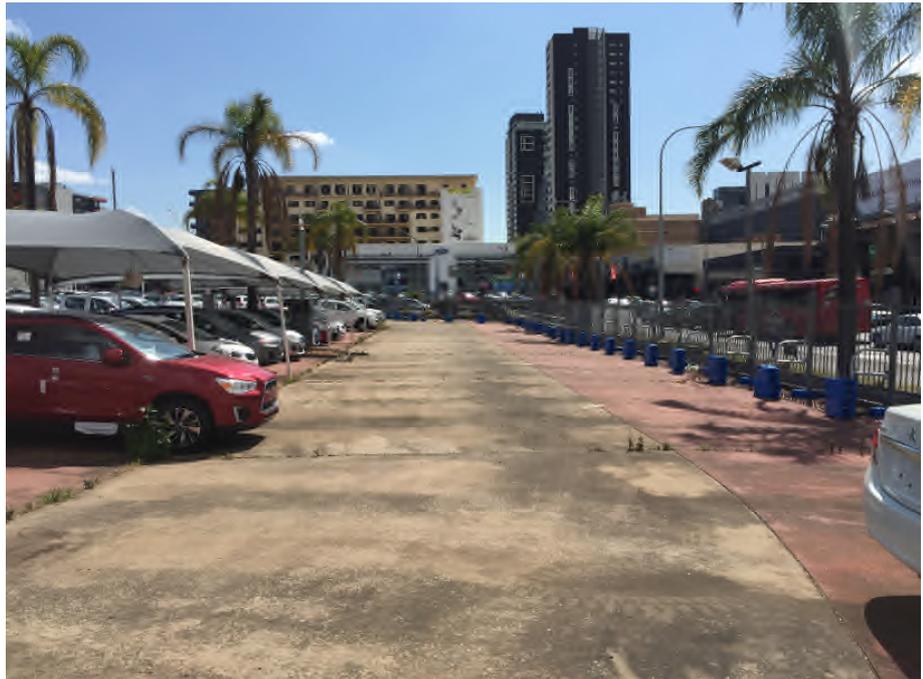
CONSULTING EARTH SCIENTISTS		Photographic Log
Client Name: Gateway Parramatta One Pty Ltd		Site Location: 57, 63 & 83 Church Street, Parramatta, New South Wales	Project Number: CES150907-DYL	
Date: 12/09/15	Plate No: 2

Description: South eastern corner of Site 1. Church Street running north to the left of the photograph.				
Direction Photo Taken: North

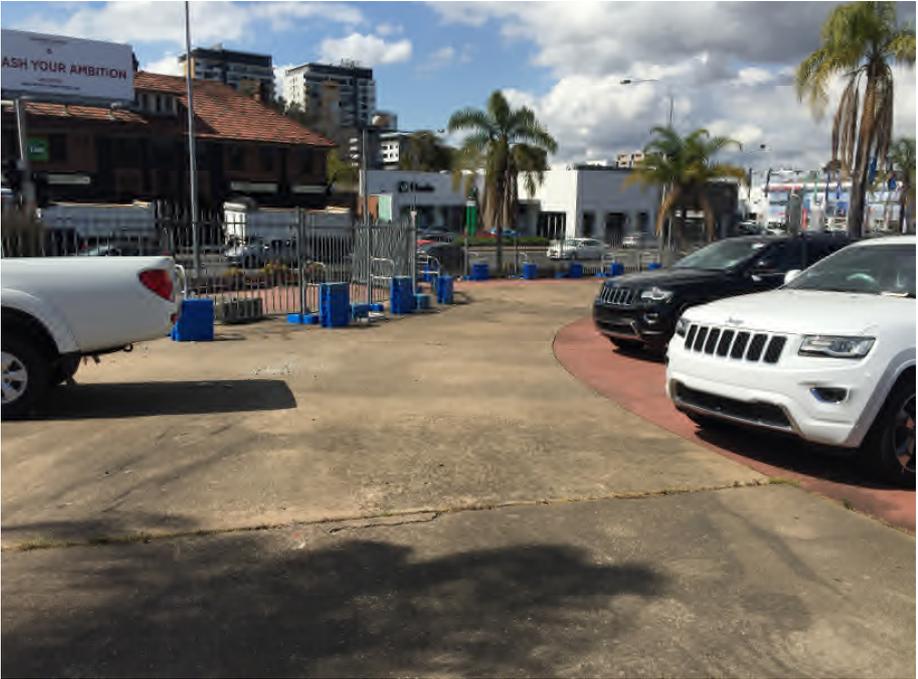
Client Name: Gateway Parramatta One Pty Ltd		Site Location: 57, 63 & 83 Church Street, Parramatta, New South Wales	Project Number: CES150907-DYL
Date: 12/09/15	Plate No: 3

Description: North eastern corner of Site 1. Church Street in the background.			
Direction Photo Taken: Southeast

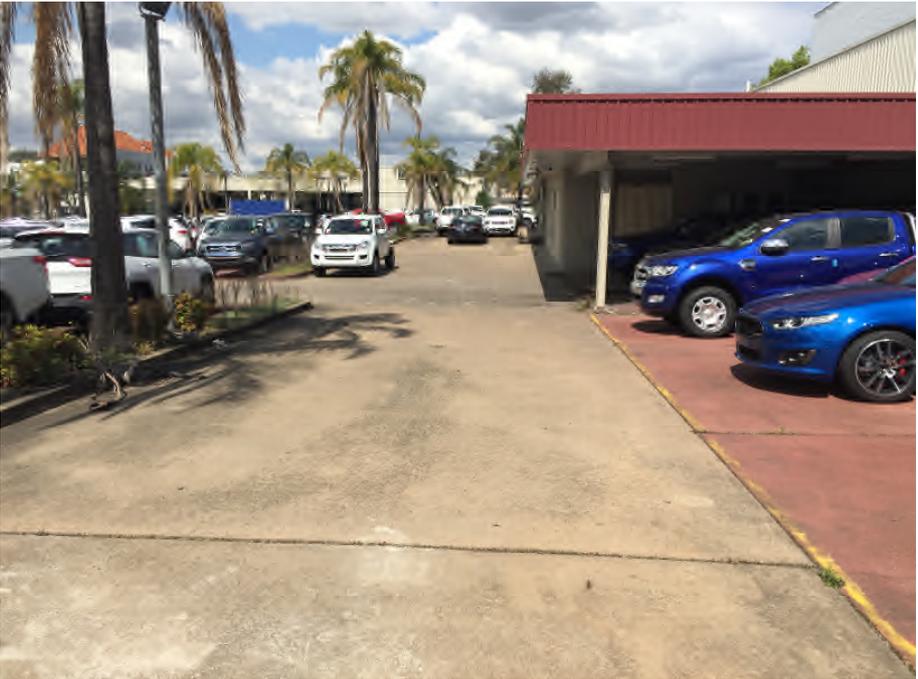
Client Name: Gateway Parramatta One Pty Ltd		Site Location: 57, 63 & 83 Church Street, Parramatta, New South Wales	Project Number: CES150907-DYL
Date: 12/09/15	Plate No: 4

Description: Northwest corner of Site 1.			
Direction Photo Taken: South

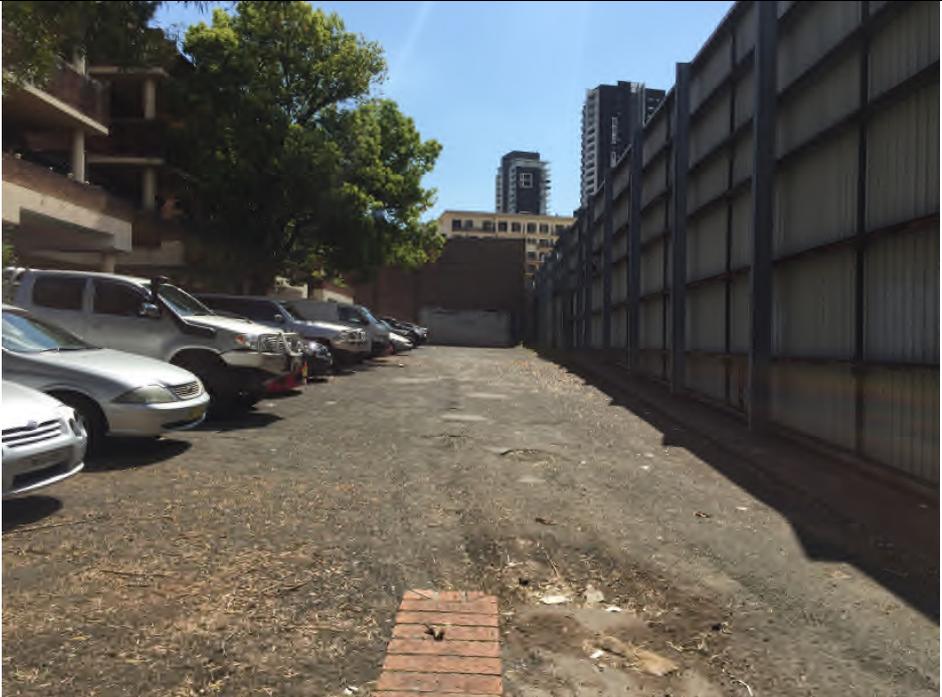
Client Name: Gateway Parramatta One Pty Ltd		Site Location: 57, 63 & 83 Church Street, Parramatta, New South Wales	Project Number: CES150907-DYL
Date: 12/09/15	Plate No: 5

Description: Western boundary of Site 1 (Lot B DP304570) facing north.			
Direction Photo Taken: North

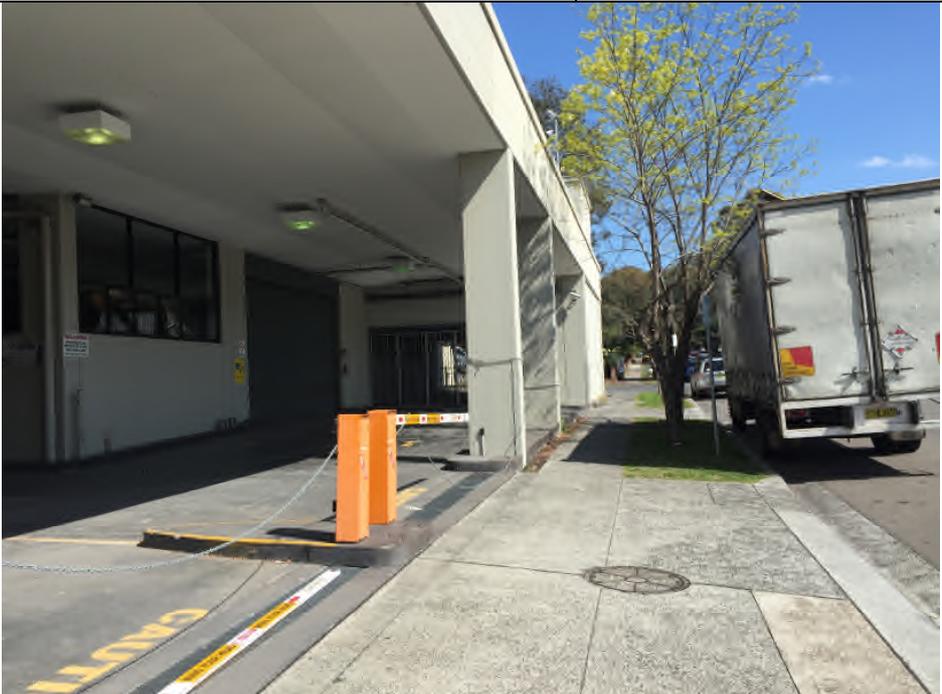
Photographic Log	
Client Name: Gateway Parramatta One Pty Ltd		Site Location: 57, 63 & 83 Church Street, Parramatta, New South Wales	Project Number: CES150907-DYL
Date: 12/09/15	Plate No: 6

Description: Centre of northern boundary and entry way of Site 2. Early Street running west to the right of the photograph			
Direction Photo Taken: West

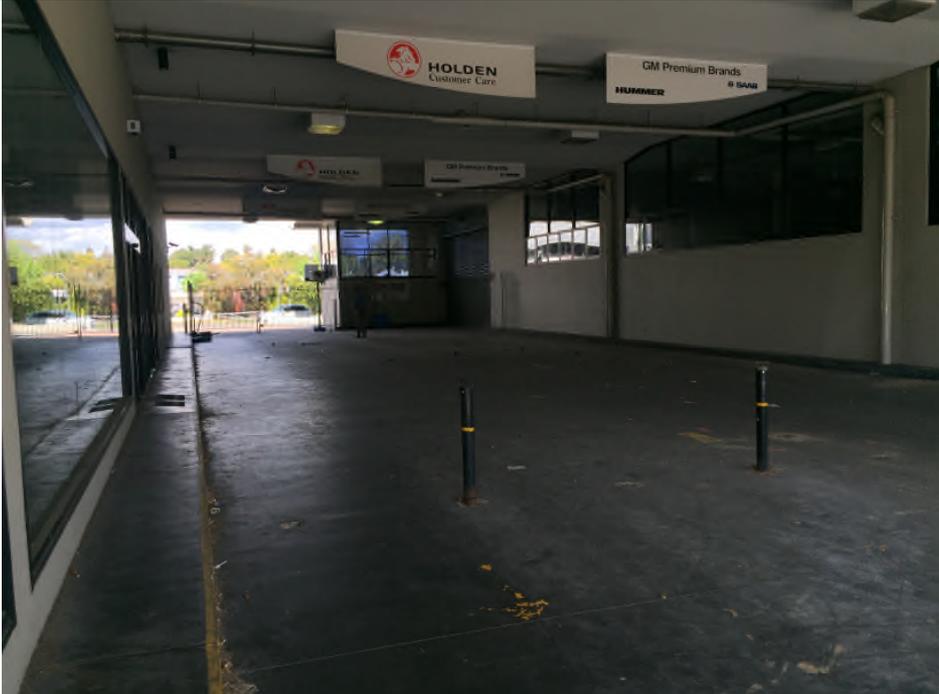
Client Name: Gateway Parramatta One Pty Ltd		Site Location: 57, 63 & 83 Church Street, Parramatta, New South Wales	Project Number: CES150907-DYL
Date: 12/09/15	Plate No: 7

Description: Centre of Site 2 taken from the entry way on the northern boundary, facing south. Offices and showroom to the left and workshop to the right.			
Direction Photo Taken: South

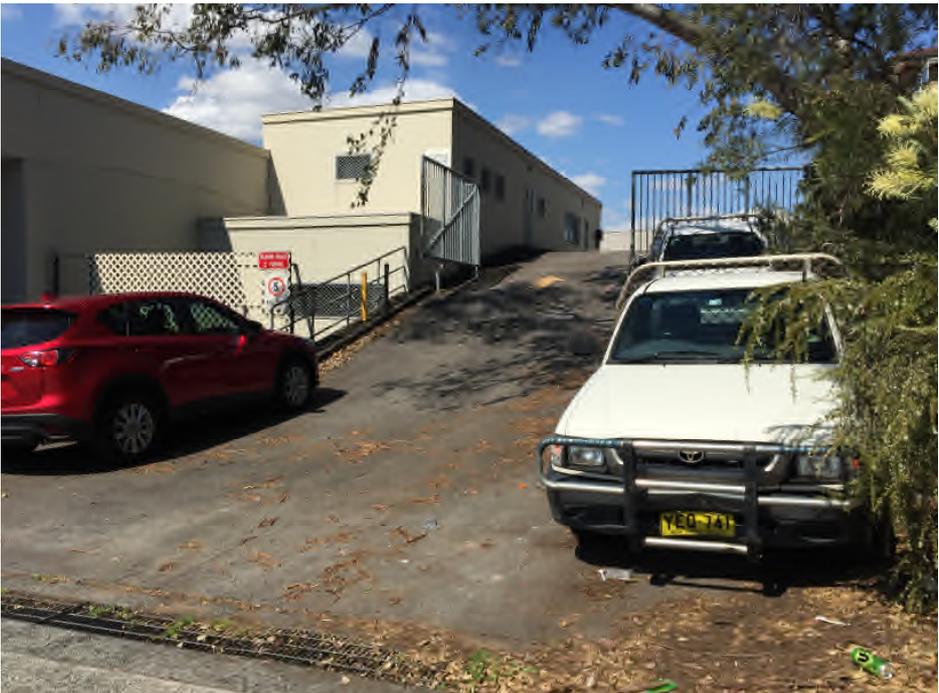
Client Name: Gateway Parramatta One Pty Ltd		Site Location: 57, 63 & 83 Church Street, Parramatta, New South Wales	Project Number: CES150907-DYL
Date: 12/09/15	Plate No: 8

Description: North western corner of Site 2. Entry way to rooftop parking			
Direction Photo Taken: South

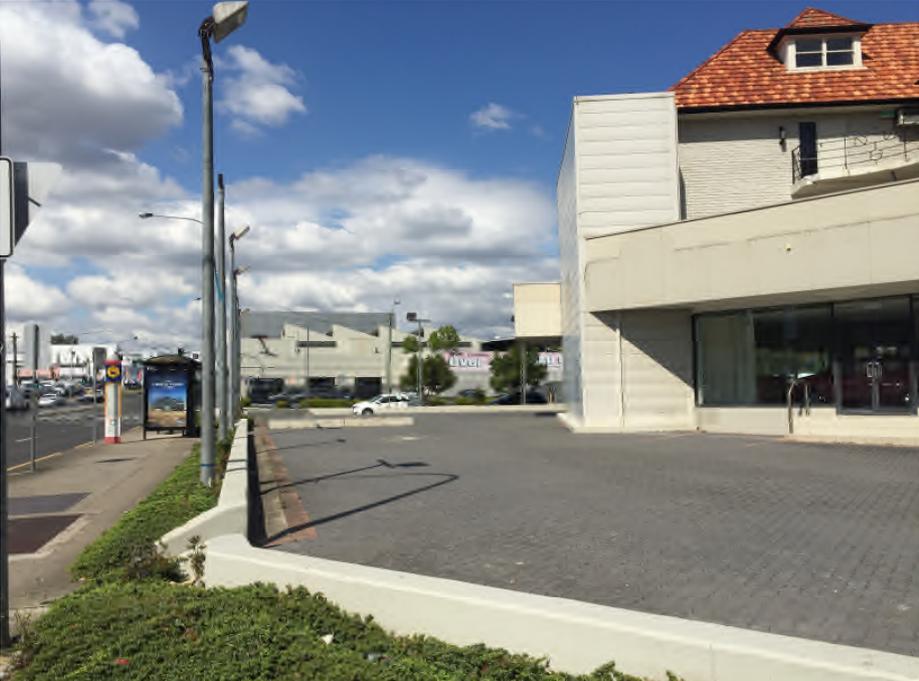
Client Name: Gateway Parramatta One Pty Ltd		Site Location: 57, 63 & 83 Church Street, Parramatta, New South Wales	Project Number: CES150907-DYL
Date: 12/09/15	Plate No: 9

Description: Northeast corner of Site 2 facing south towards Lansdowne Street and Site 3. Church Street to the right of the photograph.			
Direction Photo Taken: South

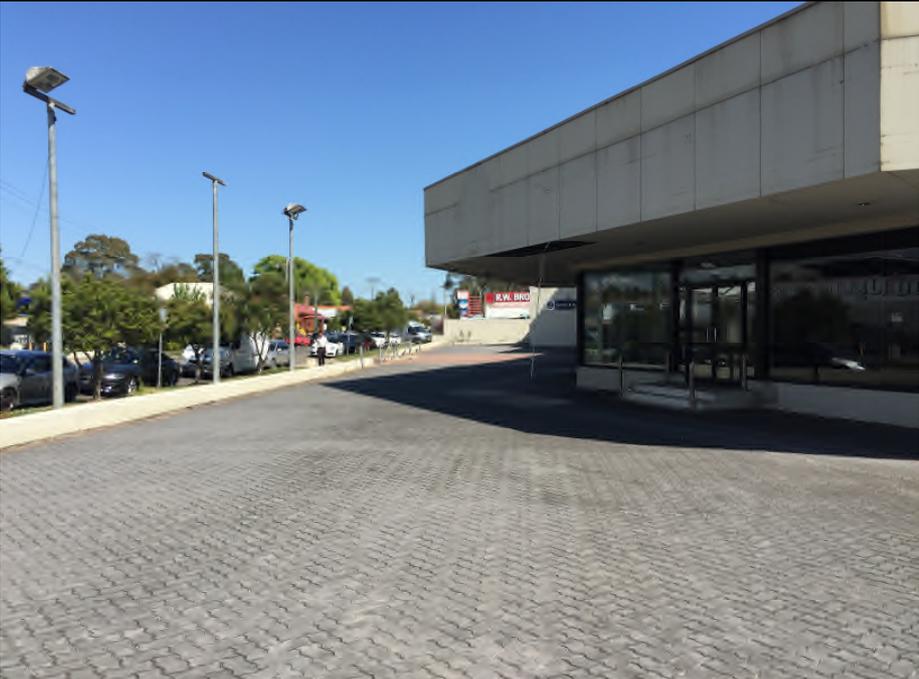
Client Name: Gateway Parramatta One Pty Ltd		Site Location: 57, 63 & 83 Church Street, Parramatta, New South Wales	Project Number: CES150907-DYL
Date: 12/09/15	Plate No: 10

Description: Southeast corner of Site 2 facing west. Lansdowne Street running along the left of the photograph and entry to vehicle showroom shown to the right.			
Direction Photo Taken: West

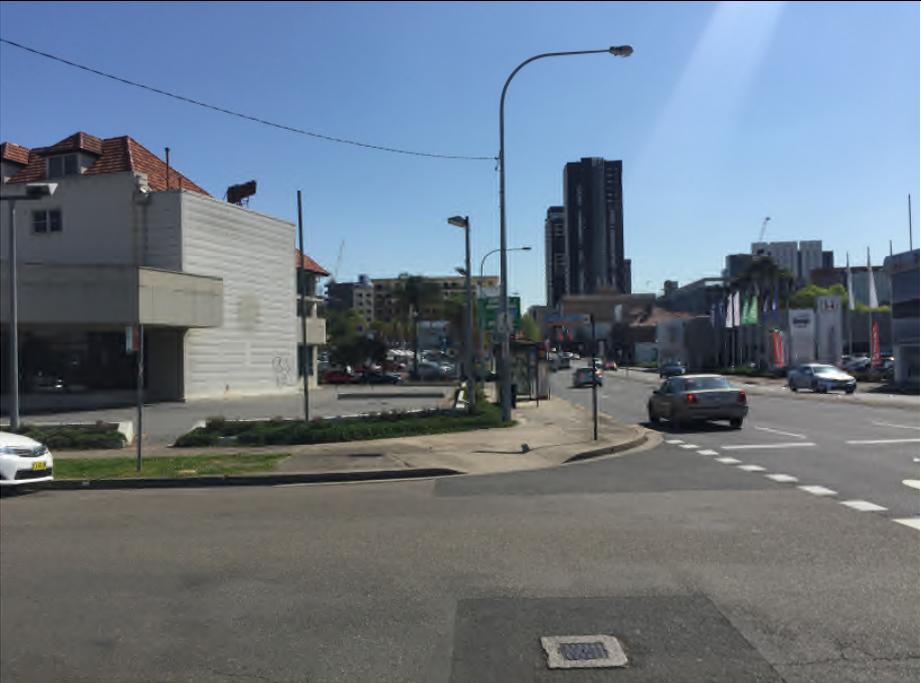
Client Name: Gateway Parramatta One Pty Ltd		Site Location: 57, 63 & 83 Church Street, Parramatta, New South Wales	Project Number: CES150907-DYL
Date: 12/09/15	Plate No: 11

Description: Corner of Lansdowne Street and Church Street.			
Direction Photo Taken: North

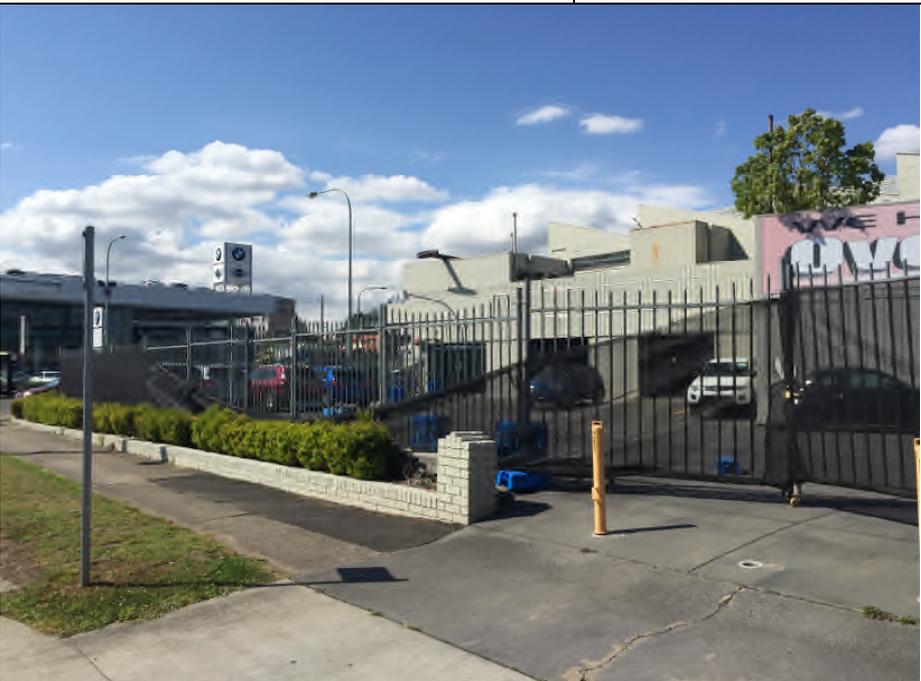
Client Name: Gateway Parramatta One Pty Ltd		Site Location: 57, 63 & 83 Church Street, Parramatta, New South Wales	Project Number: CES150907-DYL
Date: 12/09/15	Plate No: 12

Description: Northern boundary and entry way to Site 3.			
Direction Photo Taken: Southeast

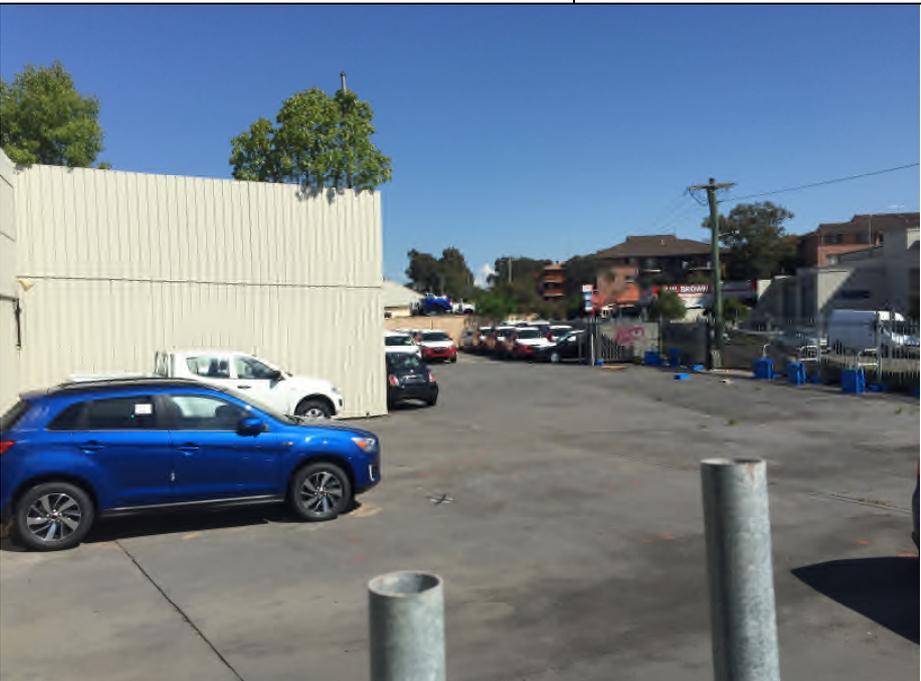
Client Name: Gateway Parramatta One Pty Ltd		Site Location: 57, 63 & 83 Church Street, Parramatta, New South Wales	Project Number: CES150907-DYL
Date: 12/09/15	Plate No: 14

Description: Site 3 largely used for storage of vehicles.			
Direction Photo Taken: West

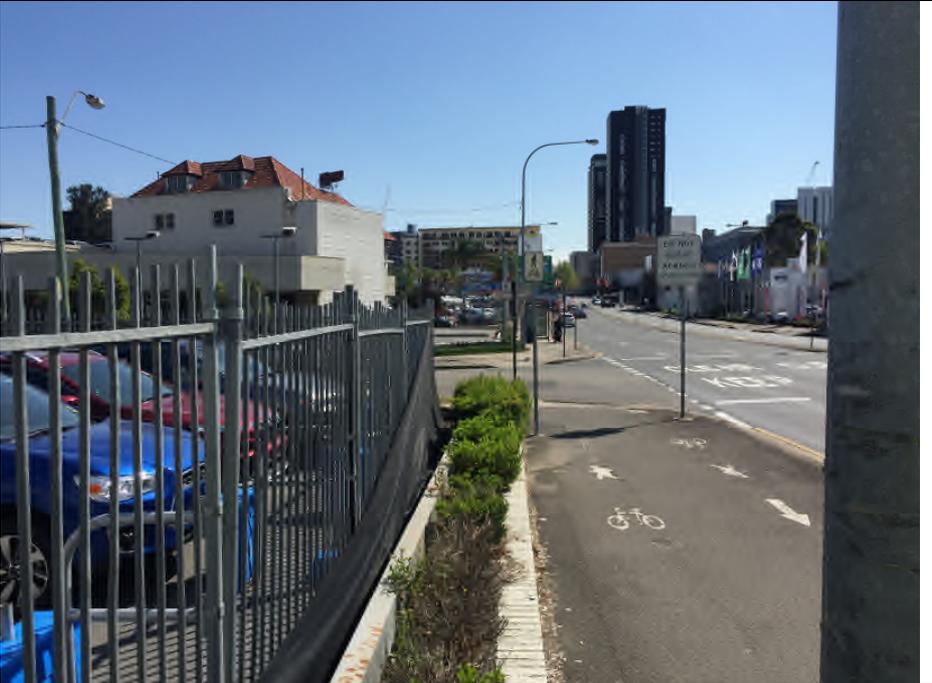
Client Name: Gateway Parramatta One Pty Ltd		Site Location: 57, 63 & 83 Church Street, Parramatta, New South Wales	Project Number: CES150907-DYL
Date: 12/09/15	Plate No: 15

Description: Outside the eastern boundary of Site 3.			
Direction Photo Taken: North
