Remedial Action Plan

**'Parramatta Civic Link – Block 3', Horwood Place,
Parramatta, NSW, 2150**

Our Ref: 30286862_PCC-Parra-Block3_RAP_R02

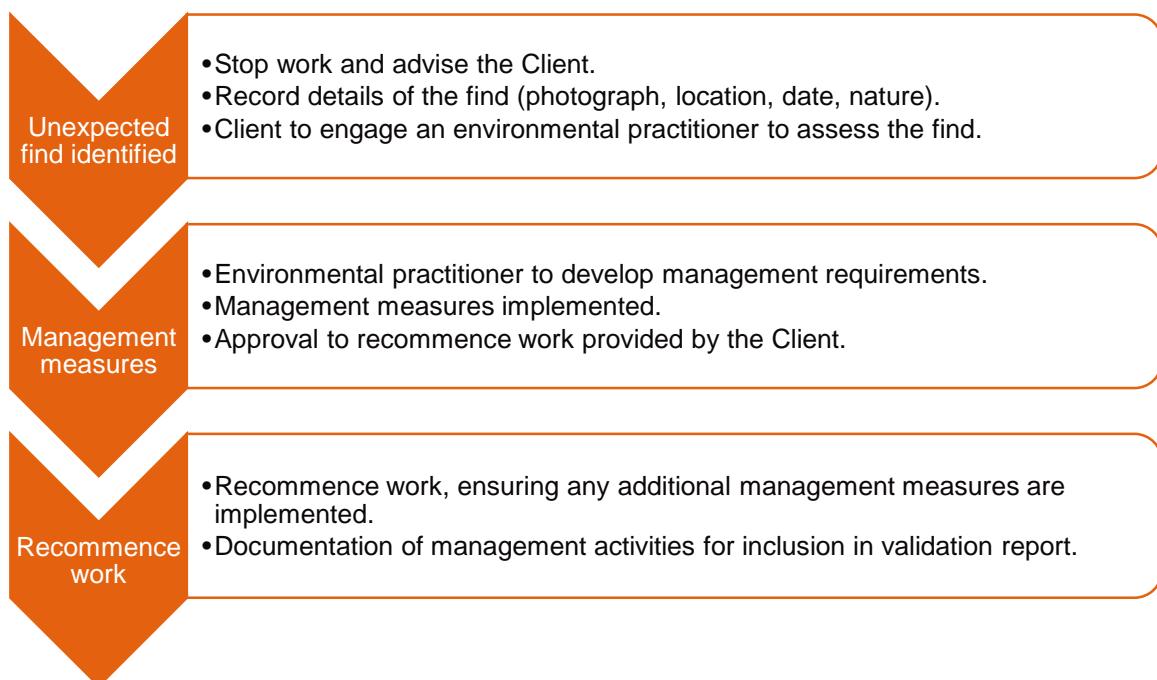
Chart 5-1 Unexpected Finds Protocol

- Previously unidentified contamination including large volumes of asbestos and/or friable asbestos.
- Large quantities of anthropogenic materials (>10%).
- Offensive odours emanating from soil or groundwater.
- Unusual staining (e.g. sheen or dark colouring) of soil.
- Ingress of steady flow of groundwater.
- Underground infrastructure (e.g. underground storage tanks, underground sumps/pits).

A summary of the UEF Protocol is provided in Chart 5-1

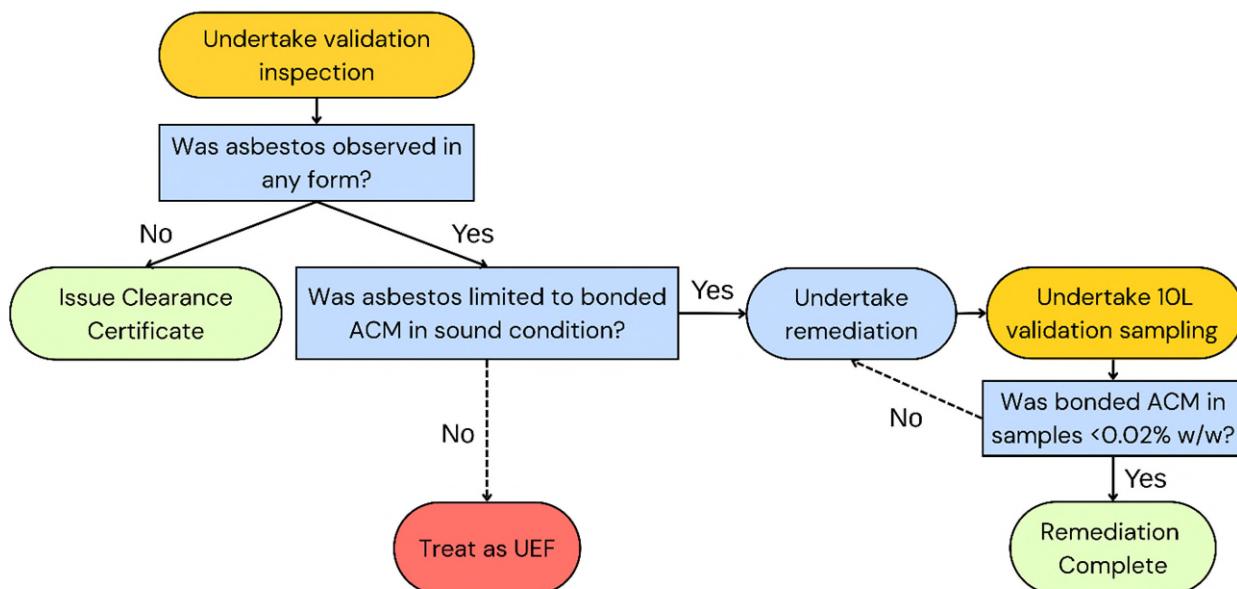
Chart 7-1 Validation Strategy

The validation strategy is summarised in *Chart 7-1* with relevant validation activities shown in yellow.

Surfaces are to be systematically visually inspected for the presence of asbestos by an appropriately competent person².

If remediation is required, then validation of the remediation is by both visual inspection and by asbestos validation sampling and field screening to be undertaken in accordance with the recommended methodology detailed in the NEPM (NEPC, 2013).

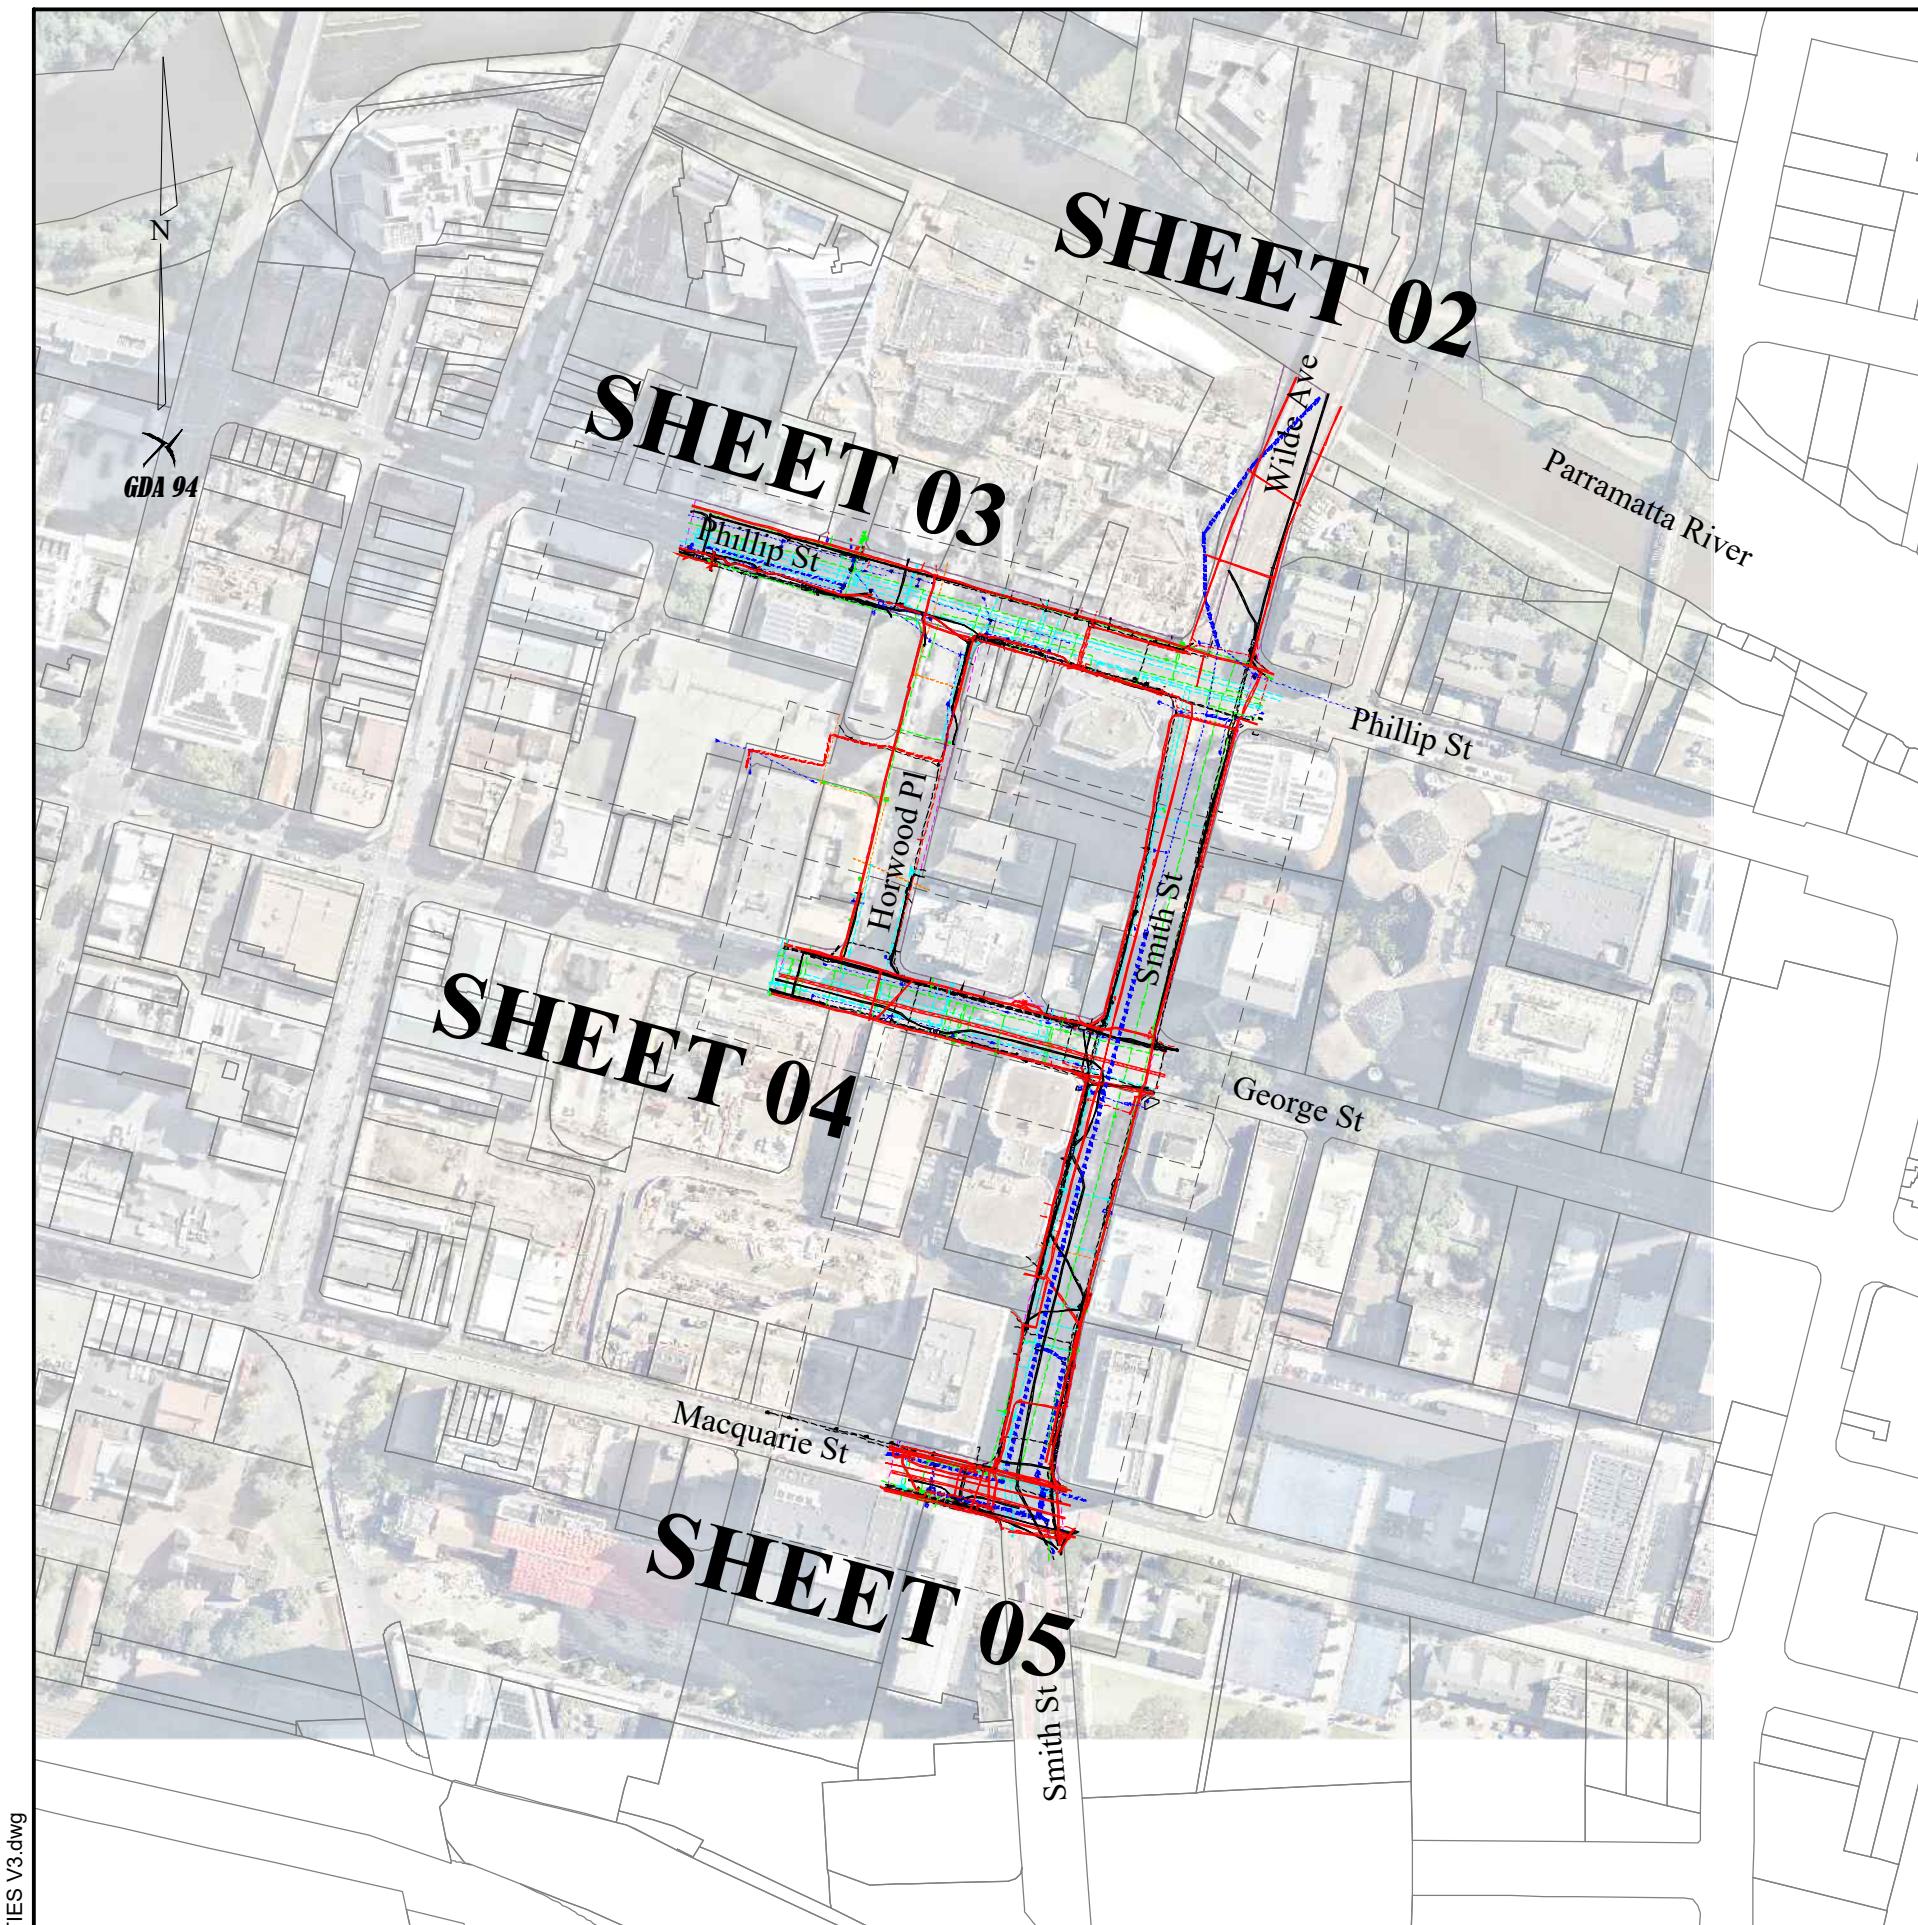
Electronic Subsurface Utility Information (SUI) detection techniques such as EM & GPR are influenced by Sub-Surface Utility (SSU) type & ground conditions. Best practice detection rates are 80-90% and depth accuracy ranges between +/- 300mm for 90% of readings with significant outliers for the remainder.

Quality levels (as per AS-5488-2019) are mentioned for each point. Please note that Quality Levels may vary for different points of a string. Please see the definitions of the Quality Levels for more information.

Storm Water assets are QL-A at SW Pits unless the pipes have not been accessible (pits full of dirt, rusted gatic lids, etc.) and QL-C between pits. Storm Water pipes have been shown where the judgment could be made based on the location of the SW surface features. In some areas, it's impossible to work out the alignments as the SW pipes bend and change directions. If the exact route of the SW pipes is needed for design purposes, a comprehensive drainage survey using CCTV techniques is required to confirm the alignments and connectivity.

Potholing is recommended to confirm the depth & position of all utilities located.

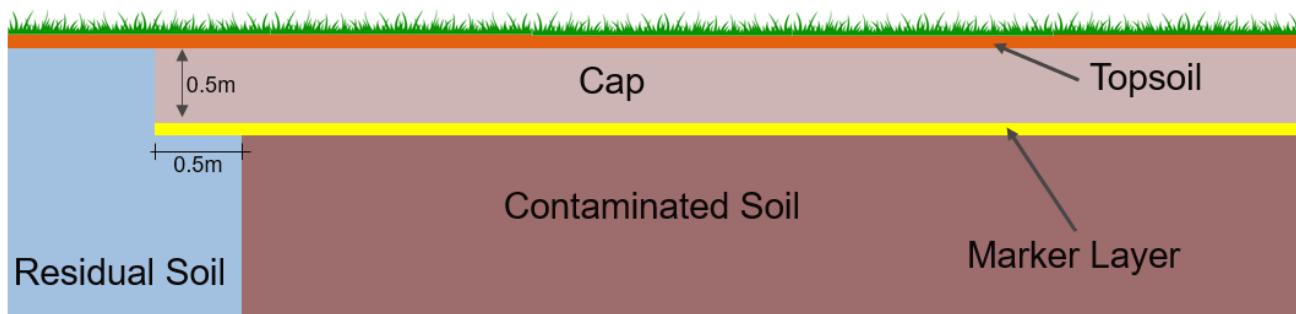
Image 1: Landscaped Area Capping Example

To reduce the potential for erosion or penetration of the capping layer, loose or unconsolidated sediments should not be used to create the cap.

Areas are to be finished with a layer of grass, mulch or concrete (for the pedestrian pathway) as is required for future land use. A schematic example of the required capping is shown in image below.

Damage sustained to the marker layer during or following installation will be rectified by placement of a patch of marker layer atop the damage and including sufficient overlap for the shear strength of the underlying soil.
