MARRI BADOO PLAYGROUND UPGRADE

ORIGINAL CONCEPT DESIGN

REVISED CONCEPT DESIGN

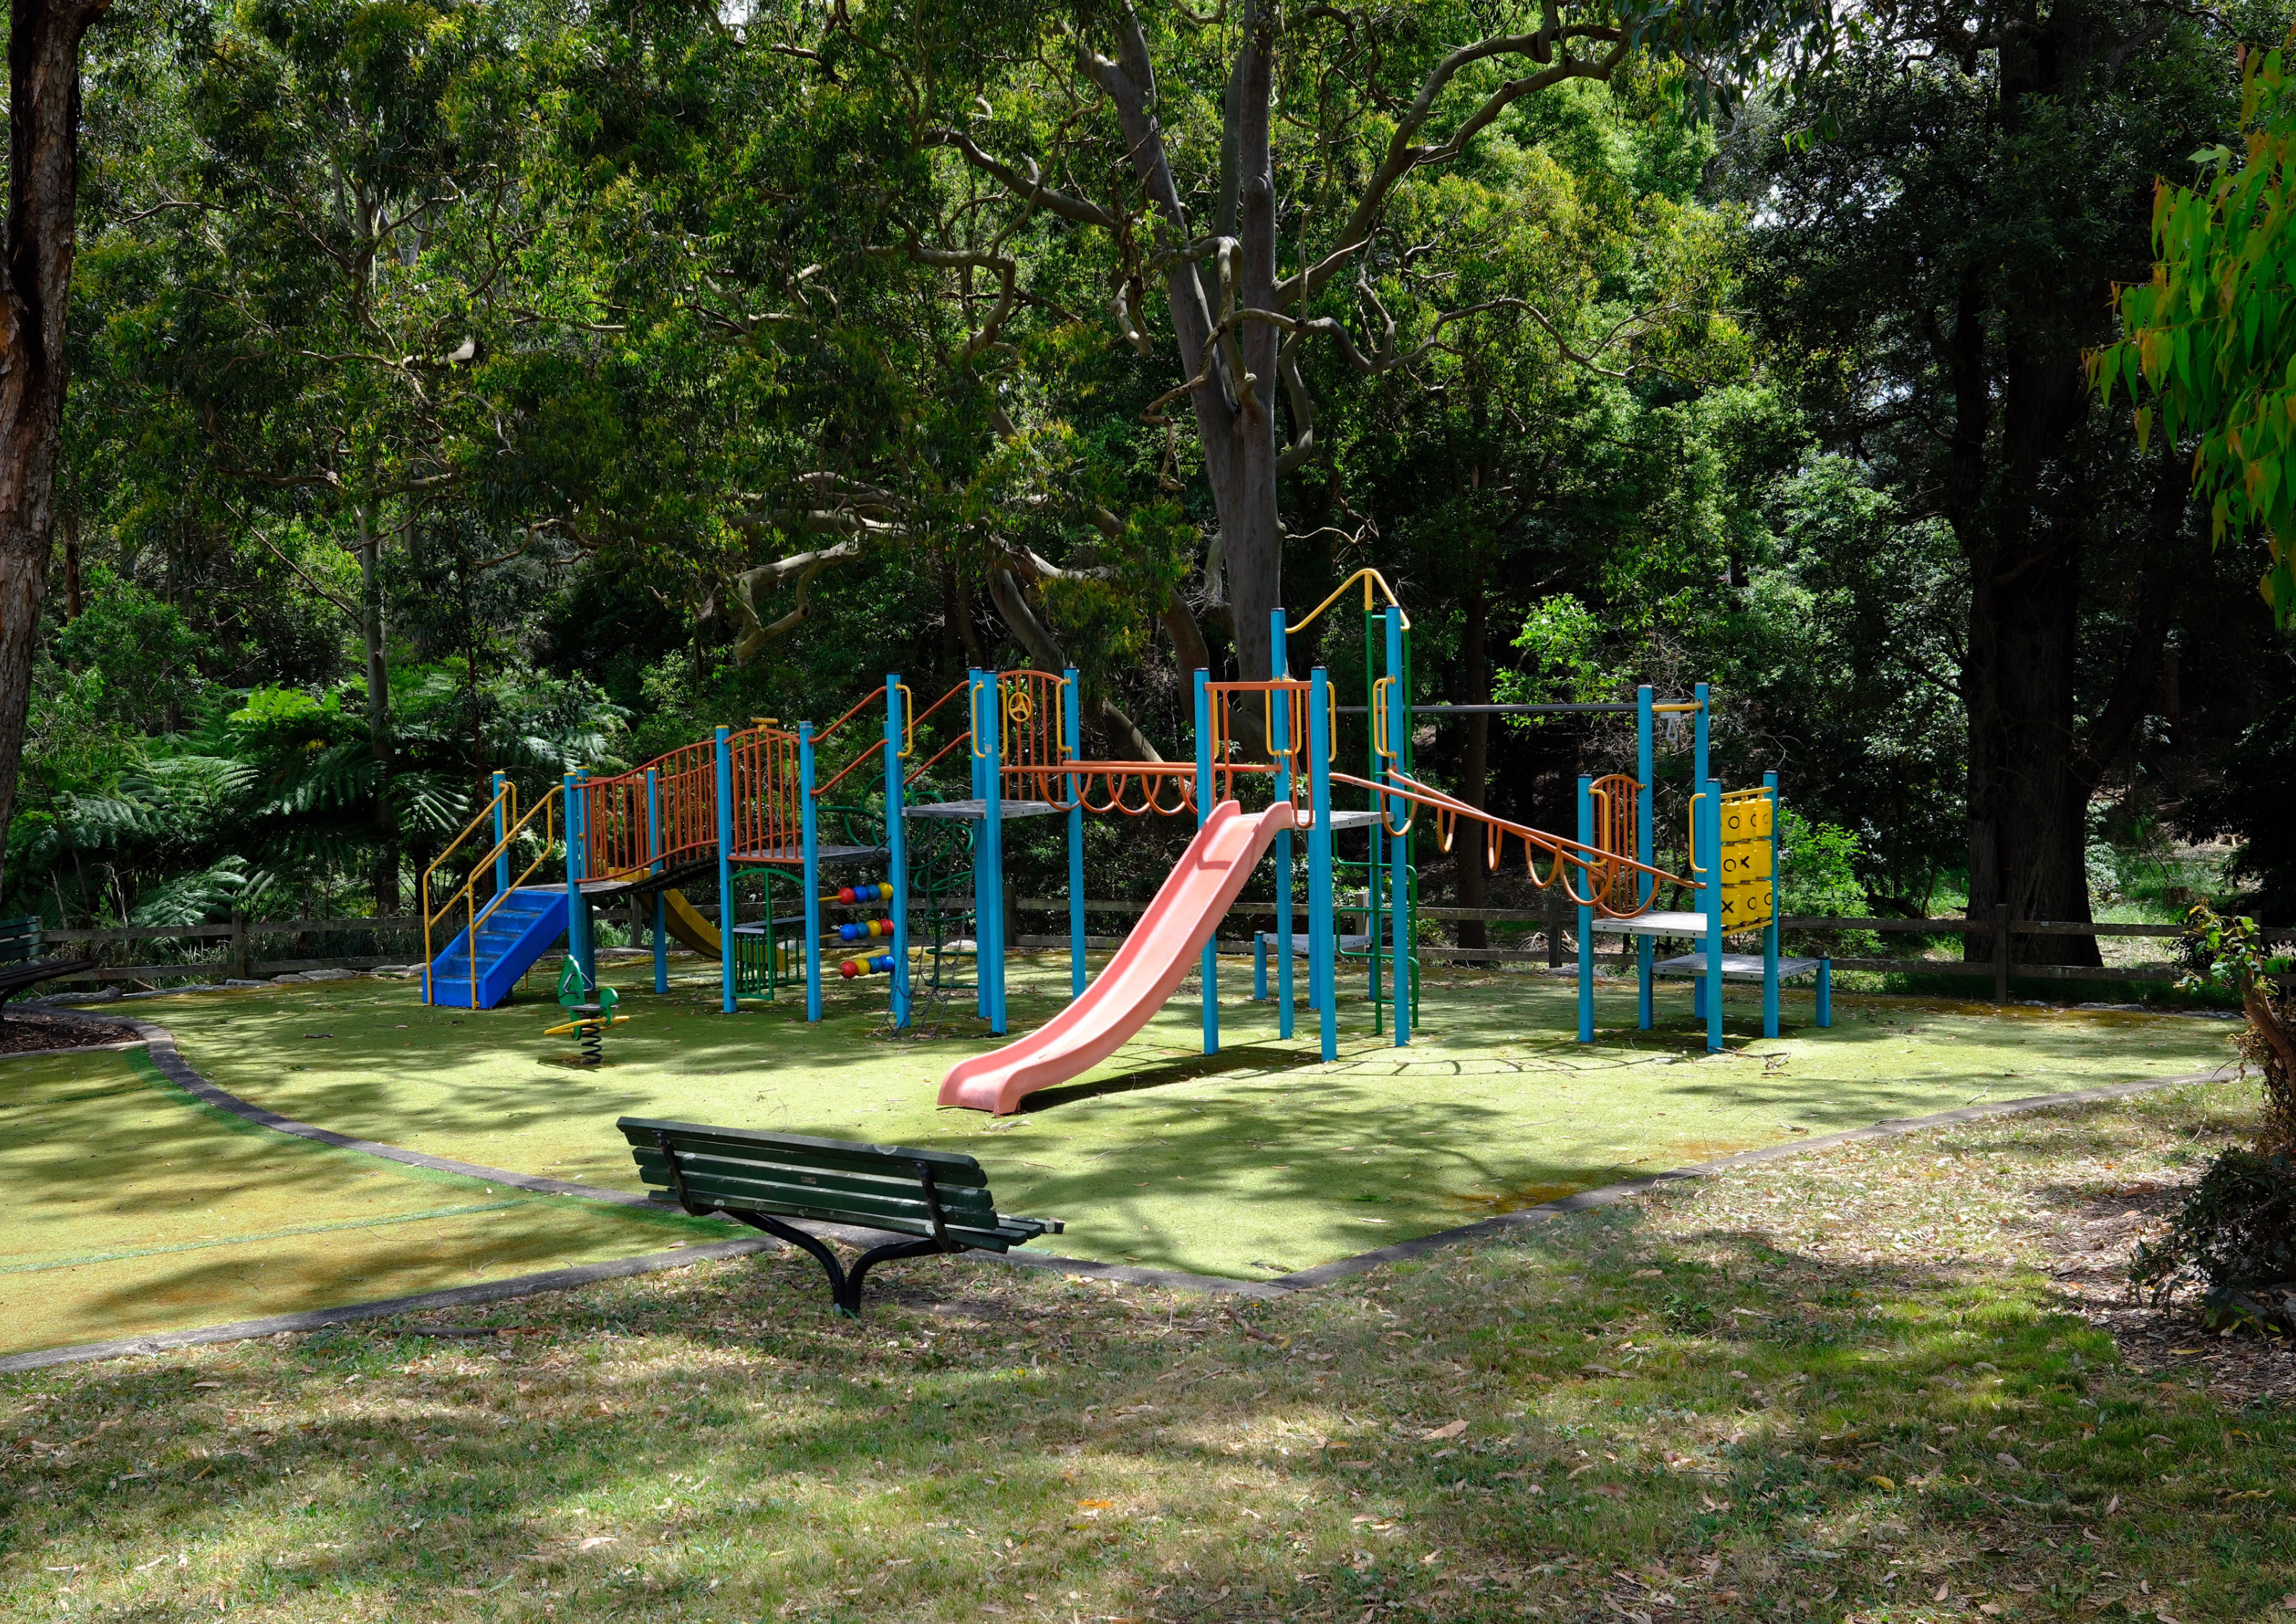
REVISION A

- ① New picnic shelter and picnic table setting
- ② Paved area with two new bench seats
- ③ Existing stone retaining wall retained
- ④ New climbing play equipment
- ⑤ New triple swing, with regular swing, infant swing and hammock
- ⑥ Potential future path connection to Christina Street
- ⑦ All existing trees to be retained and protected

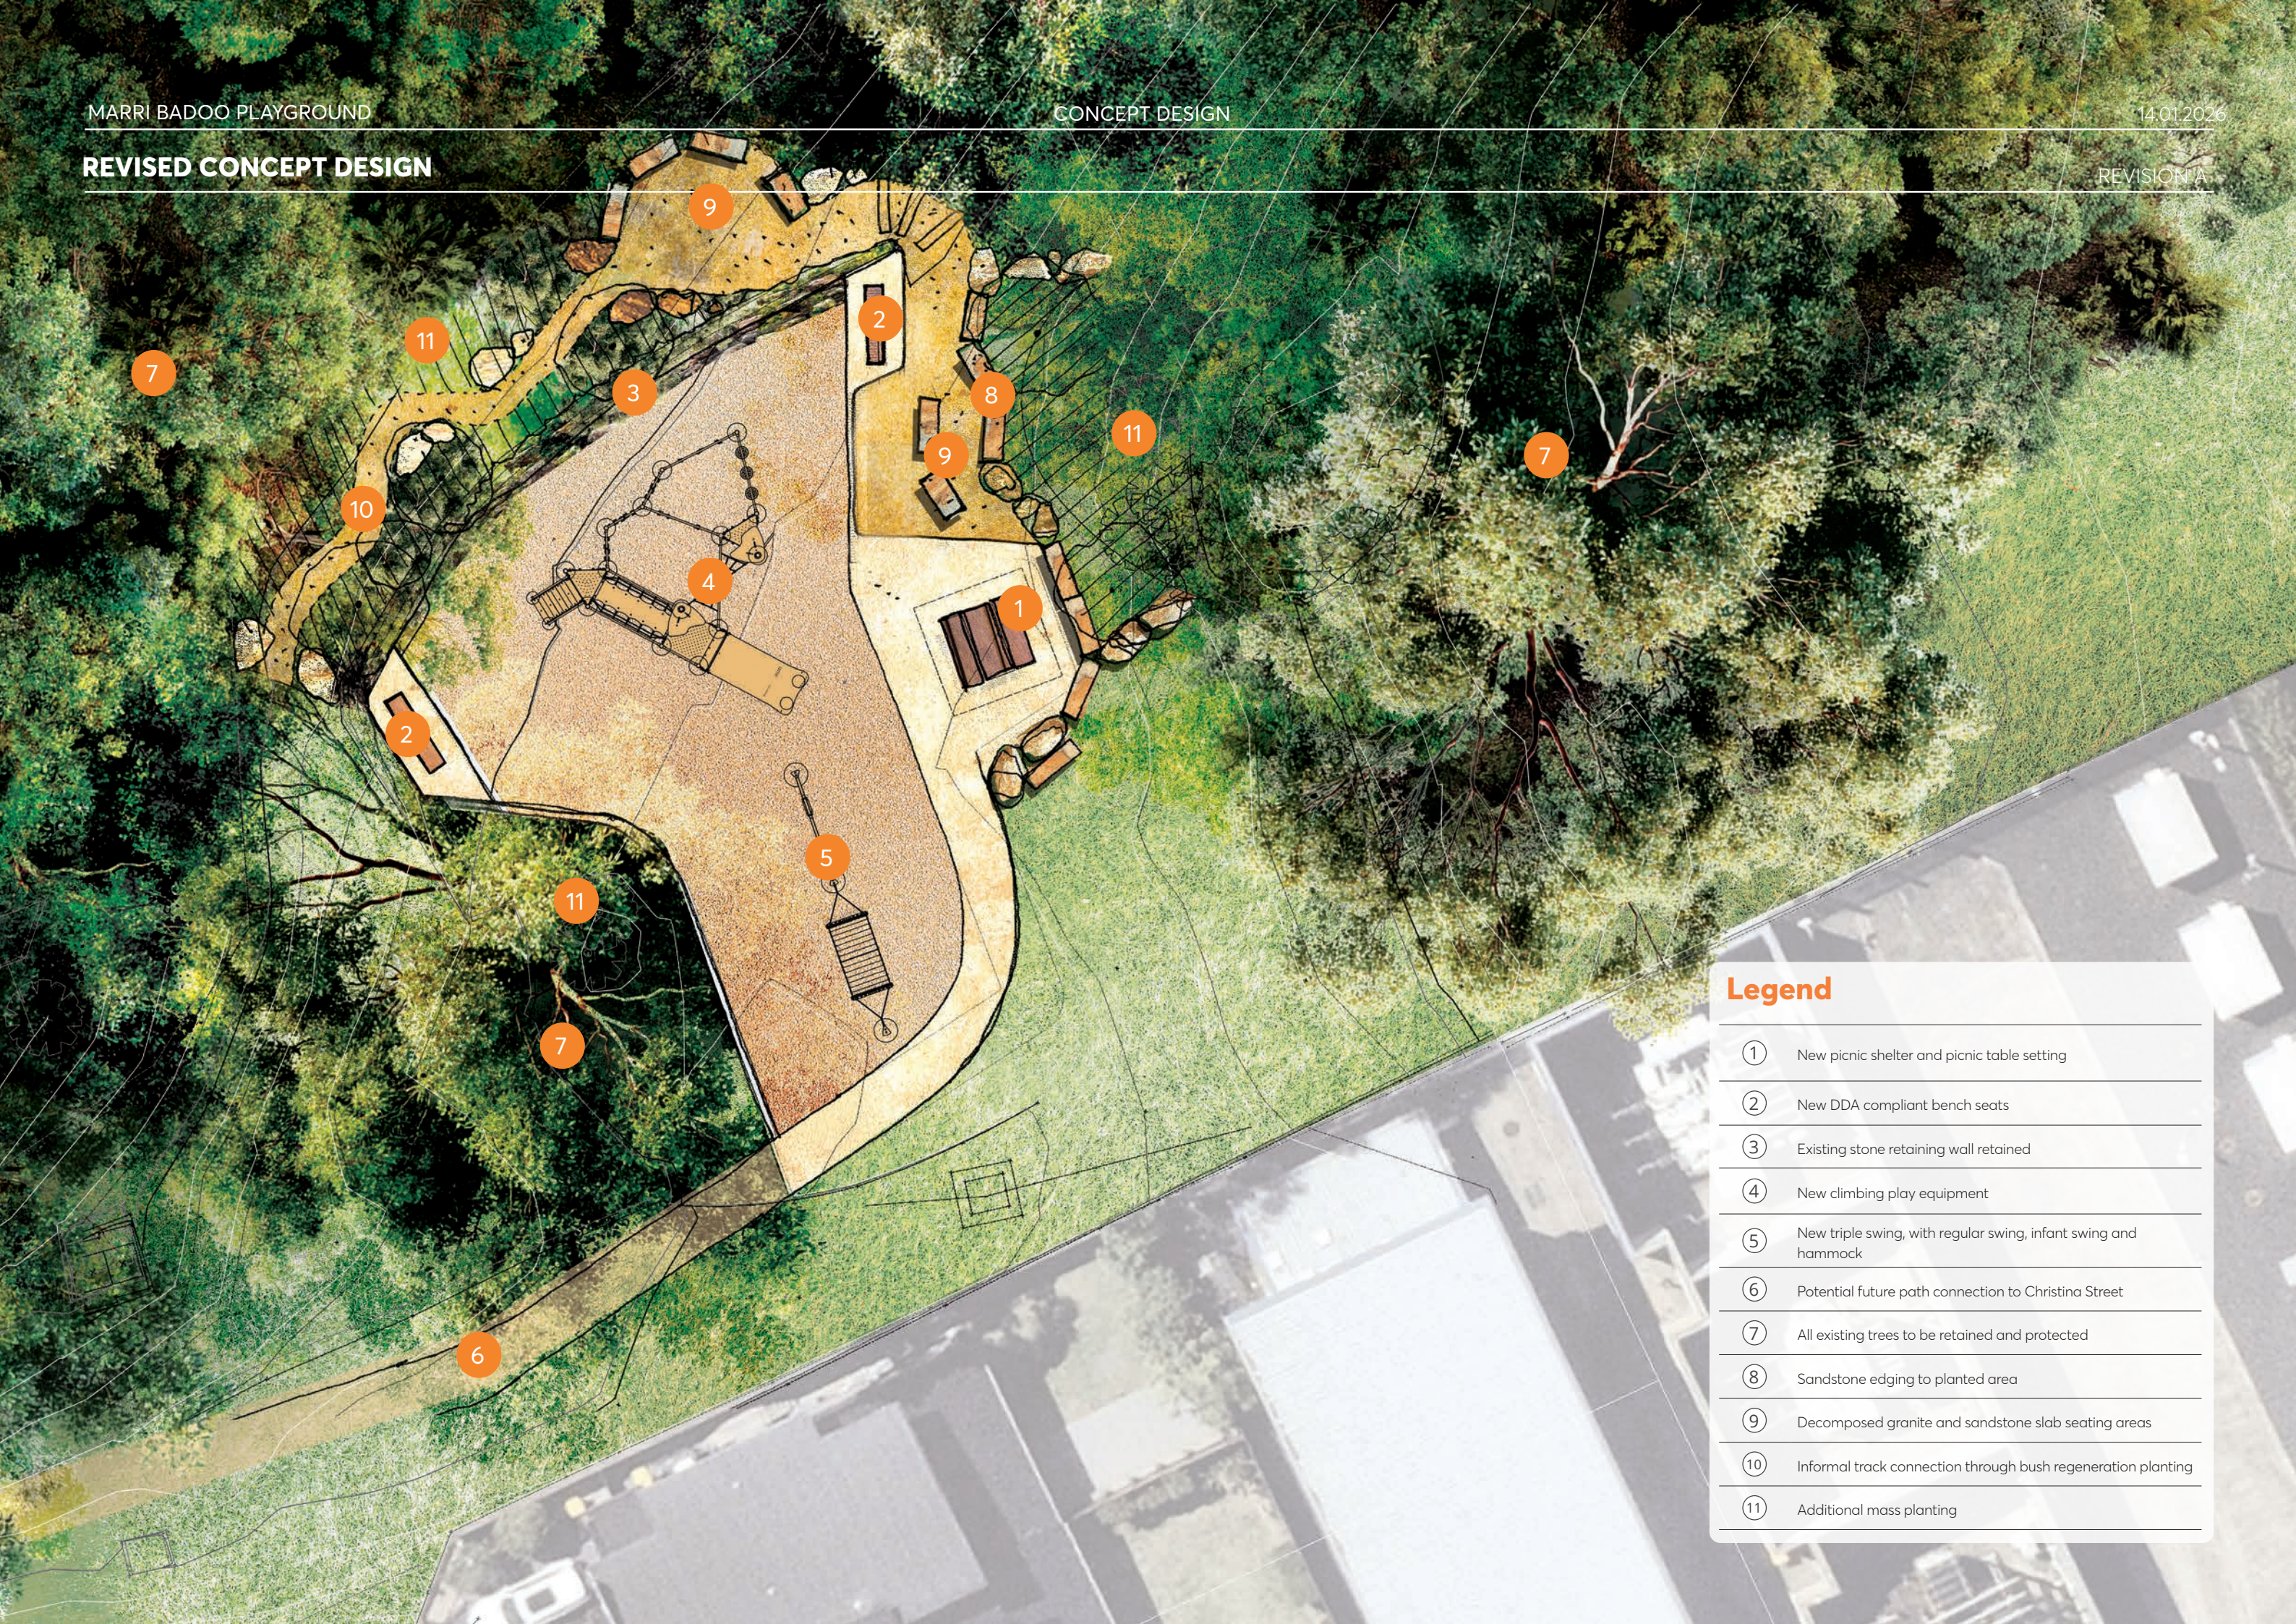
- ① New picnic shelter and picnic table setting
- ② New DDA compliant bench seats
- ③ Existing stone retaining wall retained
- ④ New climbing play equipment
- ⑤ New triple swing, with regular swing, infant swing and hammock
- ⑥ Potential future path connection to Christina Street
- ⑦ All existing trees to be retained and protected
- ⑧ Sandstone edging to planted area
- ⑨ Decomposed granite and sandstone slab seating areas
- ⑩ Informal track connection through bush regeneration planting
- ⑪ Additional mass planting

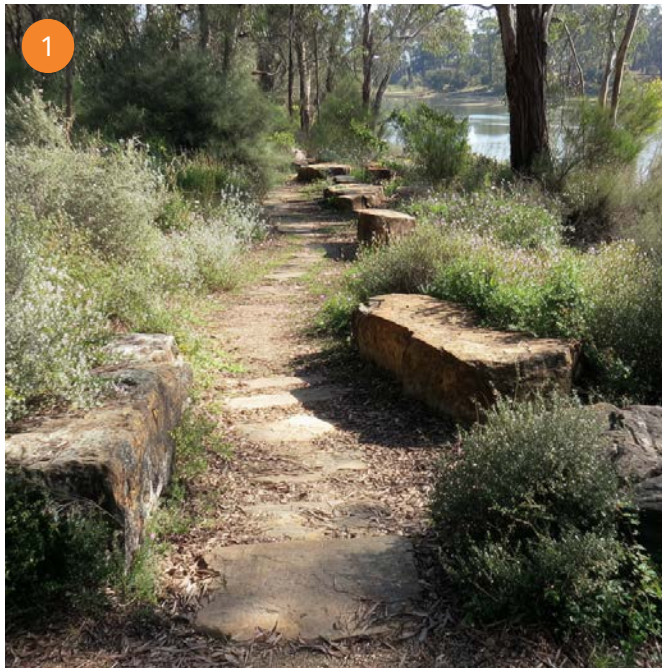
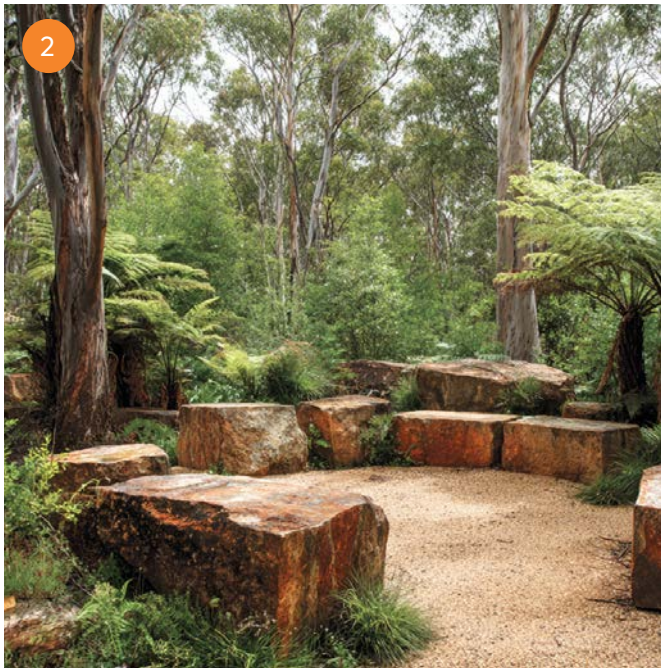
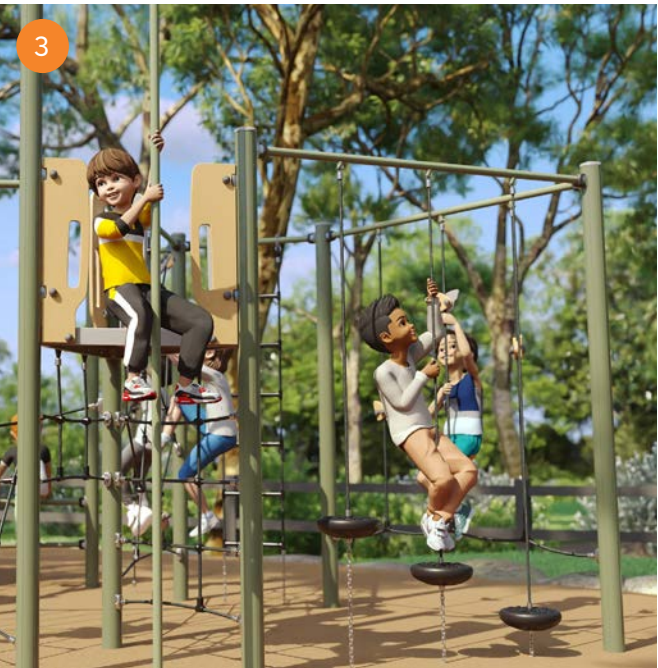
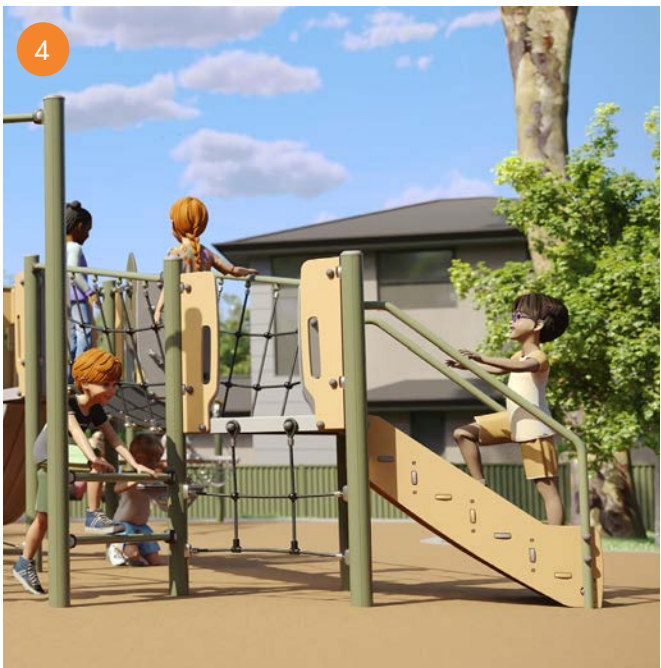
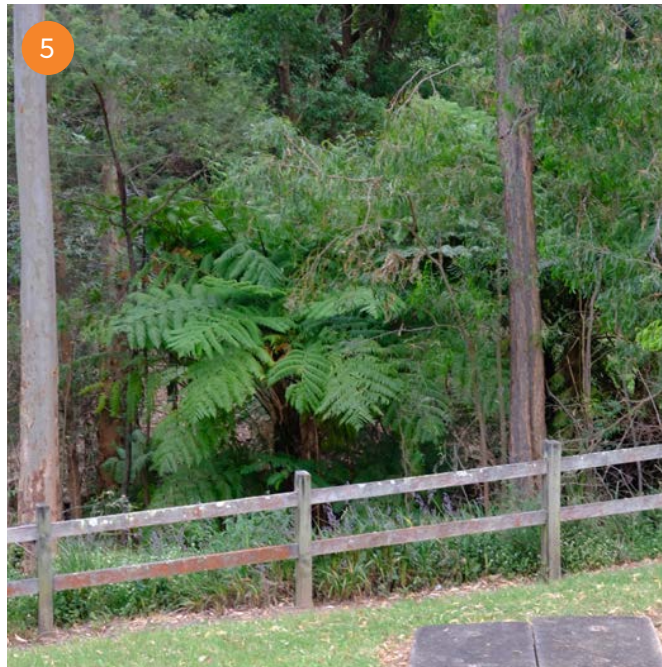
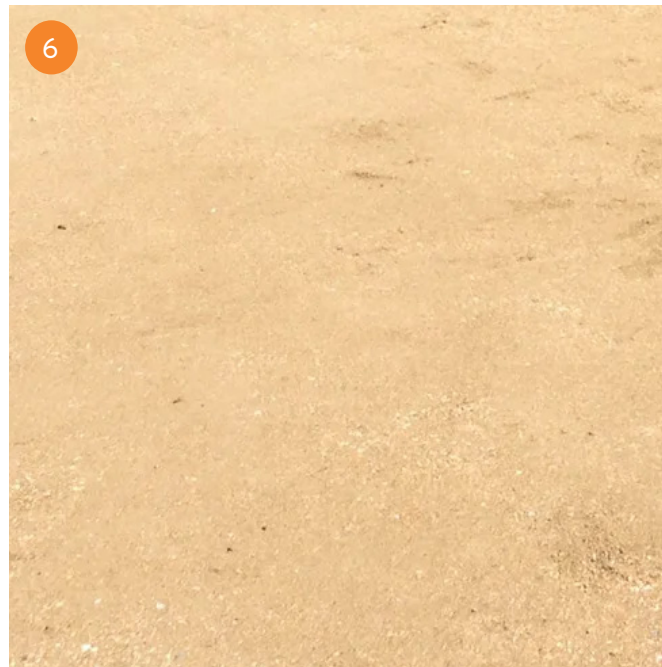
①	Indicative track pathway through regeneration planting	④	Existing bushland character to inform species selection in areas of mass planting
②	Proposed decomposed granite and sandstone slab seating areas	⑤	Decomposed granite surface example
③	Proposed equipment colours and finishes	⑥	Proposed rubber impact attenuation surface colour selection
④	Proposed equipment colours and finishes	⑦	Proposed equipment colours and finishes
